# **In-Service Condition Monitoring of Polymer Housed Surge Arrester within EThekweni Electricity**

A dissertation submitted in fulfillment of the requirements for the degree of Master in  
Technology

**Department of Electrical Power Engineering  
Faculty of Engineering and Built Environment**

February 2014

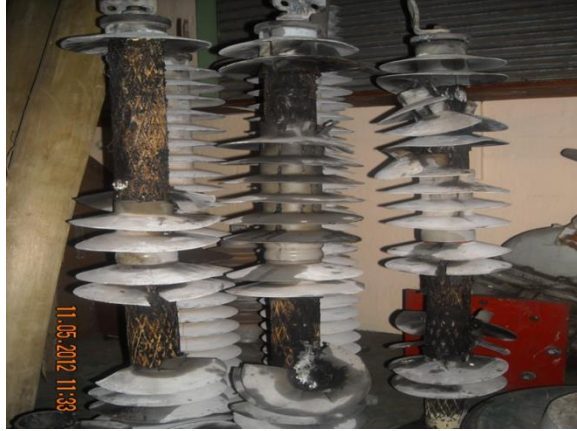
Recently, eThekwini Electricity has experienced a trend where a certain brand of surge arresters fails (see Figure 1.2) without any associated overvoltages in the electrical system. (Overvoltages caused by lightning strikes, switching operations, or system faults).

**Figure 1.2:** ZnO surge arresters with polymer housing that failed.

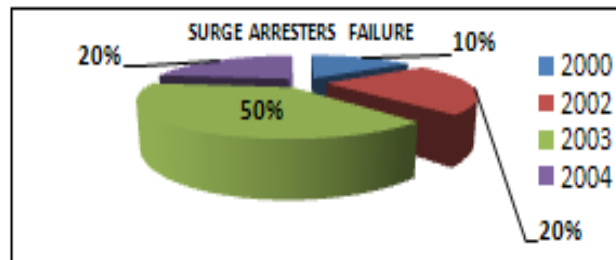
This causes unnecessary outages along the line. Figure 1.3 represents the number of surge arresters that failed in the system during the period 2000 to 2004. Since this has happened in the past and continues to happen, a decision was taken to perform an investigation to identify the causes of failure and find satisfactory solutions.

**Figure 1.3:** Surge arrester failure at eThekweni Electricity.

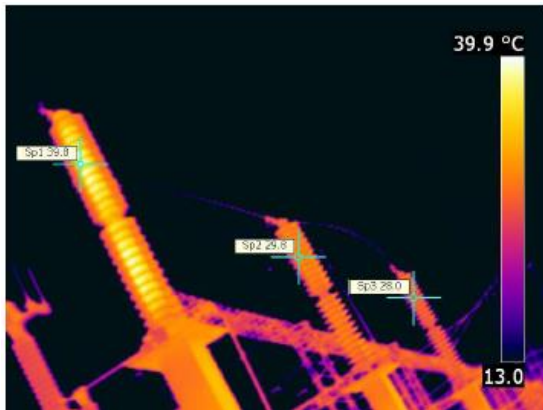
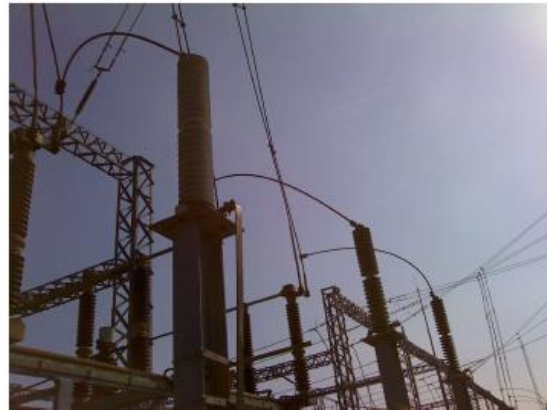
**Figure 6.1:** Thermo-grams for substation A; 2 arresters were showing a high amount of heat.

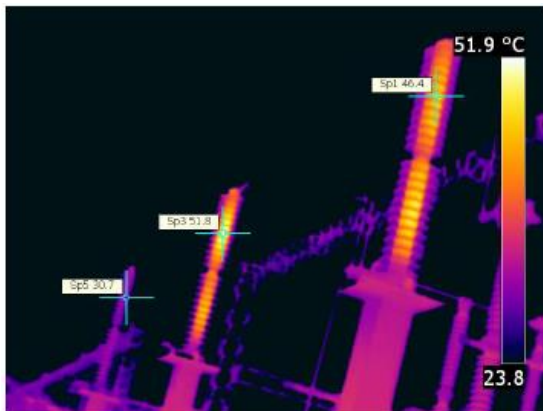
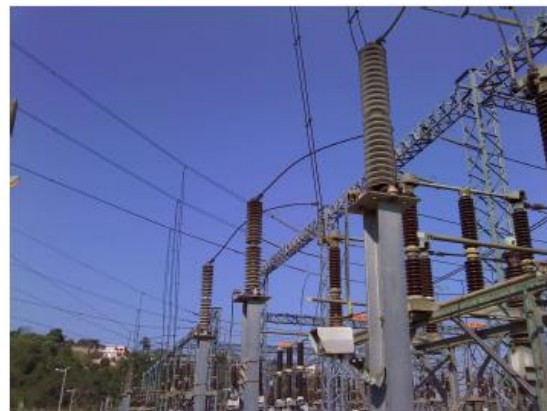
**Figure 6.2:** Thermo-grams for substation A indicated the high amount of temperature inside the arrester.

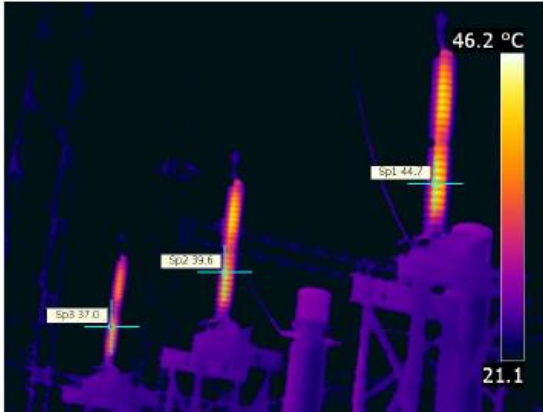
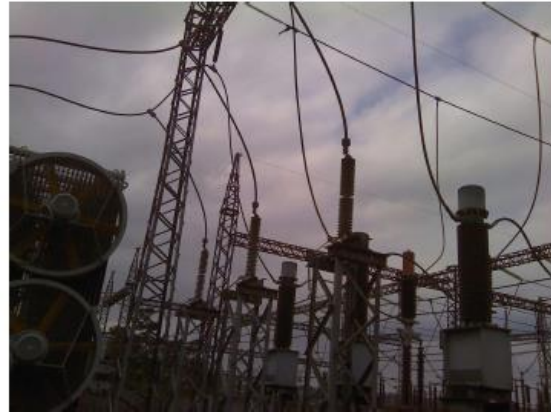
**Figure 6.7:** Thermo-grams for substation B showing the amount of heat inside arrester.

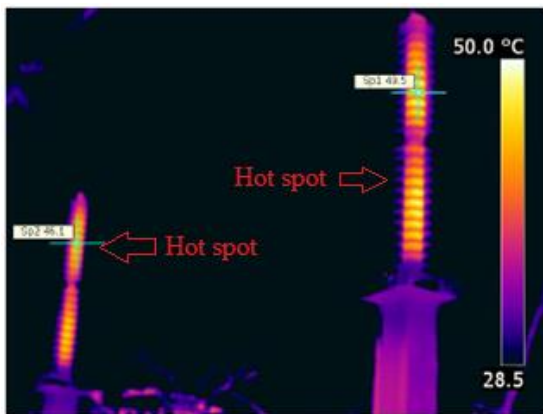
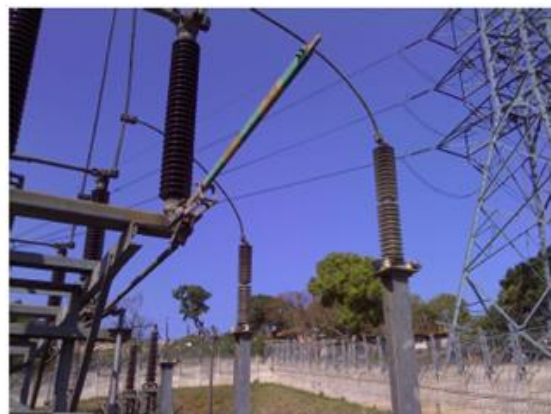
**Figure 6.8:** Thermo-grams for substation B showing the amount of heating inside arrester.

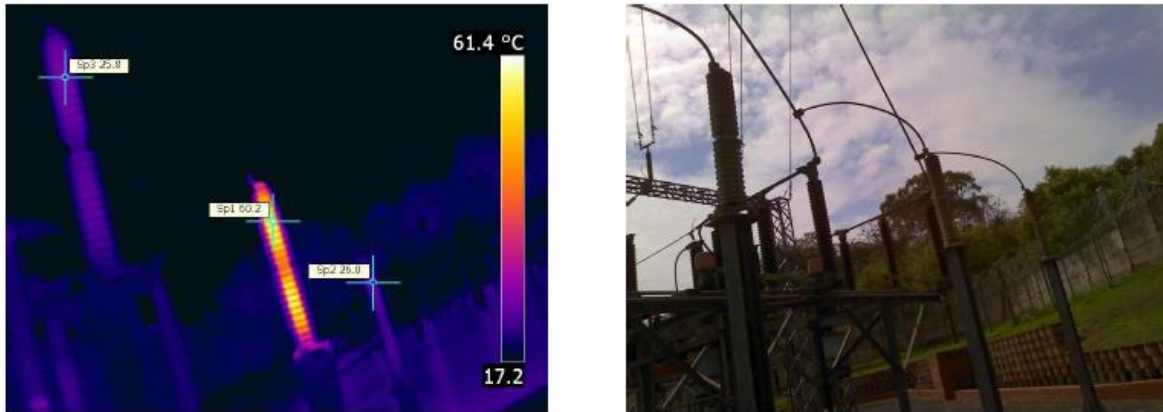
**Figure 6.9:** Thermo-grams for substation B showing the amount of heating inside arrester.

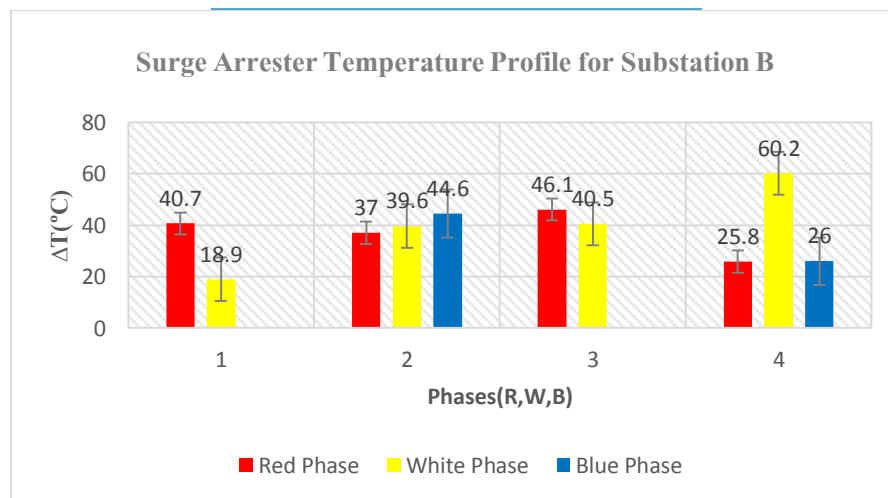
**Figure 6.10:** Temperature profile along the arrester of substation B.

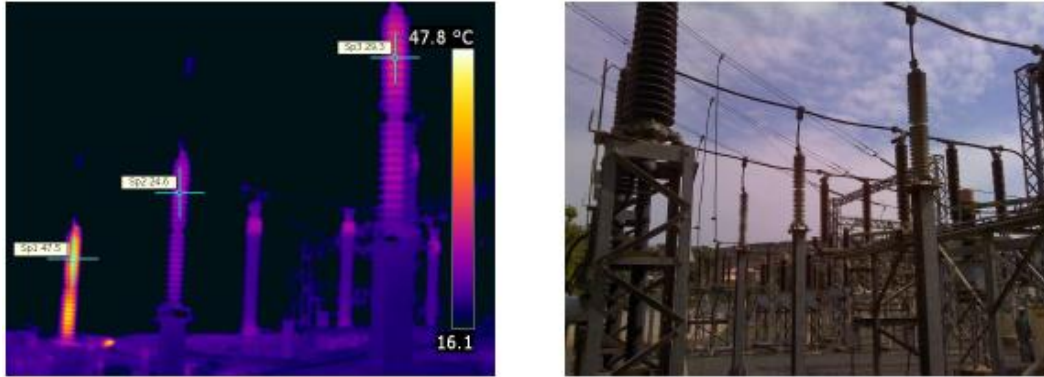
**Figure 6.16:** Thermo-grams for substation C showing the amount of heating inside arrester.

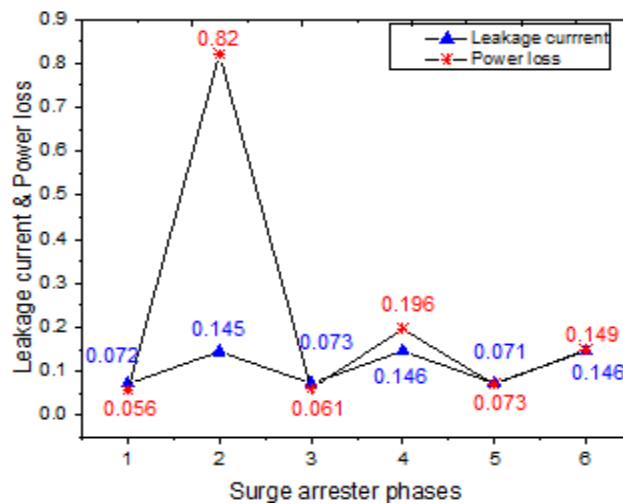
**Figure 7.1:** Graph showing power loss and leakage current on surge arrester phases on (Substation A).

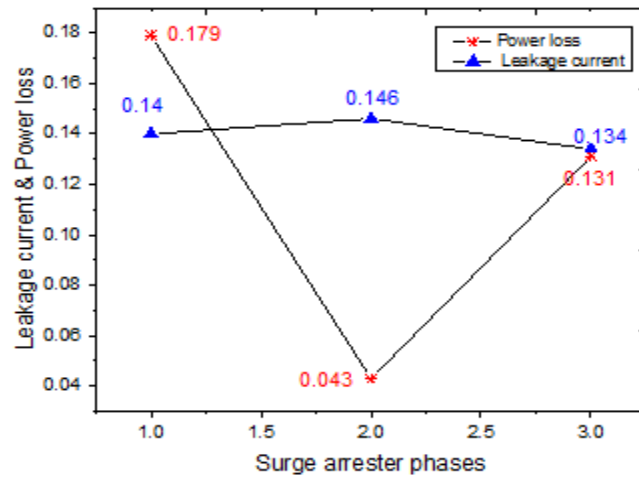
**Figure 7.2:** Graph showing power loss and leakage current on surge arrester phases (Substation B).

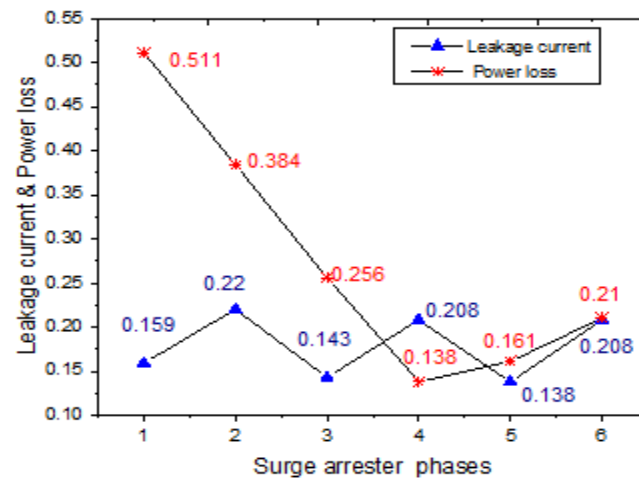
**Figure 7.3:** Graph showing power loss and leakage current on surge arrester phases (Substation C).

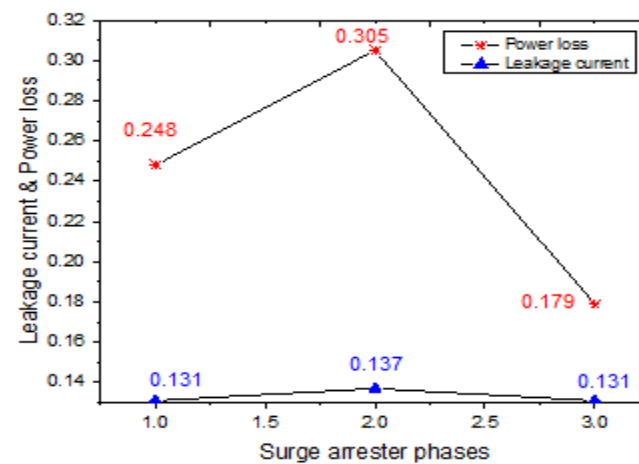
**Figure 7.4:** Graph showing power loss and leakage current on surge arrester phases (Substation C).

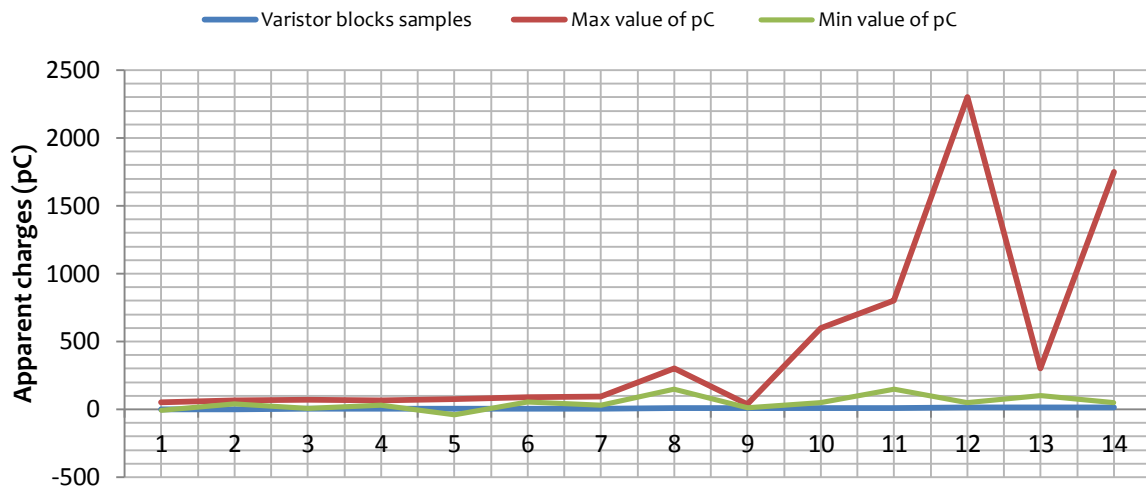
**Figure 8.3:** Comparison of partial discharge samples experimental results at laboratory.

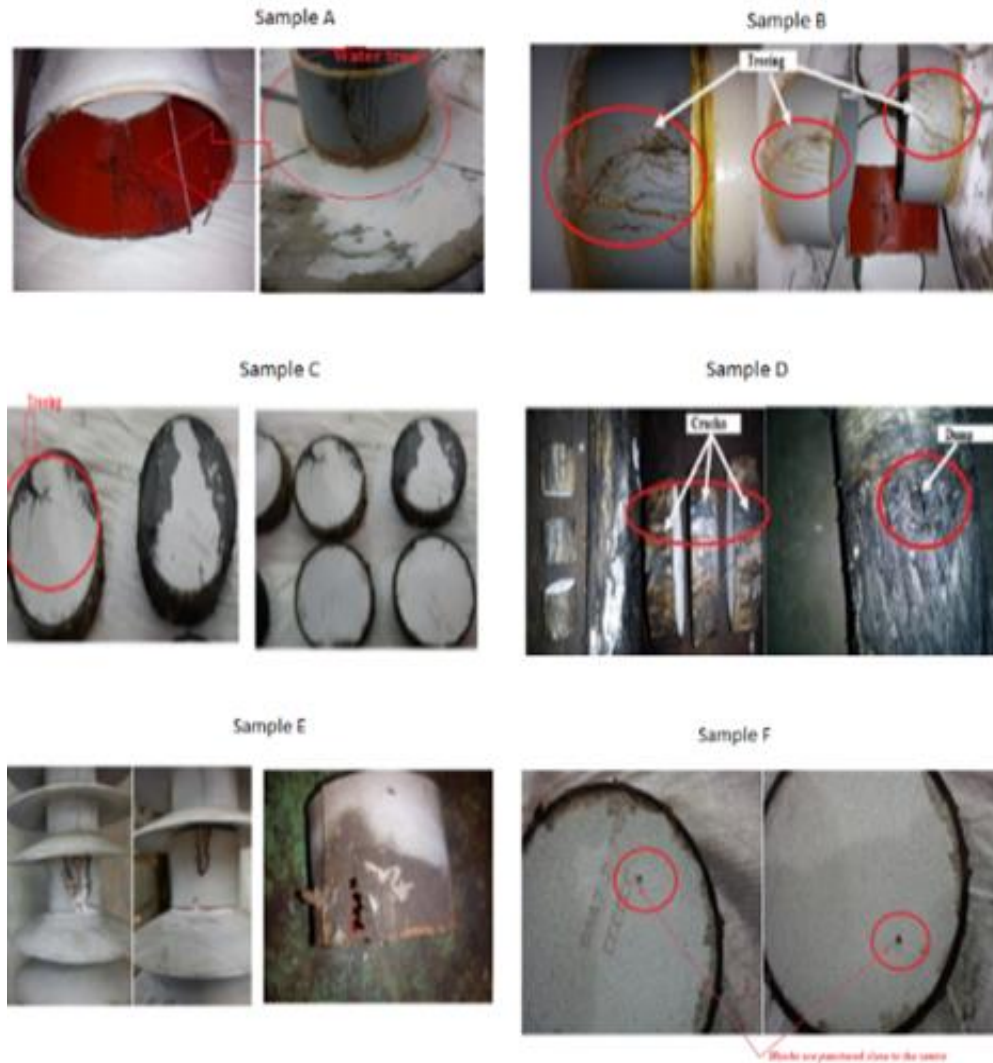
**Figure 9.1:** Surge arrester samples results that were taken during visual analysis.

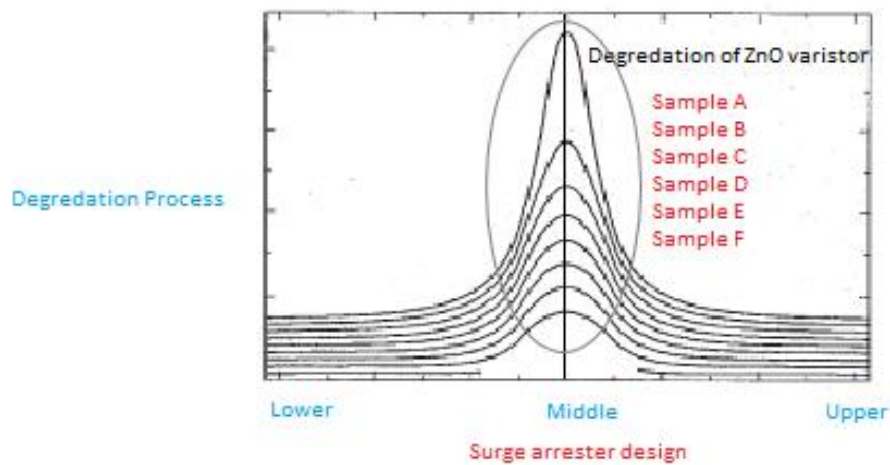
**Figure 9.2:** Graph present result taken during visual inspection.
