**“ AN INVESTIGATION INTO CONCRETE POLE
DAMAGE TO THE INWABI PLATEAU
DISTRIBUTION LINE “**

**Submitted as the dissertation component in partial fulfillment of the
requirements for the Masters Diploma in Technology (Electrical Engineering –
Heavy Current) in the Department of Electrical Engineering, ML Sultan
Technikon on the 16th of September 1998.**

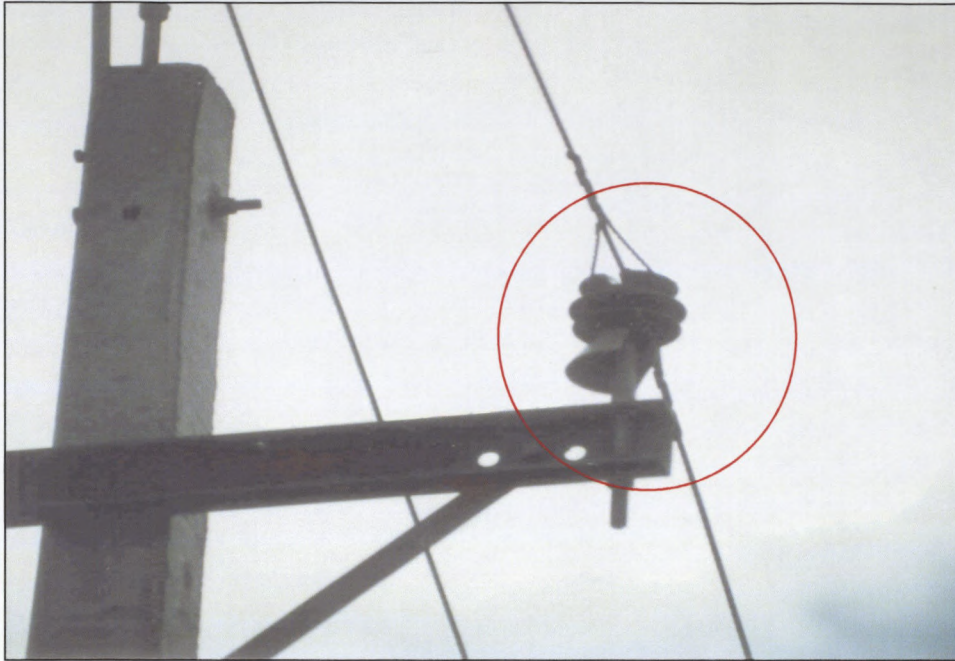
The damage to the insulators, specifically the class B cycloaliphatic pin insulators was thought to be a result of a problem with their design and manufacture. The mode of failure in the majority of cases was a puncture through the insulating material to the spindle (see plates 32 & 33, pg. 104). By comparison, however, the section of medium voltage lines constructed on gum poles using identical insulators had no reported insulator failures.

Plate 3 - Insulator damage

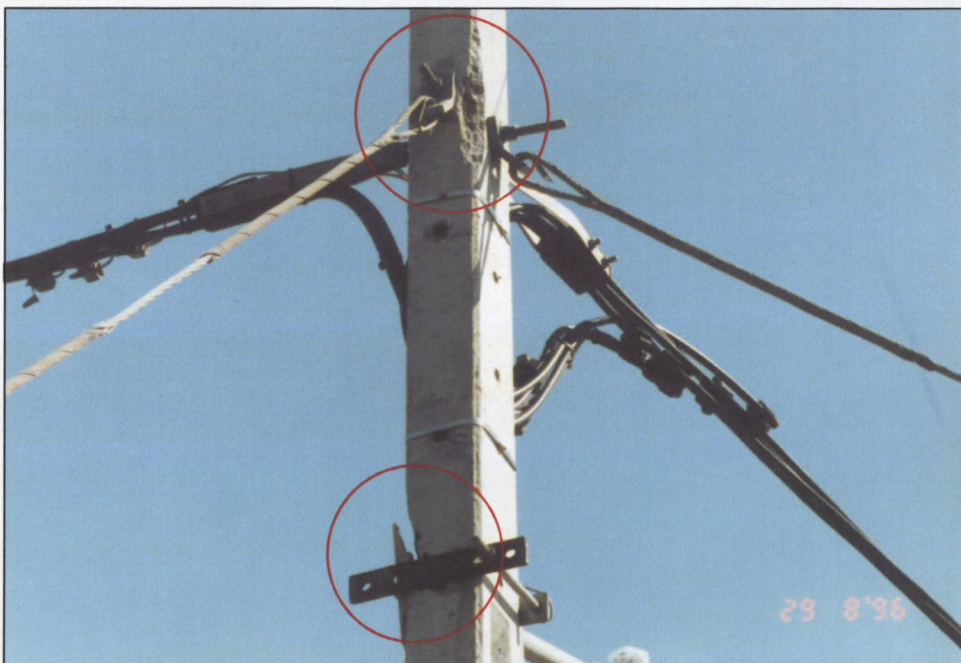
Plate 4 - Structural damage to concrete pole

Further inspections during and after power outages revealed structural damage to the concrete poles (See plate 4). Prior to the line being commissioned it had been fully inspected after construction and found to be free from any structural defects. The structural damage varied in severity and appeared at random positions on the pole. In some cases the damage was severe enough to visibly expose the internal re-inforcing wires. This was cause for concern as the damage and subsequent corrosion of re-inforcing could ultimately render the pole unsafe and unserviceable.

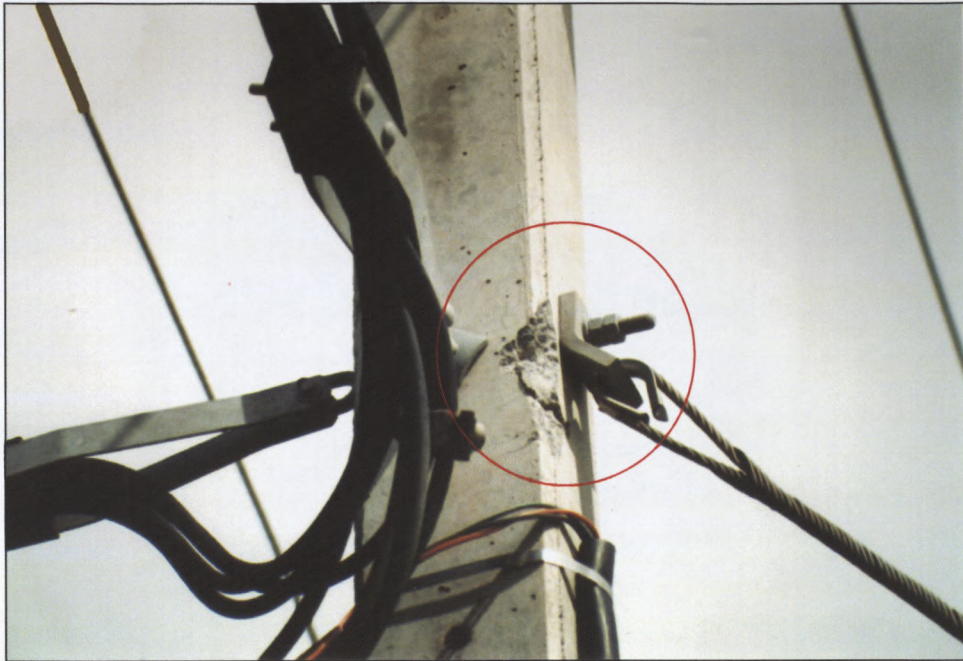
Plate 9 - Structural damage

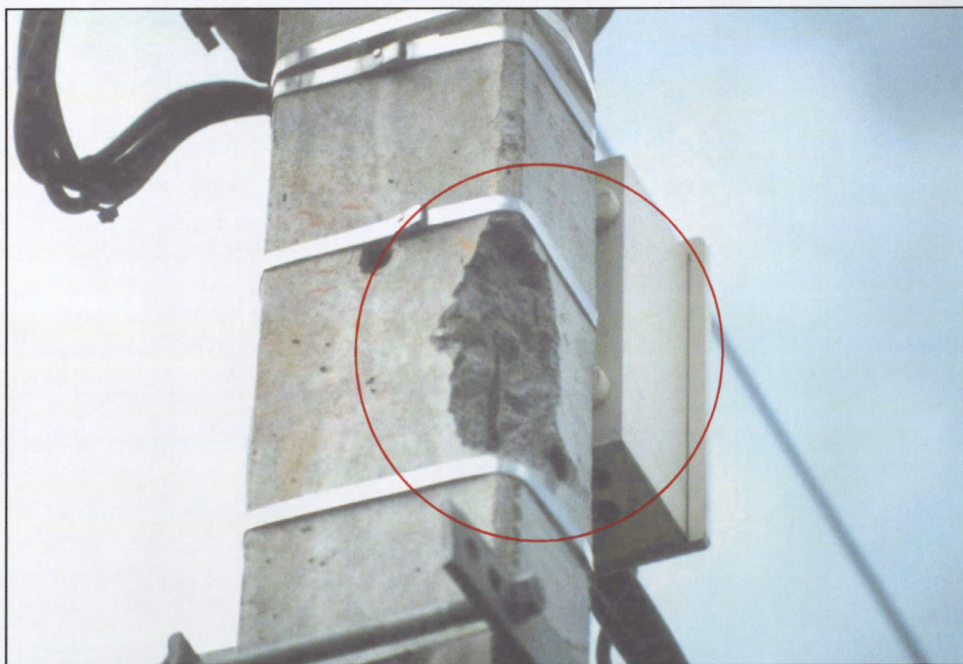
Plate 10 - Structural damage showing exposed re-inforcing

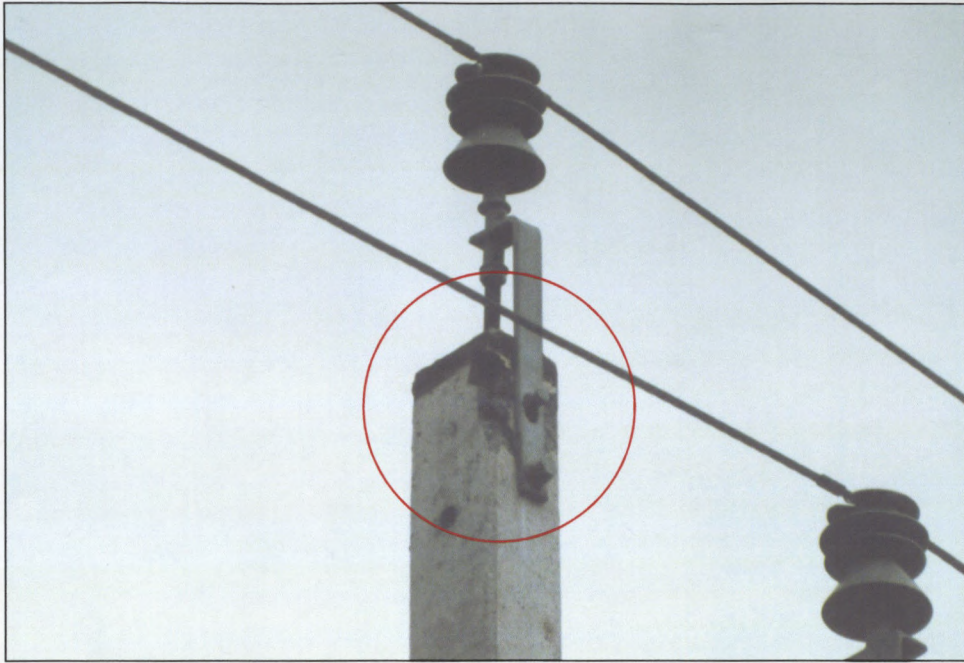
Plate 11 - Positional classification of pole tip damage

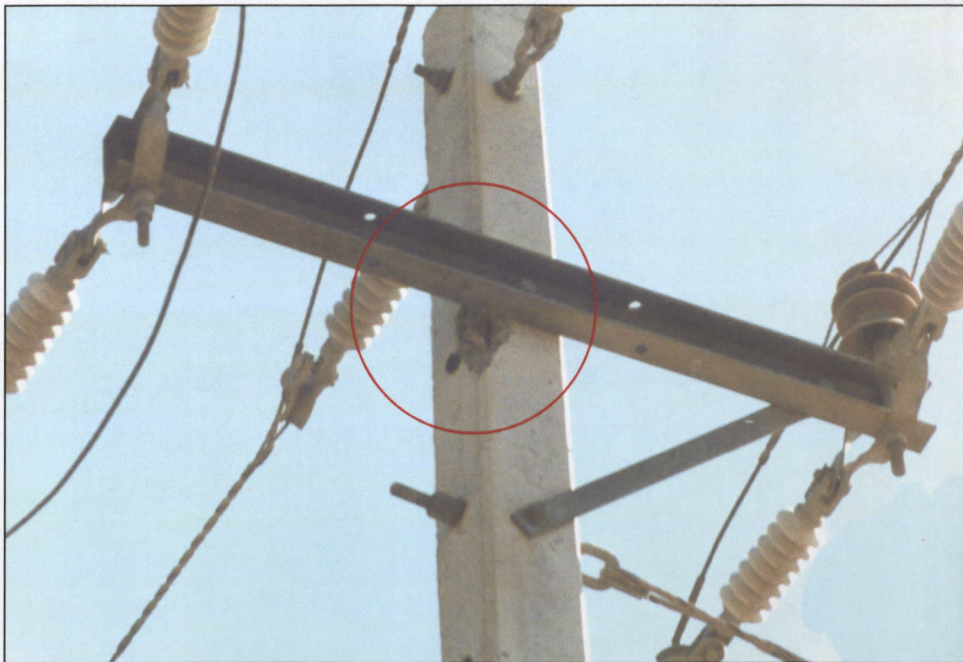
Plate 12 - Positional classification of crossarm damage

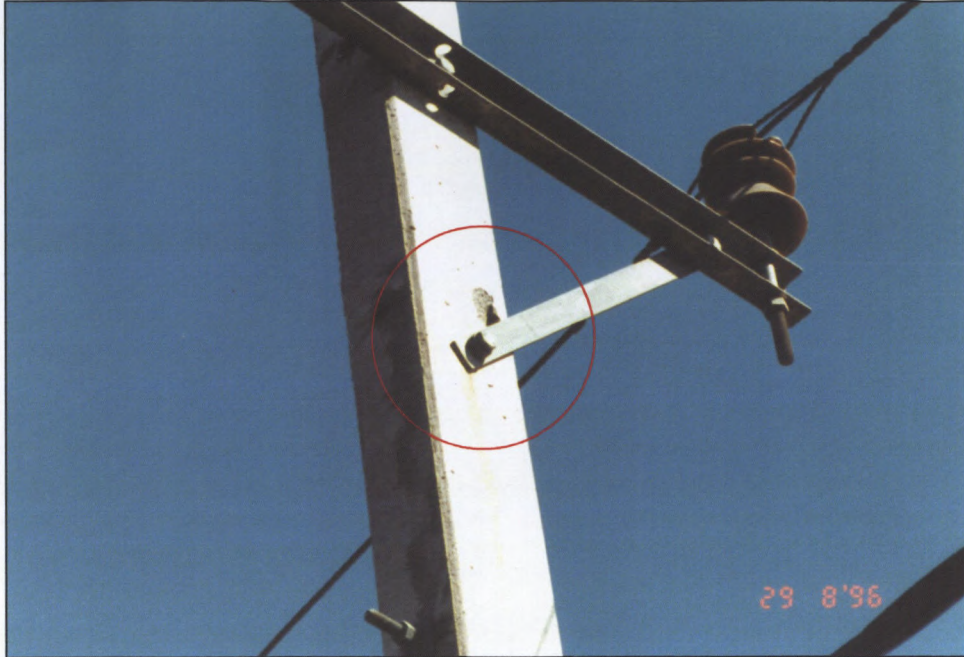
Plate 13 - Positional classification of bracing strap damage

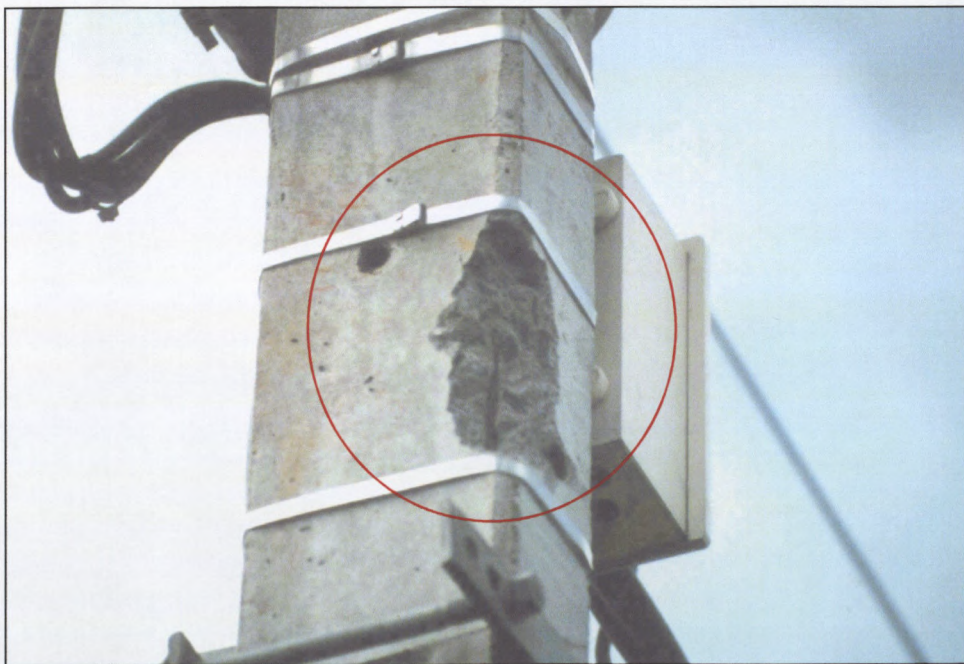
Plate 14 - Positional classification of CDU damage

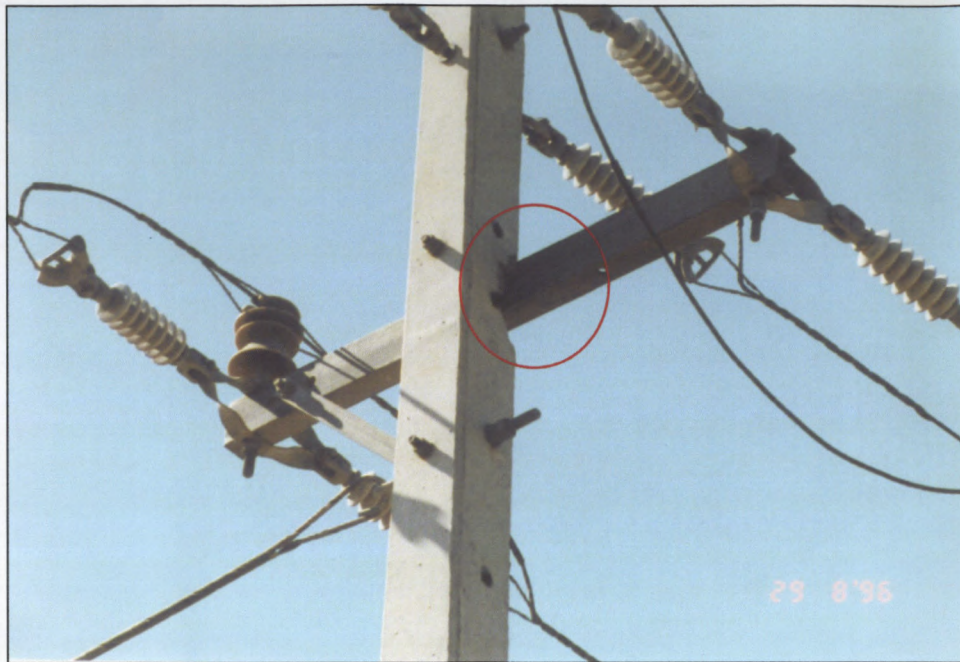
MV crossarm. By comparison the highest point on the pole (pole tip) accounts for 21 %. This is significant, as the crossarm is located about 800mm below the pole tip. Referring to the classification “MV insulators”, this is at pole positions where the strain insulators are attached directly to the pole without a crossarm and the conductors are configured in a vertical formation (see plate 18 on page 58).

Plate 15 - Typical damage in vicinity of MV crossarm

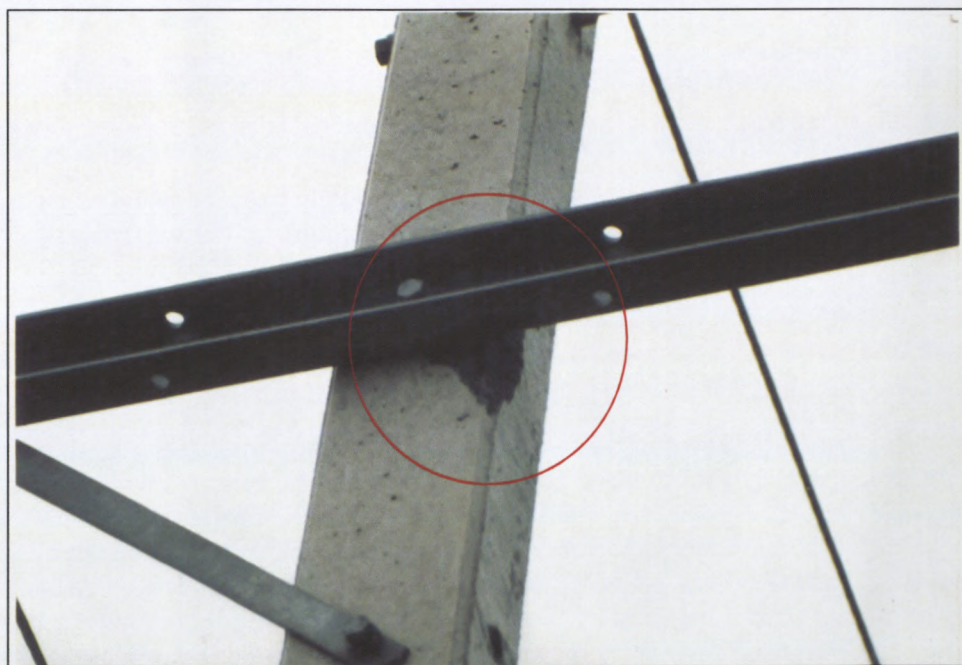
Plate 16 - Typical damage in vicinity of MV crossarm

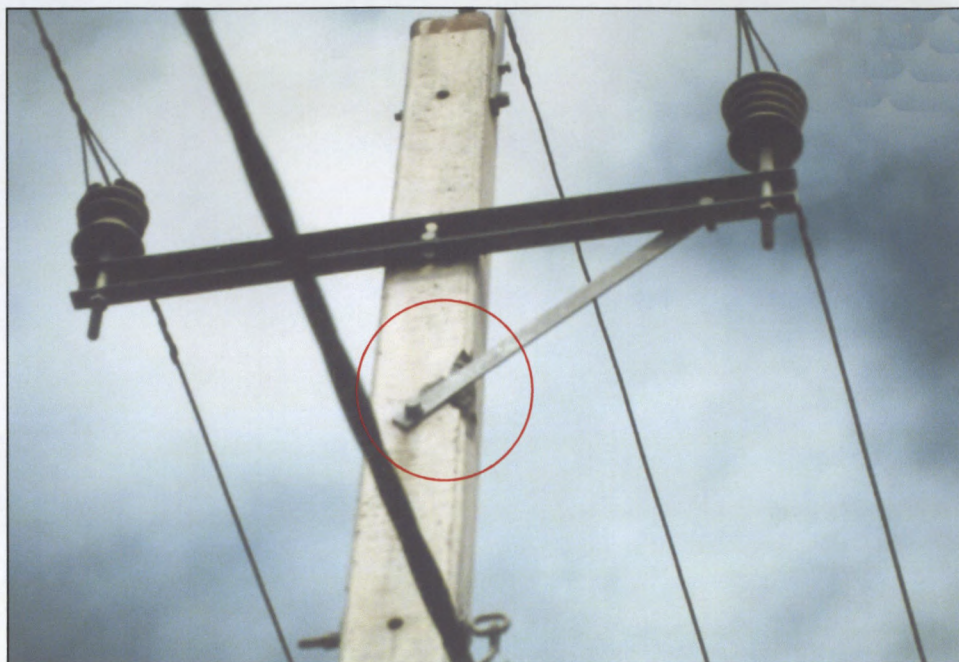
Plate 17 - Typical damage in vicinity of crossarm strap

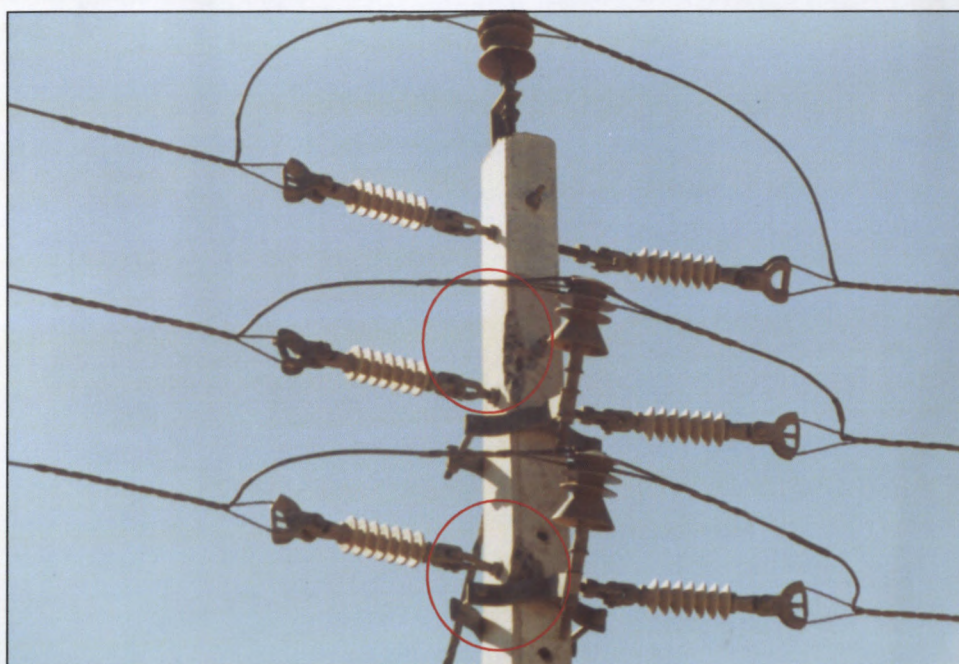
Plate 18 - Damage in vicinity of MV insulators

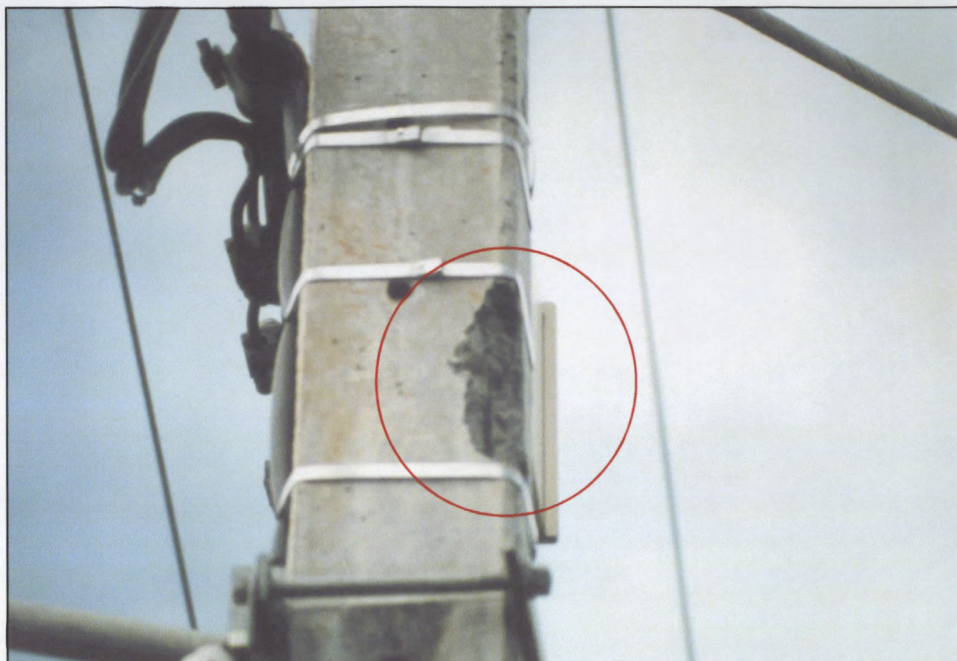
Plate 19 - Typical damage in vicinity of CDU

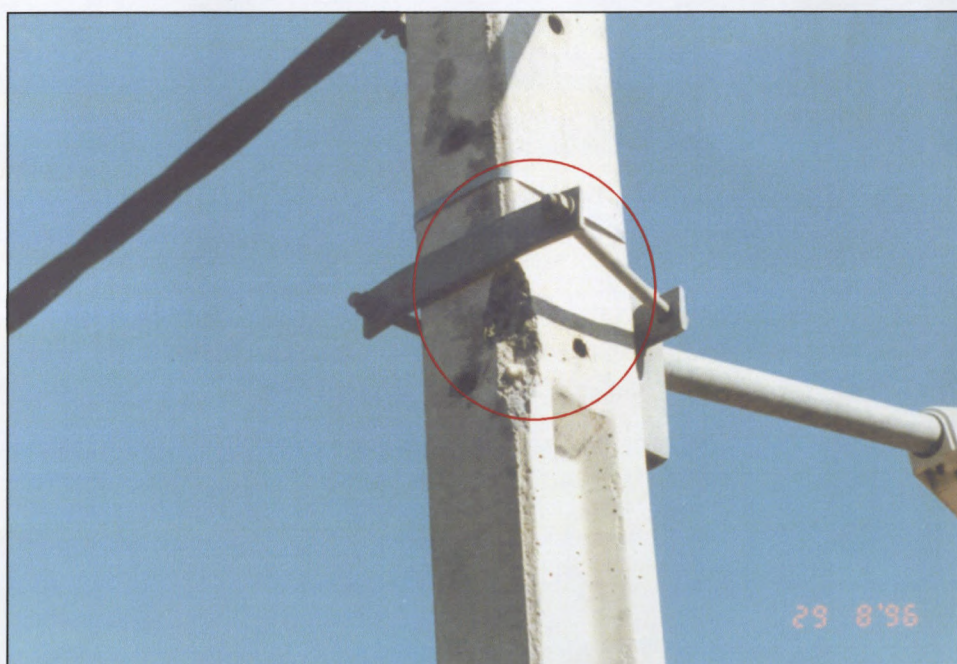
Plate 20 - Typical damage in vicinity of streetlight

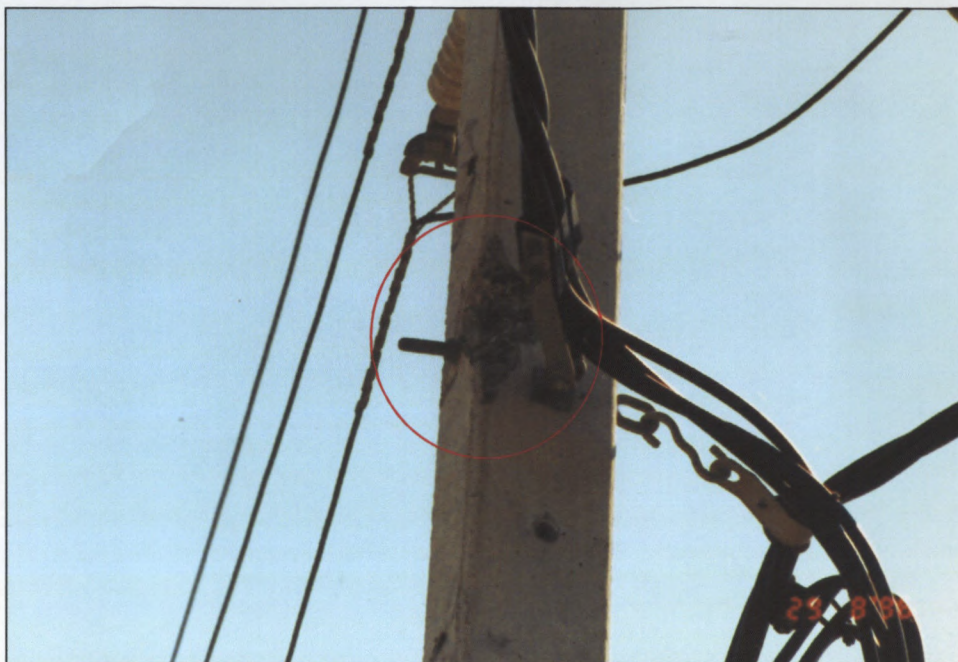
Plate 21 - Typical damage in vicinity of LV ABC strain clamp

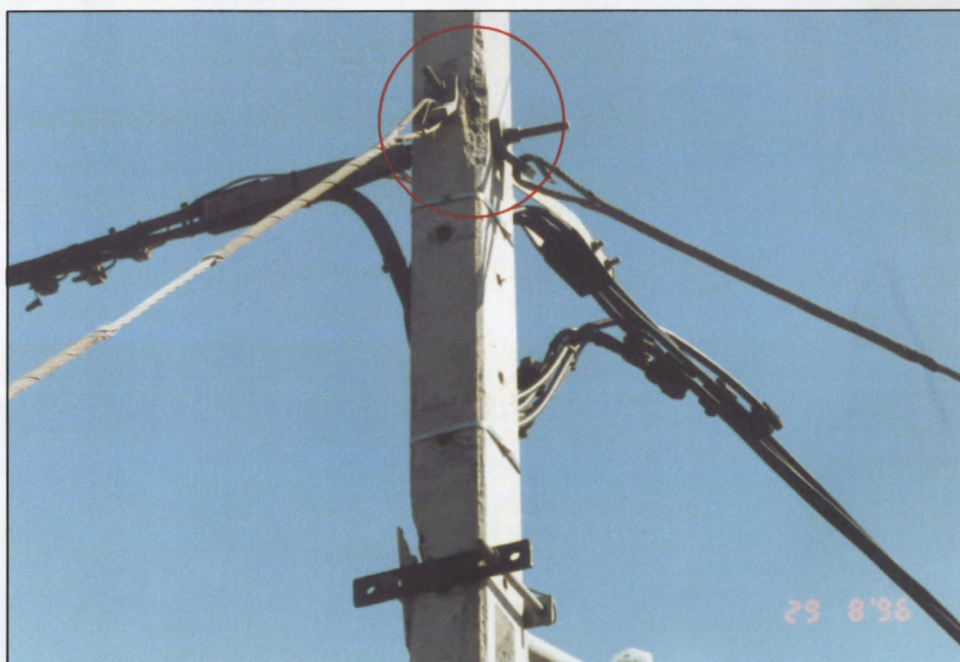
Plate 22 - Typical damage in vicinity of LV stay attachment

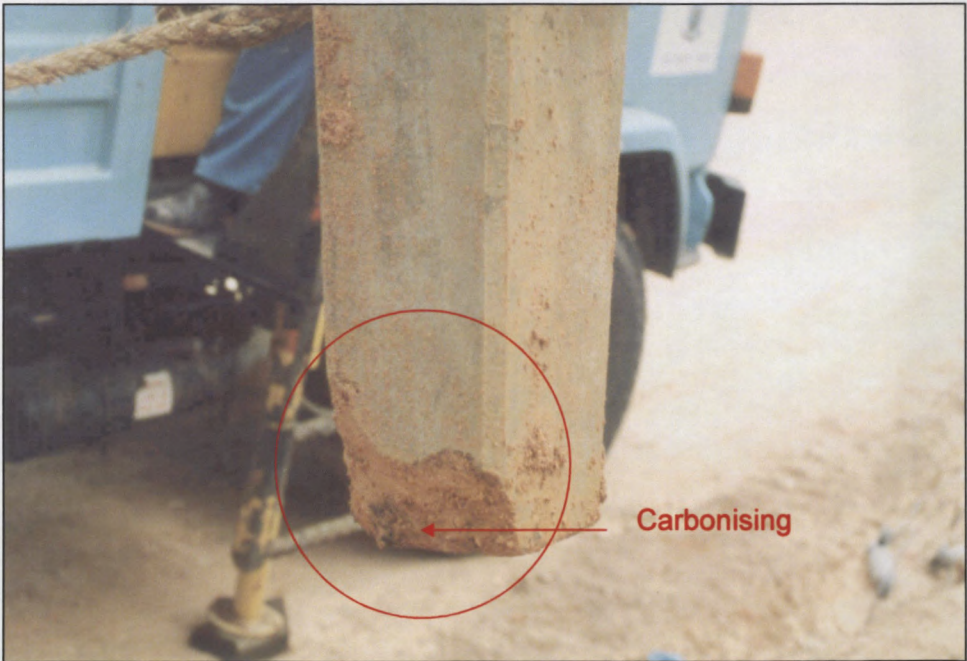
Plate 25 - Damage and carbonising at the pole butt

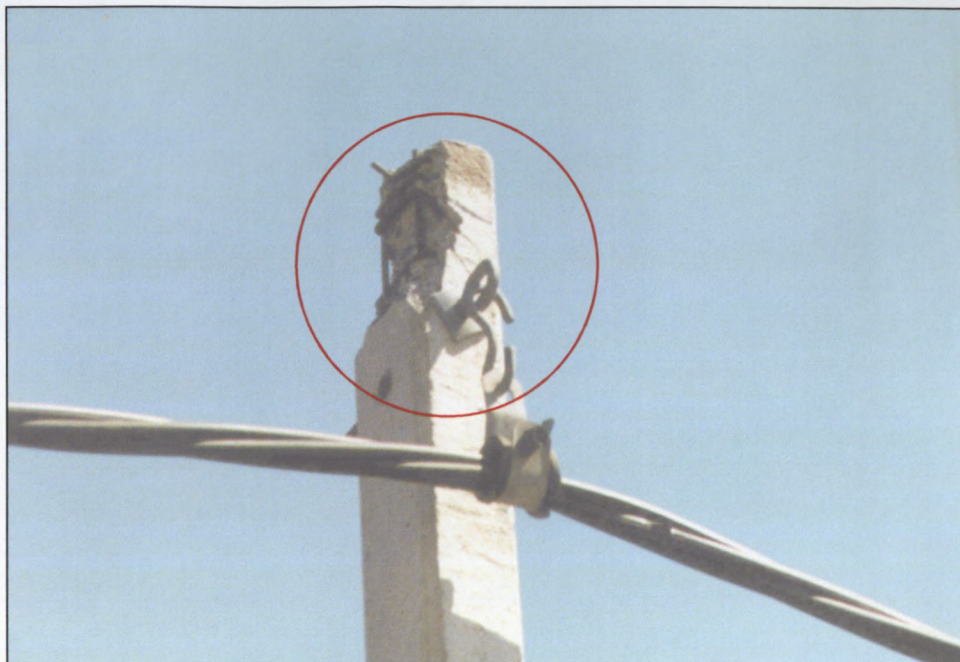
Plate 26 - Pole tip damage to LV ABC pole

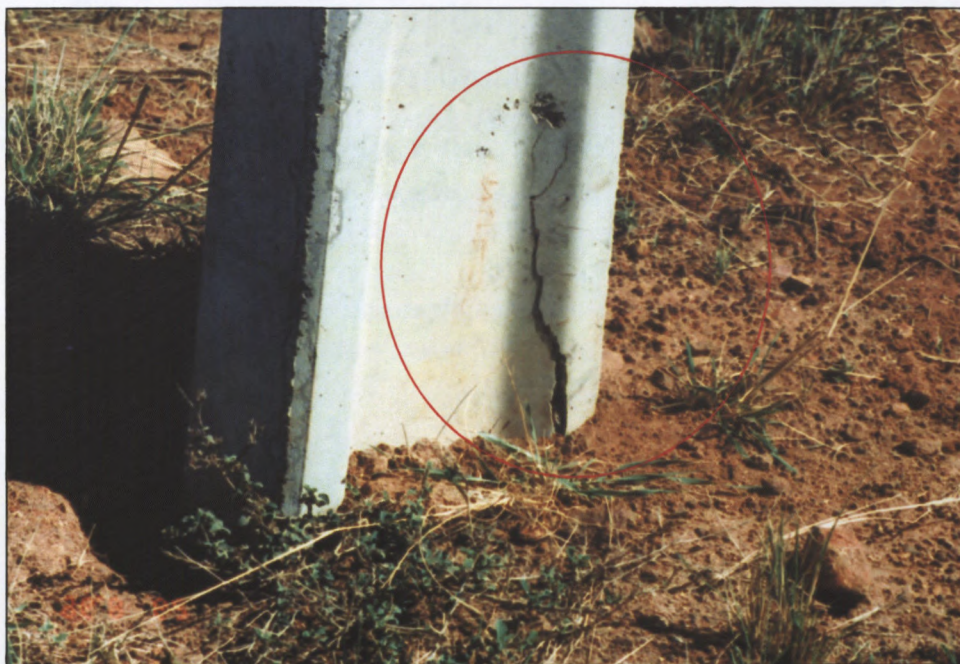
Plate 27 - Damage at pole base (same pole)

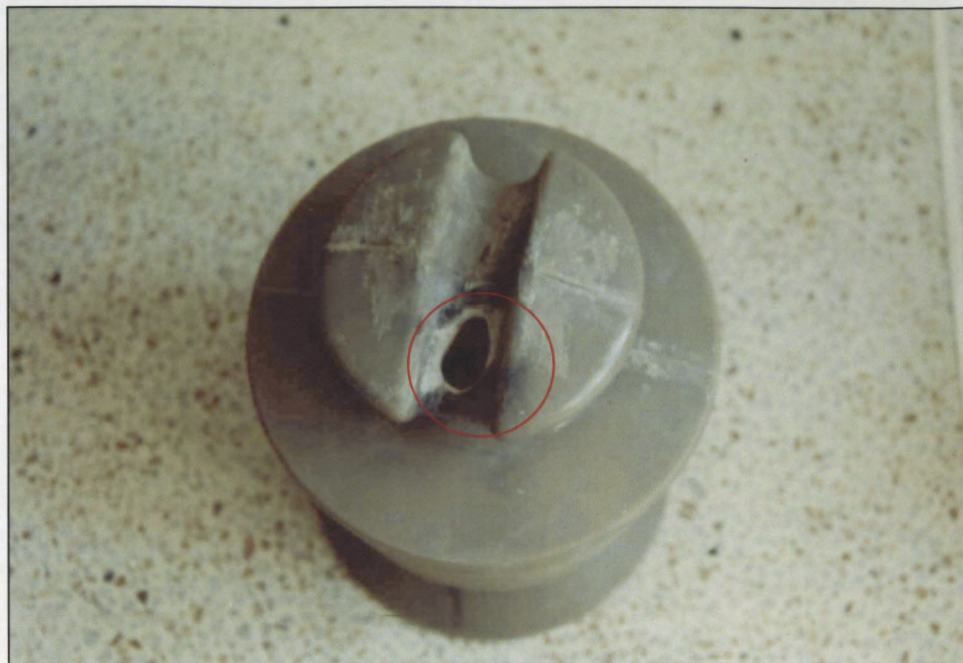
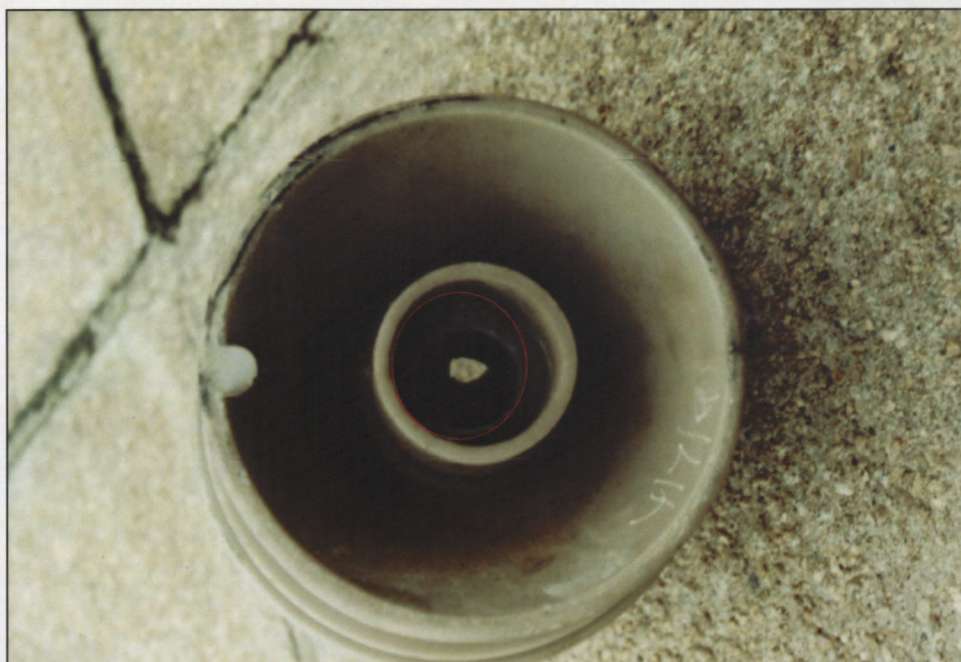
The main mode of failure is a puncture through the insulation to the metal spindle. See plates 32 and 33 overleaf. Examination of a section cut through the resin revealed the presence of "voids" within the resin casting. As the electric field strength across the insulating material is greater for insulators mounted on a low impulse structure (i.e. low phase to phase and phase to earth impulse withstand), this may be sufficient to start ongoing partial discharge across the voids within the resin. It should be noted that in the case of the concrete poles, the insulators are mounted on a common steel crossarm. This results in a higher phase to phase electric field strength across the insulator as compared to the equivalent wood crossarm. Continual partial discharge may result in cumulative degradation of the insulation, until under a transient overvoltage condition, the insulator may fail due to the high resultant electric field across the degraded insulation between the conductor and spindle. In the case of the wood poles and crossarms, the electric field across the insulator is greatly reduced due to the high insulation strength afforded by the wood. The resultant electric field strength is probably not sufficient to initiate partial discharge and therefore insulator degradation. The fact that the overall withstand to earth can be as high as 1 to 2MV for wood poles [10] would account for the lack of insulator failures on these poles.

Plate 32 - Pin Insulator failure

Plate 33 - Pin insulator failure

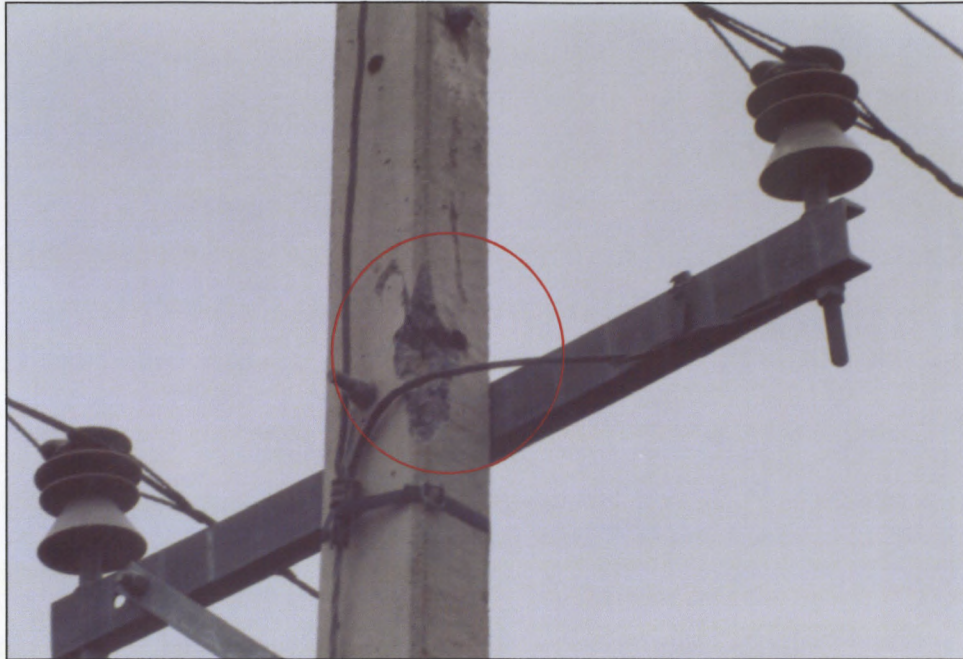
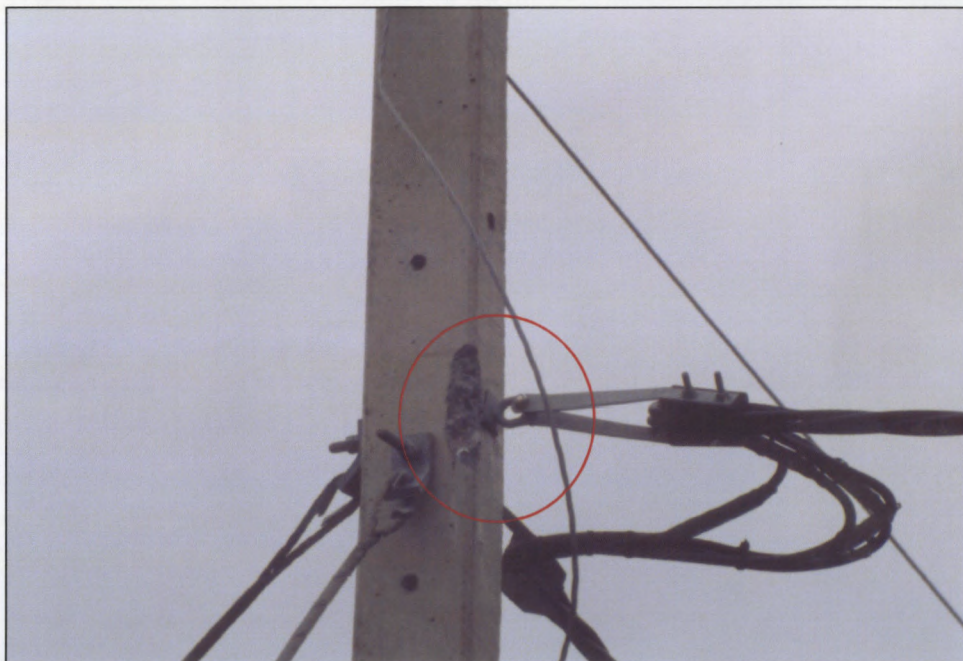
The first case involves pole A77, which has bonded hardware with a downwire, and is shown in plates 40 and 41 overleaf. Bad damage has occurred in the vicinity of the copper jumper (Plate 40) and also lower down in the vicinity of the LV eyebolt (plate 41). There was no other damage above this point on the pole. It appears that a flashover has taken place from the jumper and into the pole and then flashed back through onto the LV system below. As there was a downwire

Plate 40 -Damage to pole A77

Plate 41 - Damage to pole A77

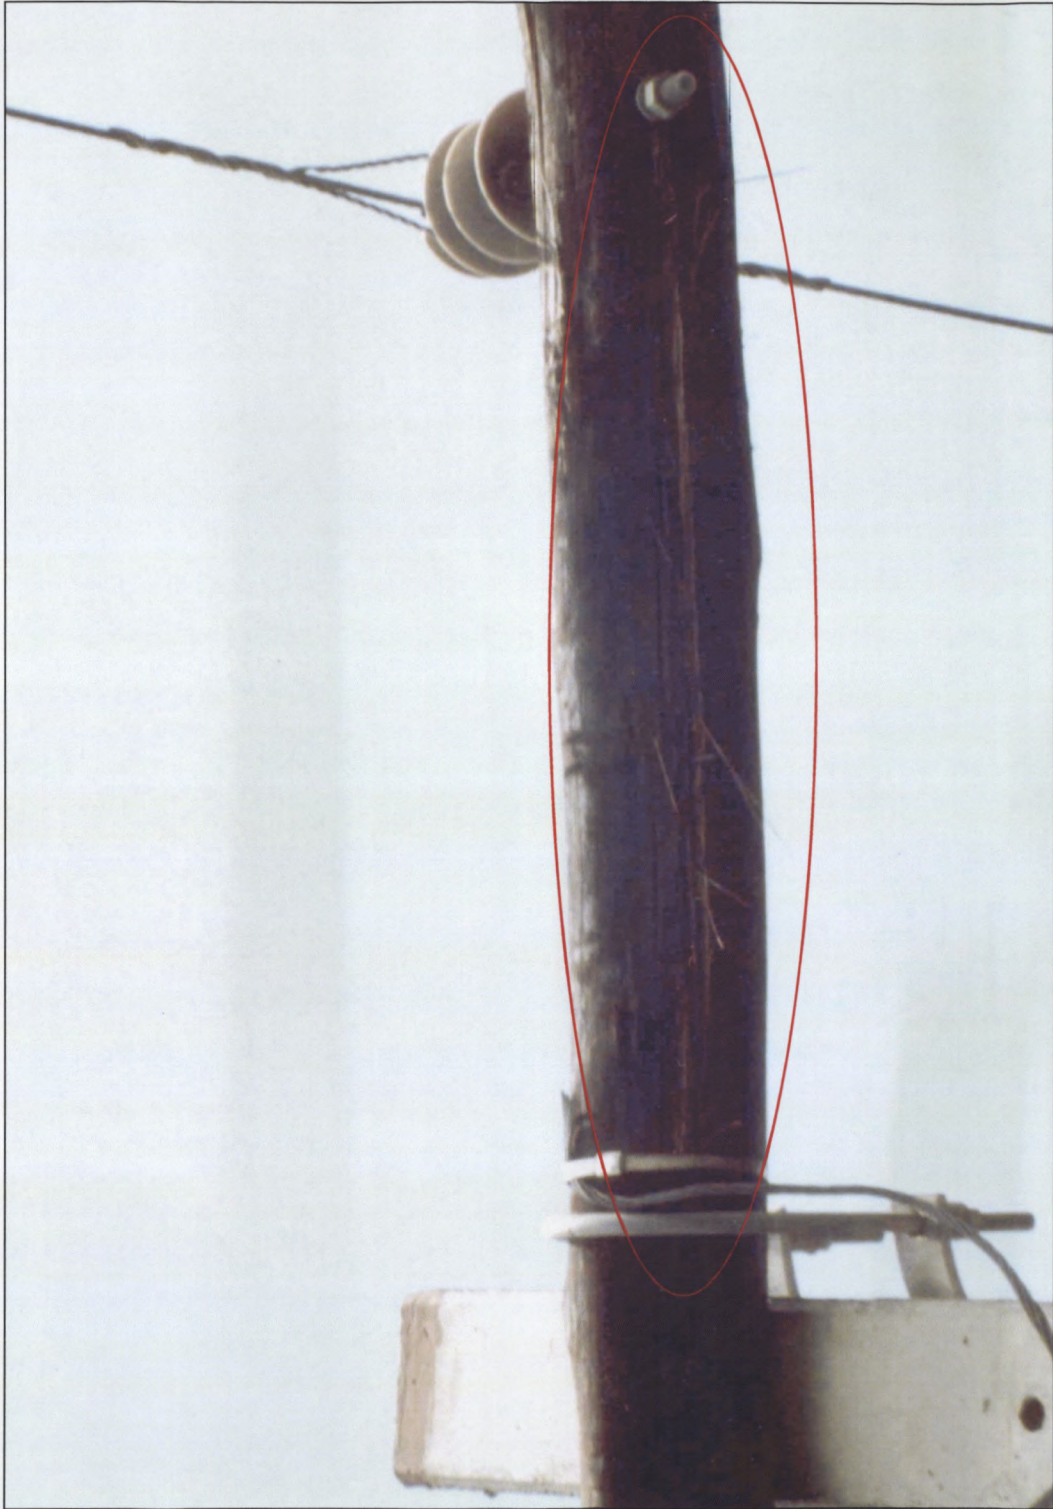
Plate 42 - Damage to pole A19
