### VISUAL ASSESSMENTS OF CURRENT PAVEMENT CONDITIONS IN THE STACK AREAS OF BERTH 203-205 AT THE DURBAN CONTAINER TERMINAL – PIER 2

**Rowen Naicker and Dhiren Allopi**

Department of Civil Engineering and Surveying, Durban University of Technology, P O Box 1334,  
Durban, 4000, South Africa

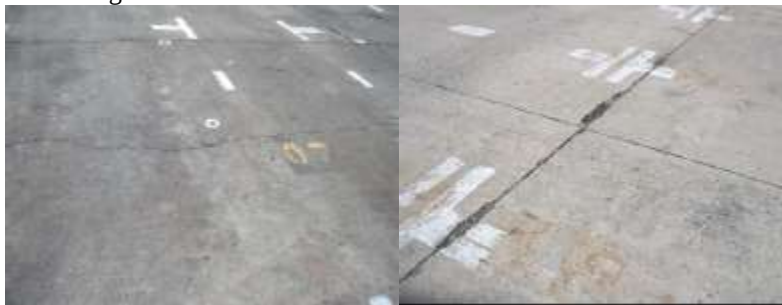
**GOOD:** No visible cracks or cracks less than 2 mm aperture. No, or minor spalling along panel edges not affecting the riding surface. Joint seal in good condition.

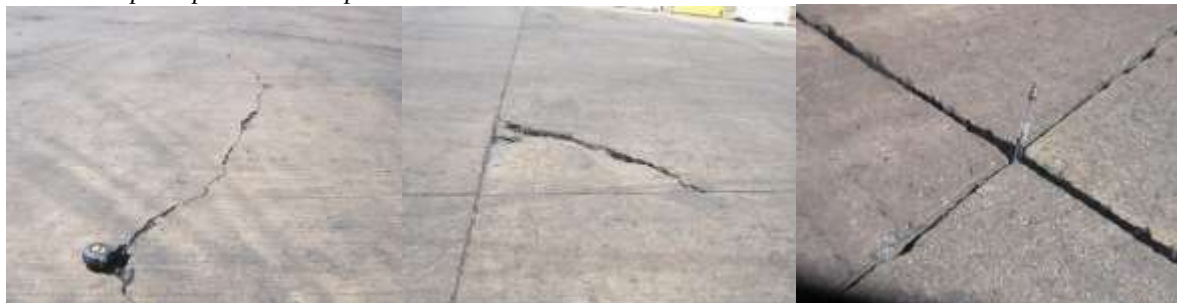
**FAIR:** Cracks with aperture between 2 and 10 mm. Spalling along panel edges to a depth in the order of 50 to 100 mm resulting in a locally uneven riding surface. Joint seal either damage or non-existent. *Condition suggests localised repairs/partial slab replacement and/or routine maintenance.*

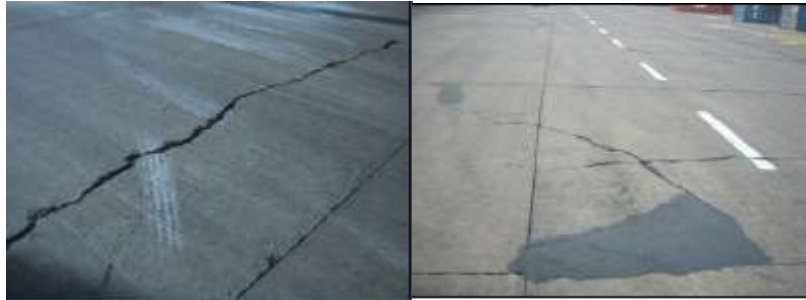
**POOR:** Cracks with aperture greater than 10 mm and panels with a general appearance of being completely broken into independent pieces (shattered slabs). Spalling to a depth greater than 100 mm. *Condition suggests slab replacement.*

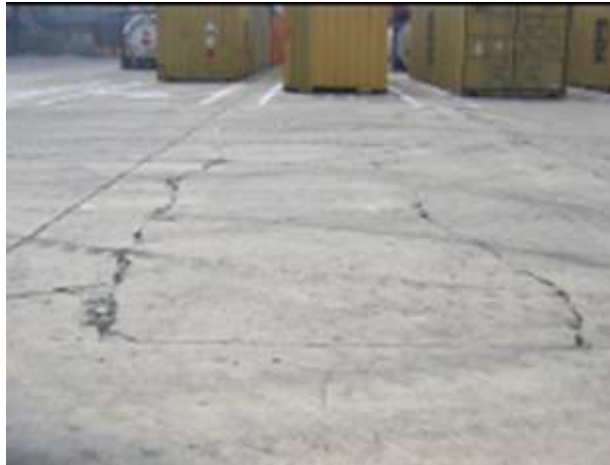
- 1) Some of the pavement in the paths used by the straddle carriers were cracked and showed signs of differential vertical movement between concrete on either side of the cracks

- 3) Comments made by straddle carrier drivers met on site indicated that the cracks had reached a stage where it detrimentally affected the riding quality
- 4) Most concrete pavement panels in the terminal were not cleaned and the presence of thick grease from the straddle carriers was visible on the panels

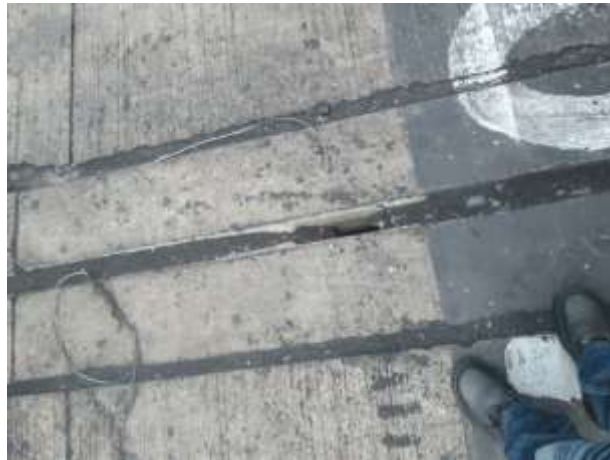
- 2) Slot drains were filled with debris, thus not allowing proper drainage through slot drains
