**AN INVESTIGATION OF THE CONDITION OF MAINTENANCE OF
FACILITIES AT PUBLIC PRIMARY AND HIGH SCHOOLS IN ALFRED NZO
EAST DISTRICT, EASTERN CAPE PROVINCE, SOUTH AFRICA**

**Submitted in fulfilment of the requirements for the degree of Master of the
Built Environment in Construction Management in the Faculty of
Engineering and Built Environment at the Durban University of
Technology**

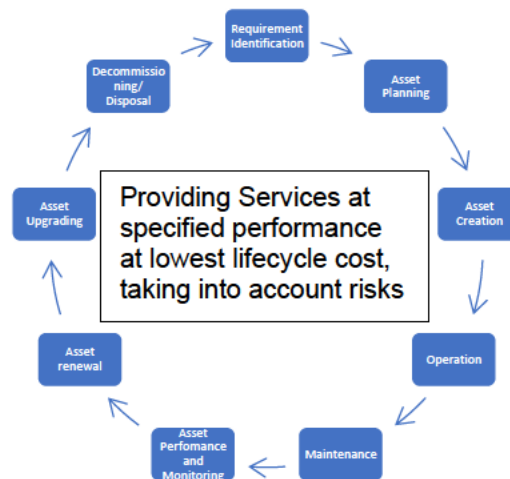
For a better understanding of property maintenance, it is important to consider the property lifecycle as it will give a picture of where exactly the maintenance work fits into the property life span. In order for the property to exist the need for it must be identified. This is followed by proper planning, with the aim of addressing the identified need. During planning, the core functions of the organization and its organogram have to be taken into consideration. This will influence whether to hire or build the property. The creation of the asset is through either building or hiring. Just after completion it starts to operate and operating costs have to be made available. Maintenance is the focus of this study. It is where life of the property is prolonged and its value is preserved. Maintenance work is continually done, based on asset performance and monitoring. As the property is aging it eventually reaches a time where replacement is required. It can be upgraded in order for it to address its purpose. If it could not be renewed, modernised, or upgraded then it will have to be disposed of. Figure 3 below indicates the property lifecycle.

Figure 3: Property lifecycle
