**CORROSION RATE MEASUREMENT OF SHEET
PILE WALL IN THE PORT OF DURBAN**

MNCEDISI MANGALISO NYAWO

MASTER OF ENGINEERING

DURBAN UNIVERSITY OF TECHNOLOGY

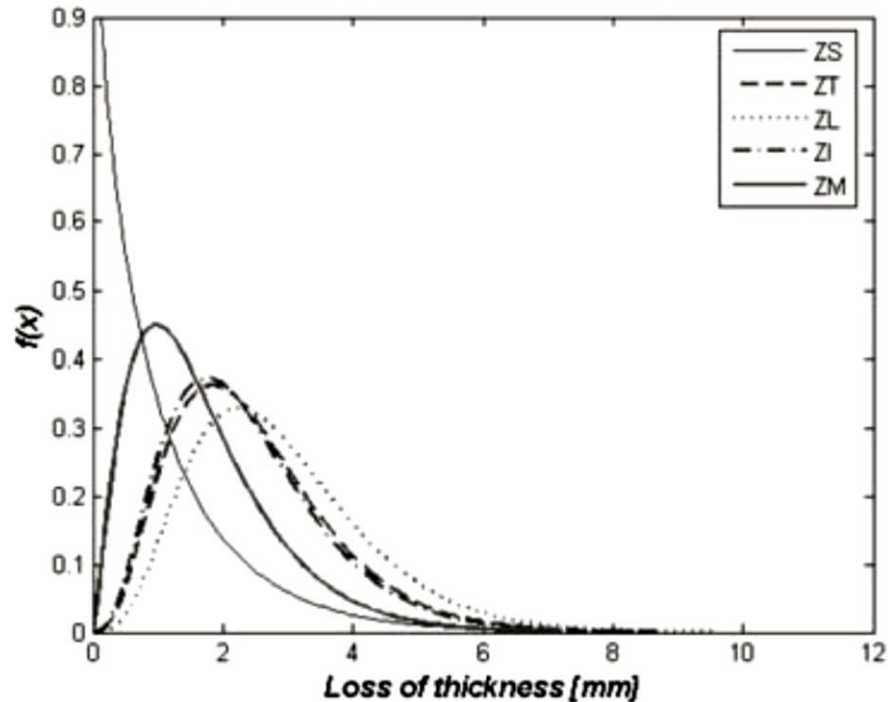
is well oxygenated, while the immersion zone experiences less oxygen. The corrosion model's distribution of thickness loss after 25 years of exposure is shown in **Figure 2.10**.

Figure 2.10: Gamma distributions of loss of thickness over several exposure zones for $t = 25$ years. (Legend: ZS = Splash zone; ZT = tide zone; ZL = Low seawater level zone; ZI = Immersion zone; ZM = Mud zone)

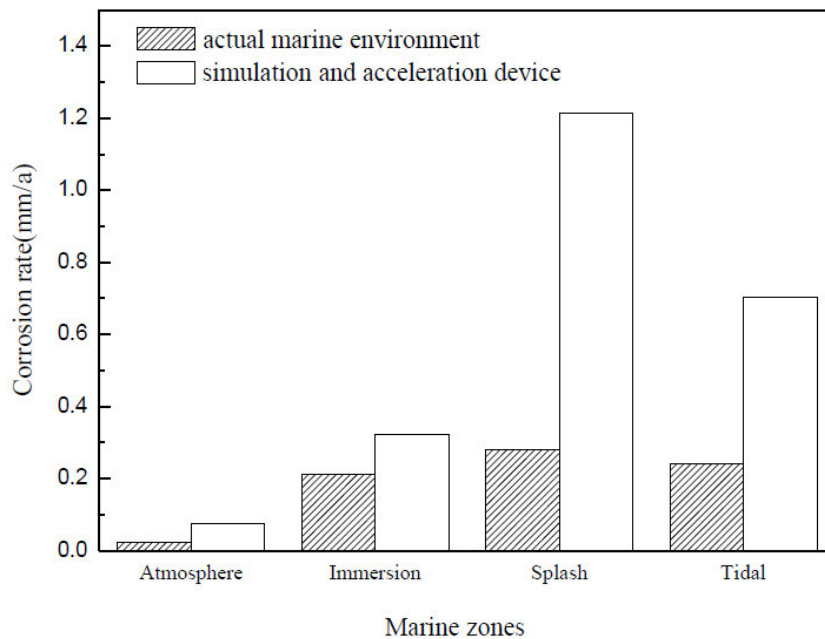
Furthermore, after the tests were conducted, results were analysed and the graphs (Figure 2.11 and Figure 2.12) were developed. It is shown that most corrosion occurs in the splash zone.

Figure 2.11: Corrosion rates of the specimens in the actual marine environment of Qingdao and in the simulation and acceleration devices

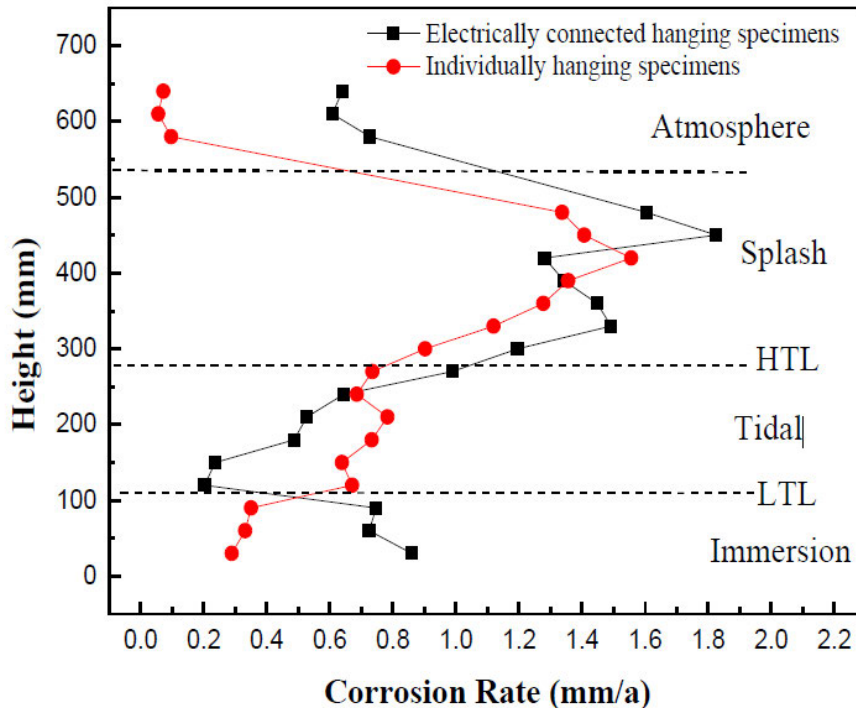
Figure 2.12: Corrosion rate curves of Q235 carbon steel exposed in the simulation and acceleration test device for 10 days

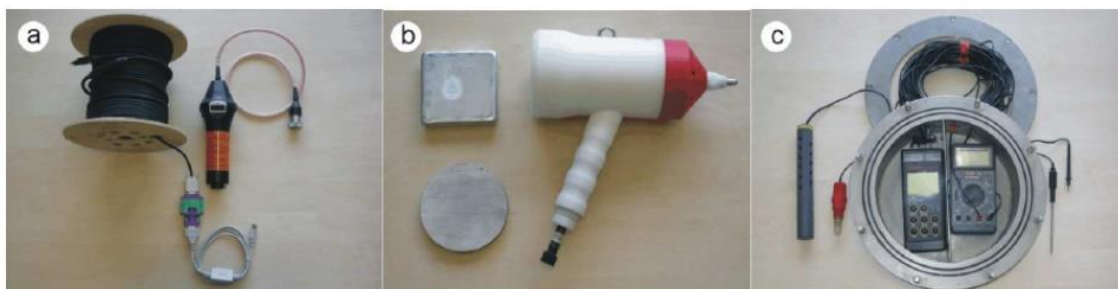
The data required was collected by utilising the Patent System, shown in **Figure 2.16**. This system comprises housing stems manufactured from stainless steel (AISI 316) and designed to operate underwater up to one hundred metres. Such a system is permitted to visualise the values of the measurements (pH electrode of flat surface model HI 1001 of Hanna Instruments, connected to a field pH meter, model HI 9025 of Hanna, and specific reference electrode Ag/AgCl (+0.262 V vs. SHE) for the determination of potentials in seawater, connected to a high impedance digital multi-meter Mastech 890G) (Bethencourt *et al.* 2007).

Figure 2.16: Monitoring the corrosion of steel-sheet piles using ultrasound and corrosion potential measurements

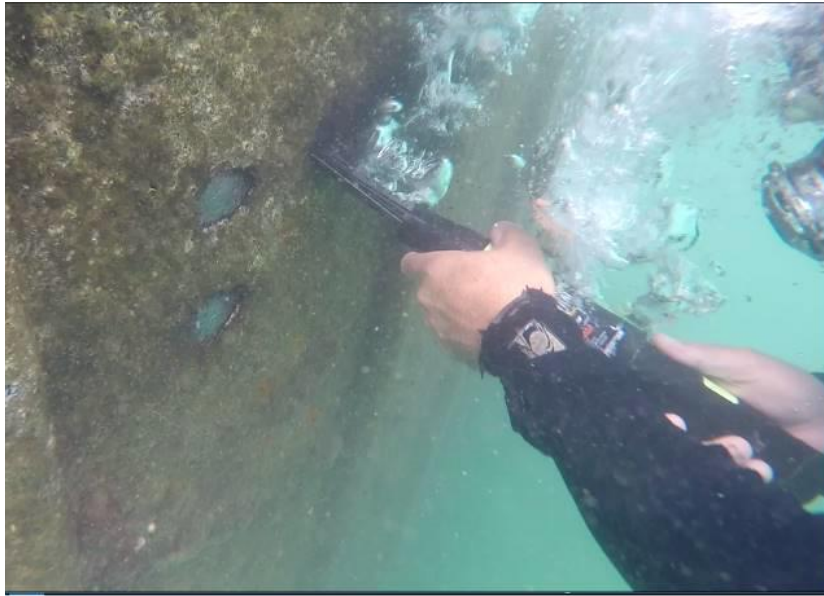
Figure 2.18: Underwater cleaning at the measurement points
Source: Solorzano (2018)

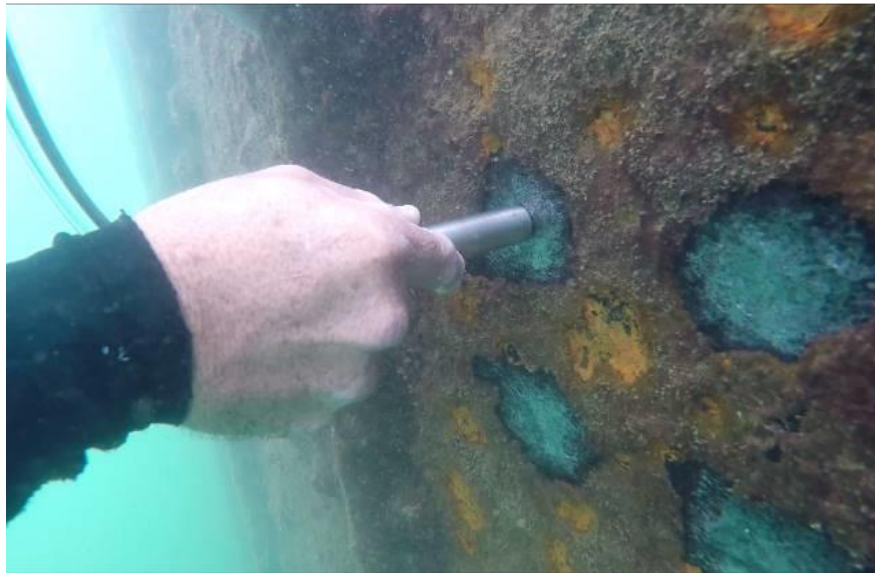
Figure 2.19: Underwater thickness measurement with an ultrasonic sensor
Source: Solorzano (2018)

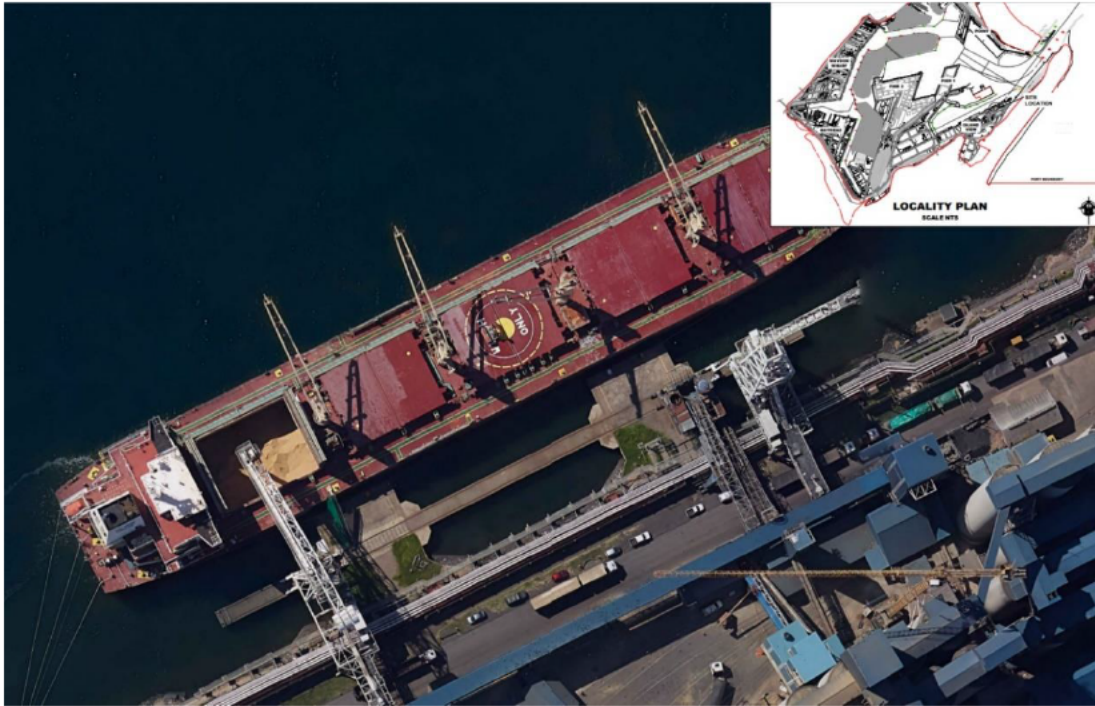
Figures 3.1 and **3.2** show the layout plans of both Island View Berth 3 and Maydon Wharf Berth 12, respectively, where the steel thickness of the existing sheet piles was measured to assess the corrosion rate.

Figure 3.1: Island View Berth 3 Layout Plan
Source: Port of Durban Aerial Photo (2020)

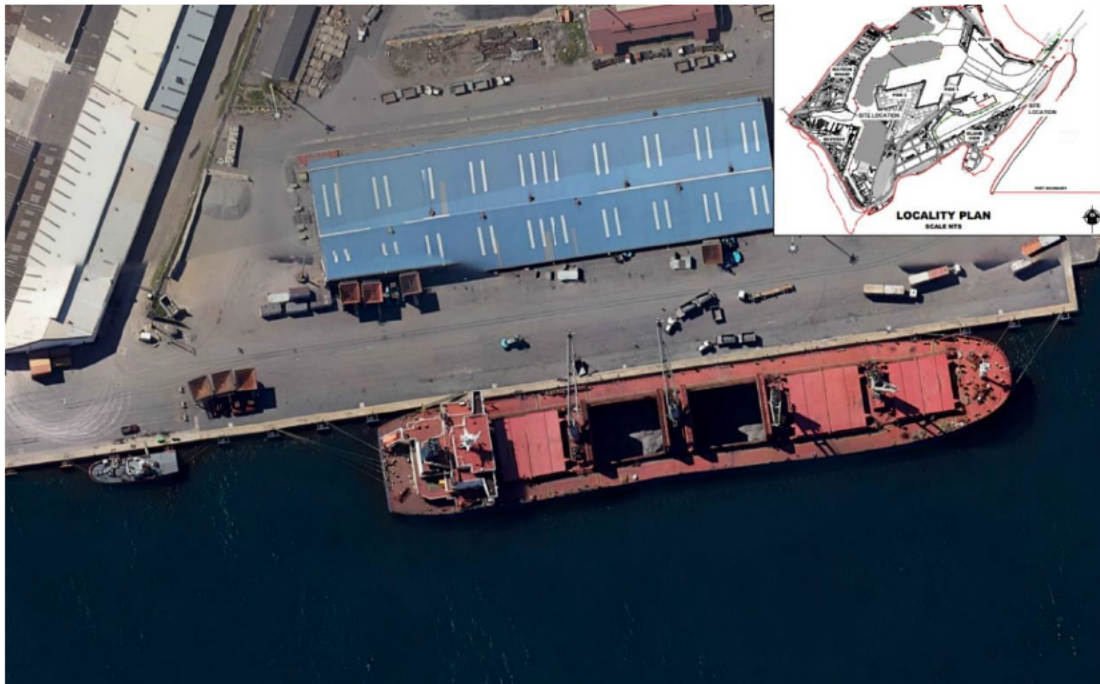
Figure 3.2: Maydon Wharf Berth 12 site layout plan
Source: Port of Durban Aerial Photo (2020)

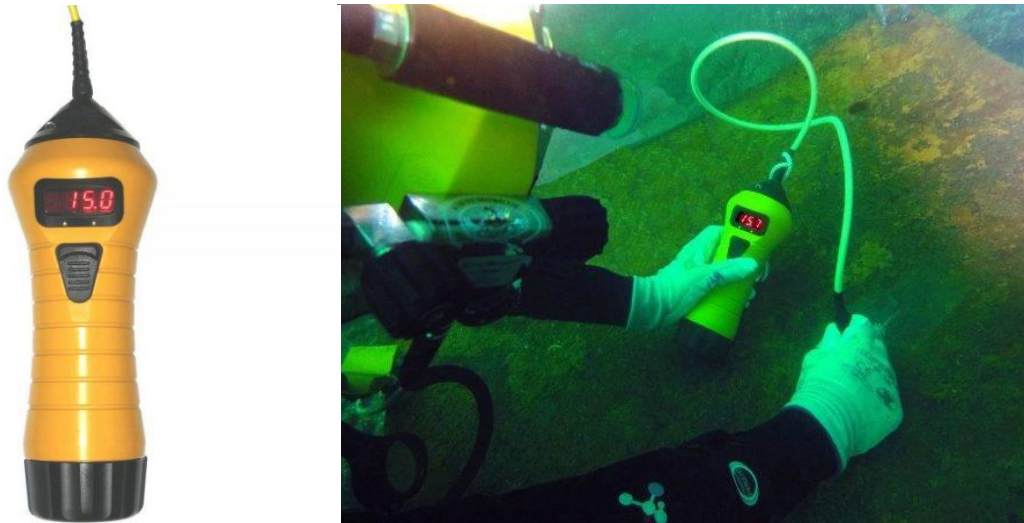
Figure 3.5 a & b: Underwater Ultrasonic Thickness Gauge

Maydon Wharf Berth 12 is 230 m long with a design draft of 10.6 m below the CD. Twenty horizontal inspection points, each measuring 200 mm x 200 mm, were cleaned using chipping hammers and wire brushes along a 230 m length. The inspection points were 10 m apart, with five inspection points in each of the four zone: atmospheric zone, splash zone, tidal zone, and low water zone). An ultrasonic thickness (UT) gauge was used to measure the steel thickness of the sheet piles underwater in various zones, in order to determine the remaining steel on the existing structure (Kelly1999). The ultrasonic thickness gauge, shown in **Figures 3.5a** and **b**, were used to measure the thickness of the existing steel sheet piles.

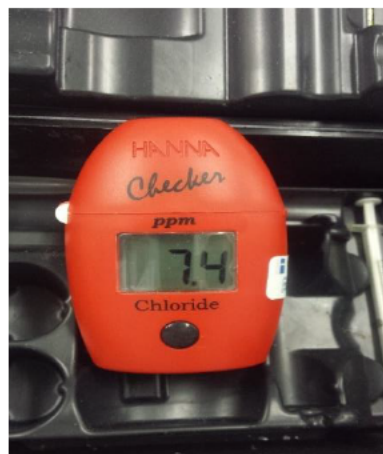
Figure 3.7: Chloride Colorimeter

These seawater samples were transported to a laboratory where their chloride content was measured using a Chloride Chequer® HC HI753, a handheld colorimeter. The chloride colorimeter (**Figure 3.7**) provides quick and accurate results.

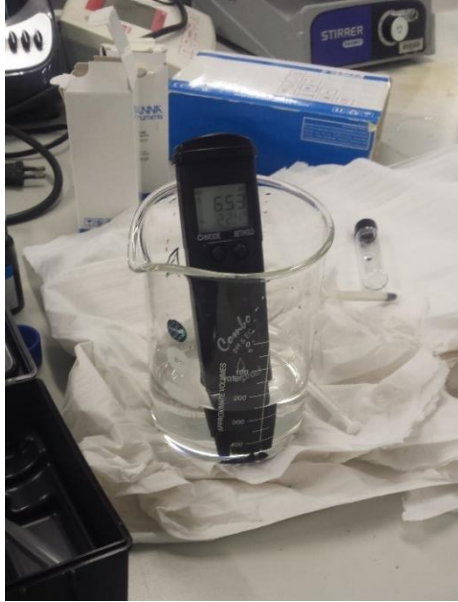
Figure 3.9: Hanna HI 98129 pH Instrument

A Hanna HI 98129 pH Meter Instrument (**Figure 3.9**) was used to measure the hydrogen-ion levels in the seawater samples taken from Island View Berth 3 and Maydon Wharf Berth 12. The pH meter measures the acidity and alkalinity of seawater by measuring the voltage between two electrodes.

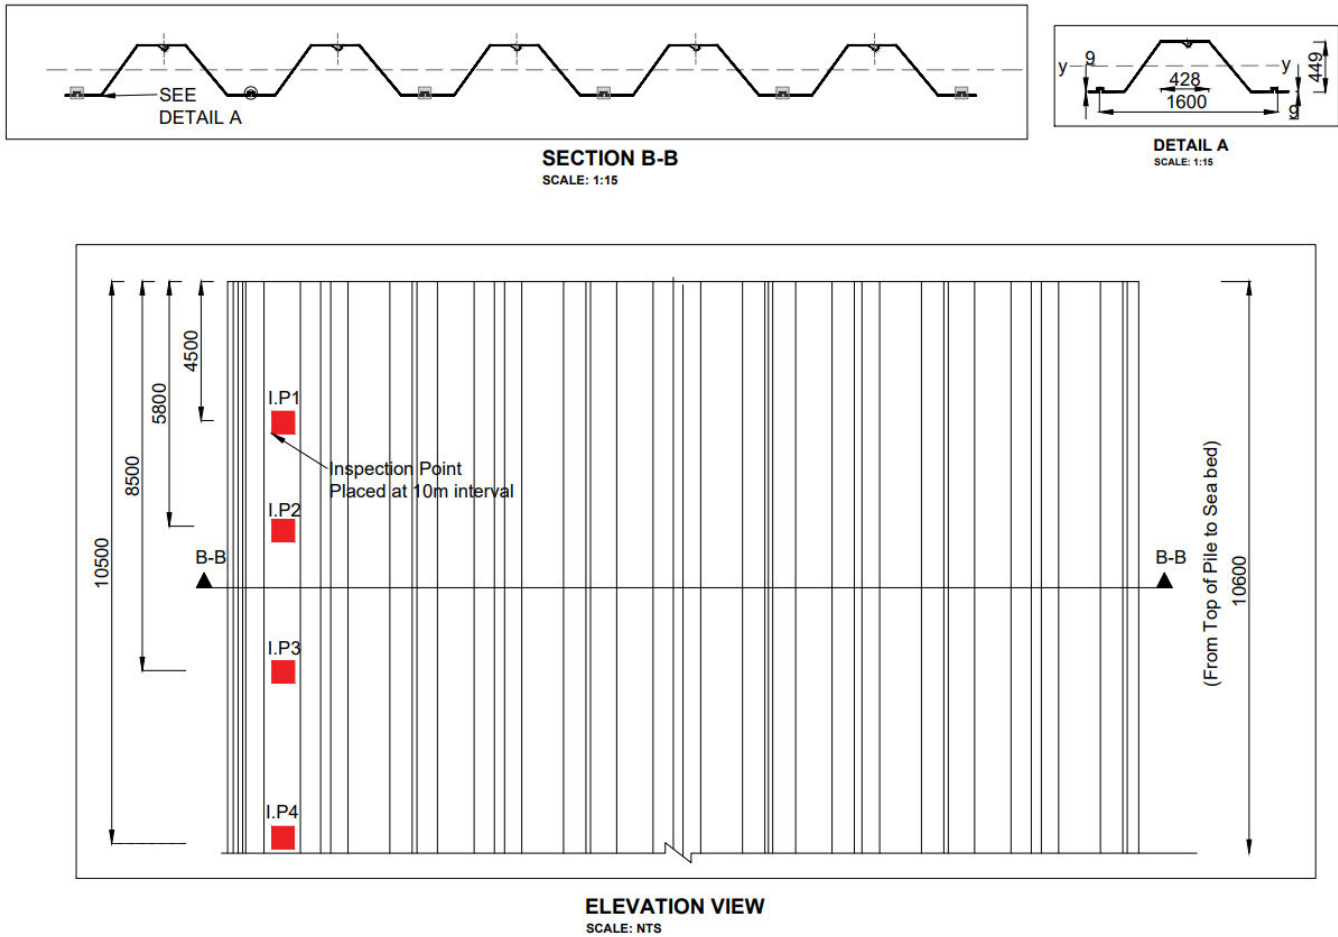
Inspections were conducted in Maydon Wharf Berth 12, and sheet piles are located underwater, starting from bollard 119 to bollard 138. At Maydon Wharf Berth 12, measurements were taken on the sheet pile walls at depths of 4.5, 5.8, 8.5, and 10.5 m, starting from the water level and progressing towards the seabed. The cope beam served as a reference point for depth measurements, which were taken using measuring tape. The tape was lowered from the top of the quay to the seabed to mark the inspection points. **Figure 3.12** illustrate the top and front views of the sheet pile wall, showing the positions of these inspection points.

Figure 3.12: Inspection points on sheet liners

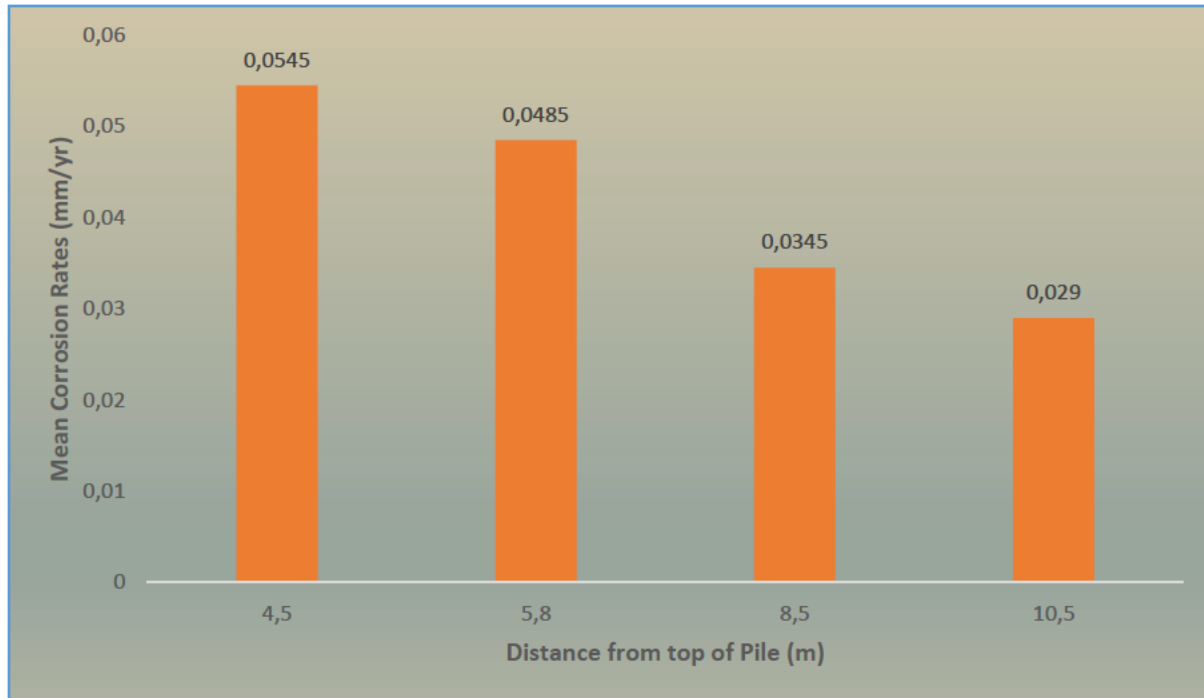
Figure 4.5: Average corrosion rate measured at different depths from the top of the pile to the seabed

Distance from the top of the pile	N	Mean corrosion rate	Std. Deviation	95% Confidence Interval for Mean	
				Lower Bound	Upper Bound
4.5 m	20	0.0545	0.06680	0.0077	0.0703
5.8 m	20	0.0485	0.03242	0.0273	0.0577
8.5 m	20	0.0345	0.04175	0.0085	0.0475
10.5 m	20	0.0290	0.03784	0.0023	0.0377
Total	80	0.0416	0.04659	0.0220	0.0427

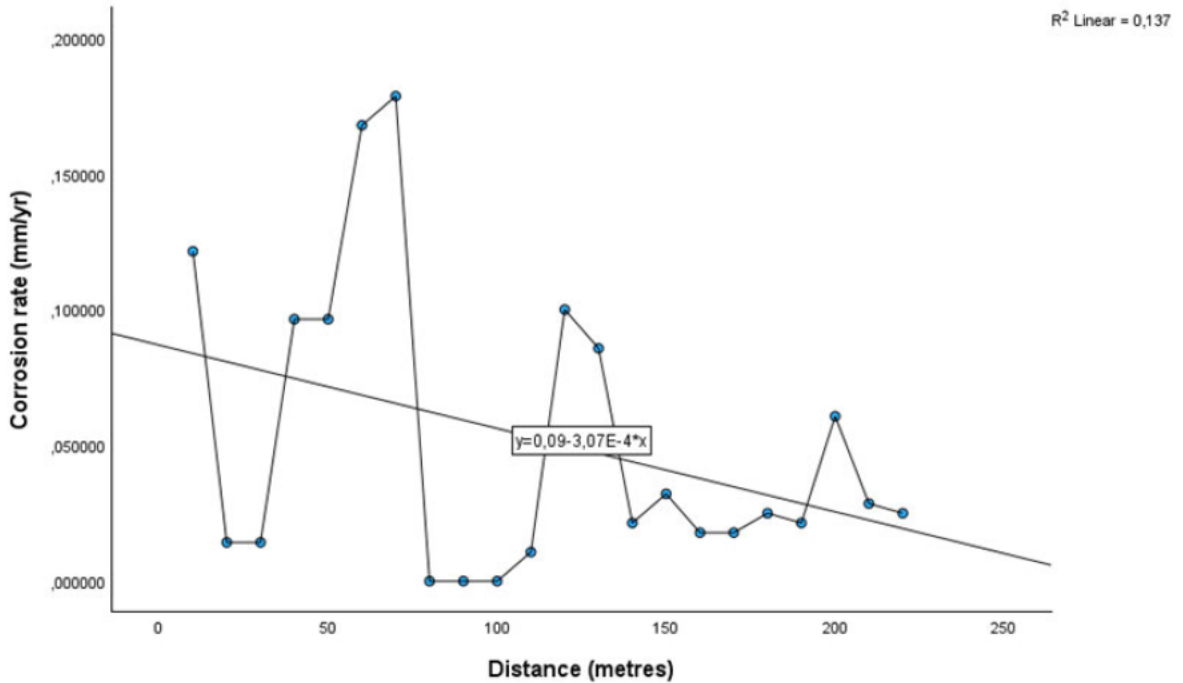
The corrosion rate was also measured horizontally at 10-along a 230-m stretch of Island View Berth 3. **Figure 4.6** summarises the recorded thickness revealing the significant variability in the remaining thickness of the sheet piles, ranging from 3.0 to 8.0 mm. **Figure 4.7** summarises the corrosion rate calculated based on the remaining steel thickness.

Figure 4.7: Corrosion rate measurements at 10-m intervals
