**ASSESSMENT OF THE LOWER ISIPINGO CATCHMENT'S ABILITY TO MITIGATE FLOODING,
CONSIDERING THE EXISTING DRAINAGE SYSTEM**

Master of Engineering

Durban University of Technology

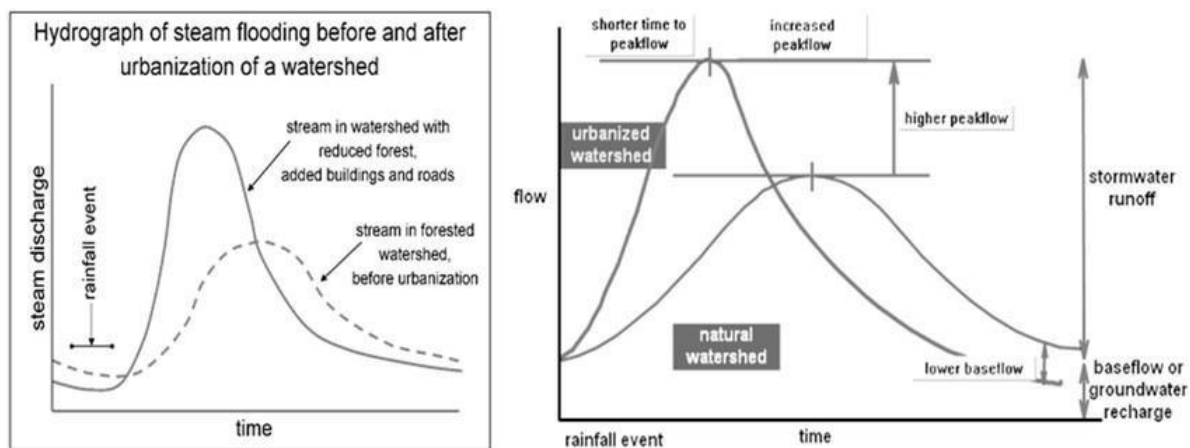
Figure 7: Link between Urbanisation and Outflow

Floods become more frequent and severe as a result of urbanisation, and they can also place urban cities at greater risk of flooding (Konrad 2003). Hydrographs are an effective tool for indicating rainfall discharge. As shown in Figure 7, the increase in the proportion of impervious surfaces results in a shorter time to peak flow and runoff peak, which in turn leads to a decrease in the recharge of groundwater and a corresponding decline in baseflow. Numerous variables, such as the duration and intensity of rainfall, geographical location, vegetation, and hydrological conditions, affect a flood's peak discharge. Additionally, land use and land cover and anthropogenic activities also influence peak discharge as they alter precipitation land surface storage and flow.

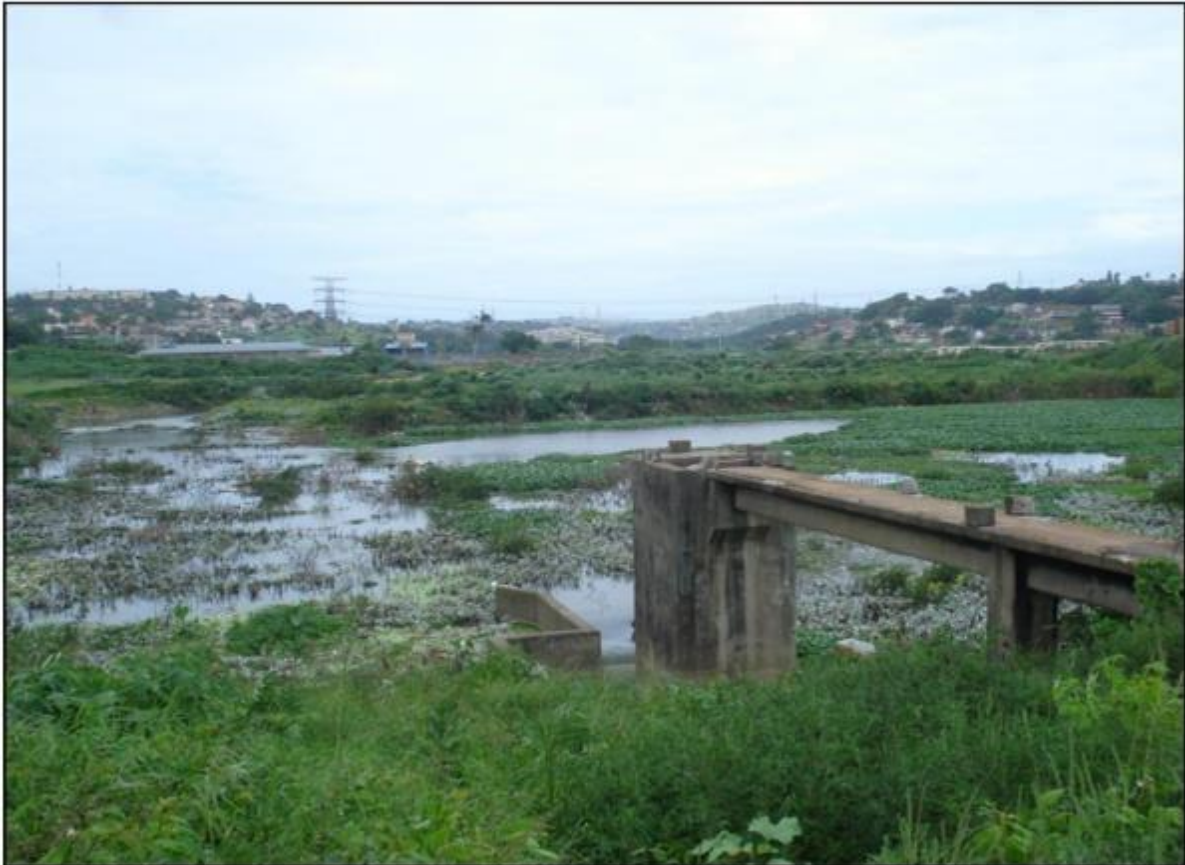
Figure 20: Sluice Gates at the head of the Prospecton Canal System.

maximum amount of water that can be admitted through the entrance of the sluice gates is 5.4 m³/s (Pillay 2013).

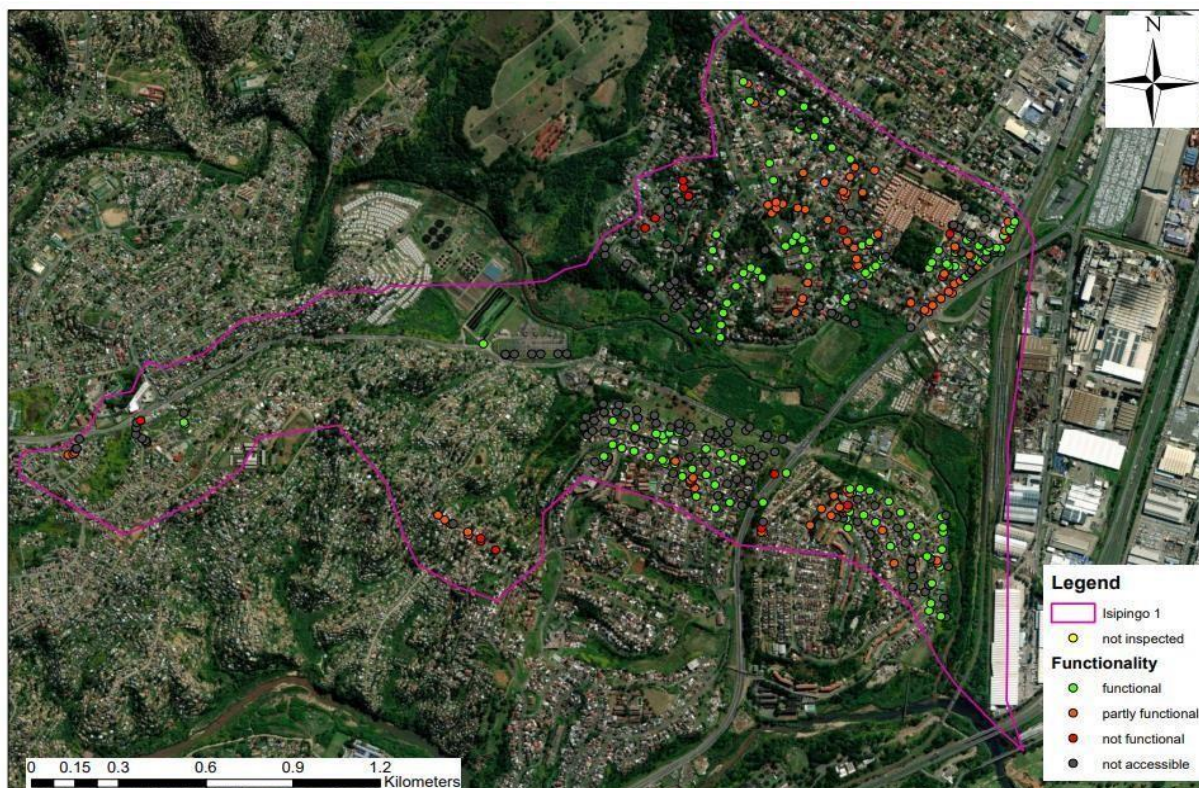
Figure 60: Isipingo 1 functional structures.

Isipingo 1 as shown on Figure 60 and Figure 61 has a total of 403 structures; 229 structures were assessed, while 174 structures were inaccessible. Several variables, including location, type of structure, manhole cover, and the structure's material type, prevented access to the 174 structures. No culverts, canals, or open channels were observed in this catchment.

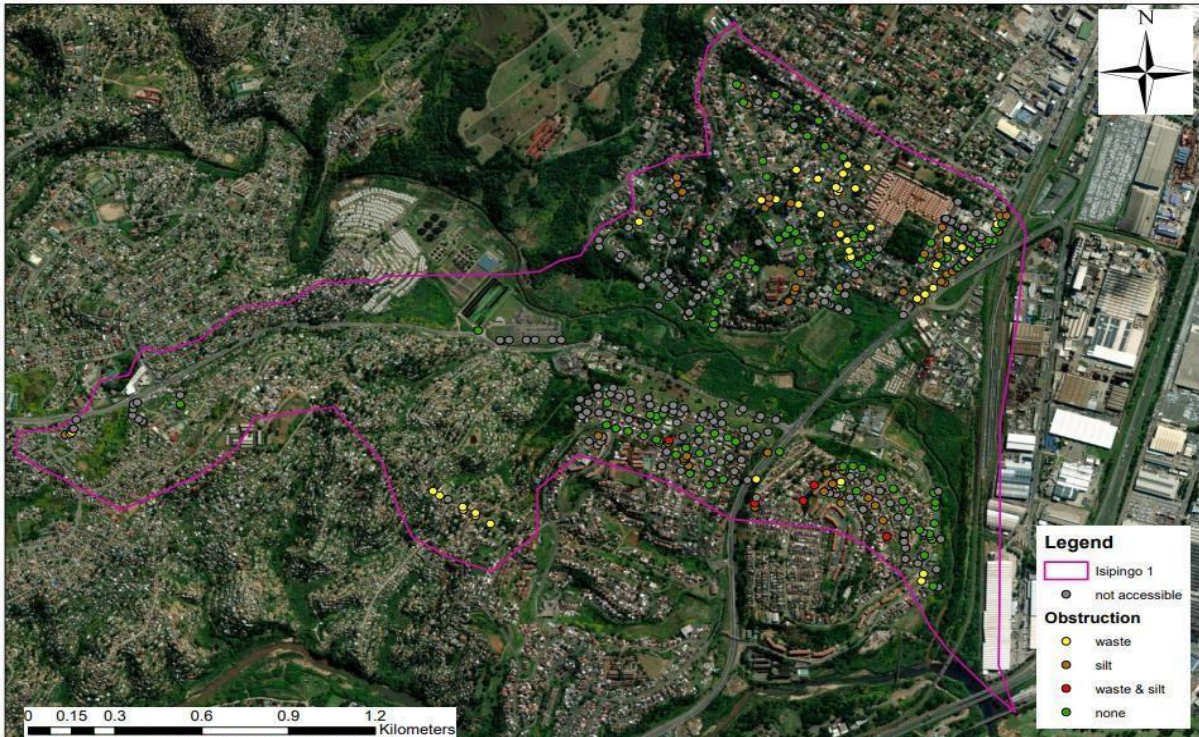
Figure 61: Isipingo 1 obstruction type.

The upper catchment's vulnerable areas are in Malukazi Township Road 1 and Asihlengi Place, where structures are partially functioning and hindered by waste and silt. In the Oriental Hills area, partly functioning structures, all of which are silted, were found on Oriental Drive, Strawberry Avenue, and Nertum Road. In the Isipingo CBD residential area, partly functional and blocked structures with waste and silt were located on Sucrose Road, Platt Drive, Marigold Avenue, Protea Road, and Wistaira Road. Conversely, 24 structures in the Malukazi Township and the Isipingo CBD residential area and surroundings were defective and require replacement. Figure 61 details the type of obstruction observed in the structures.

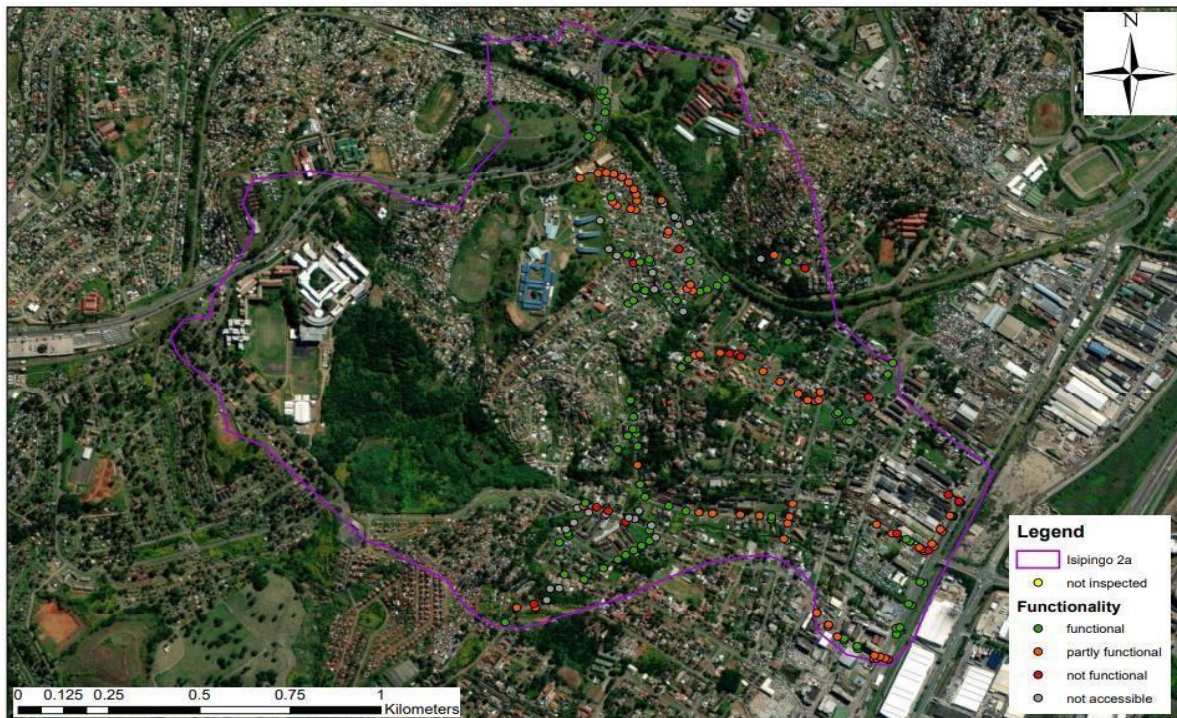
Figure 62: Isipingo 2a functional structures.

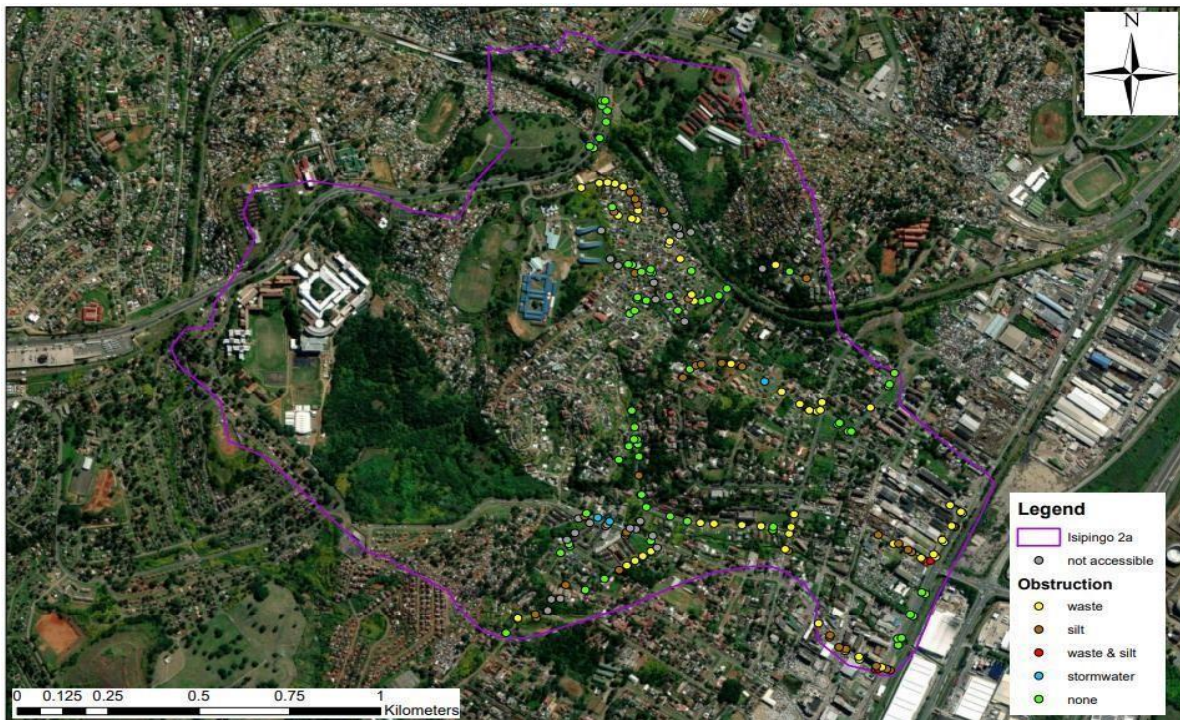
Figure 63: Isipingo 2a obstruction type.

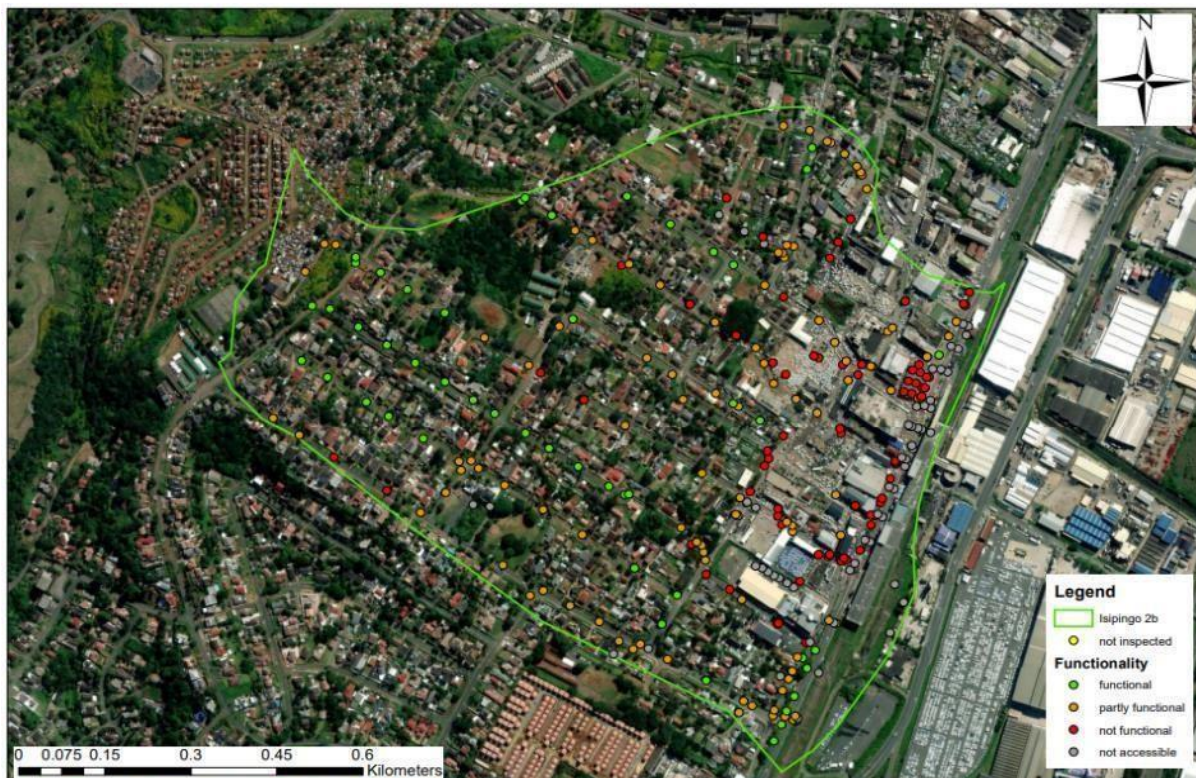
Figure 64: Isipingo 2b functional structures.

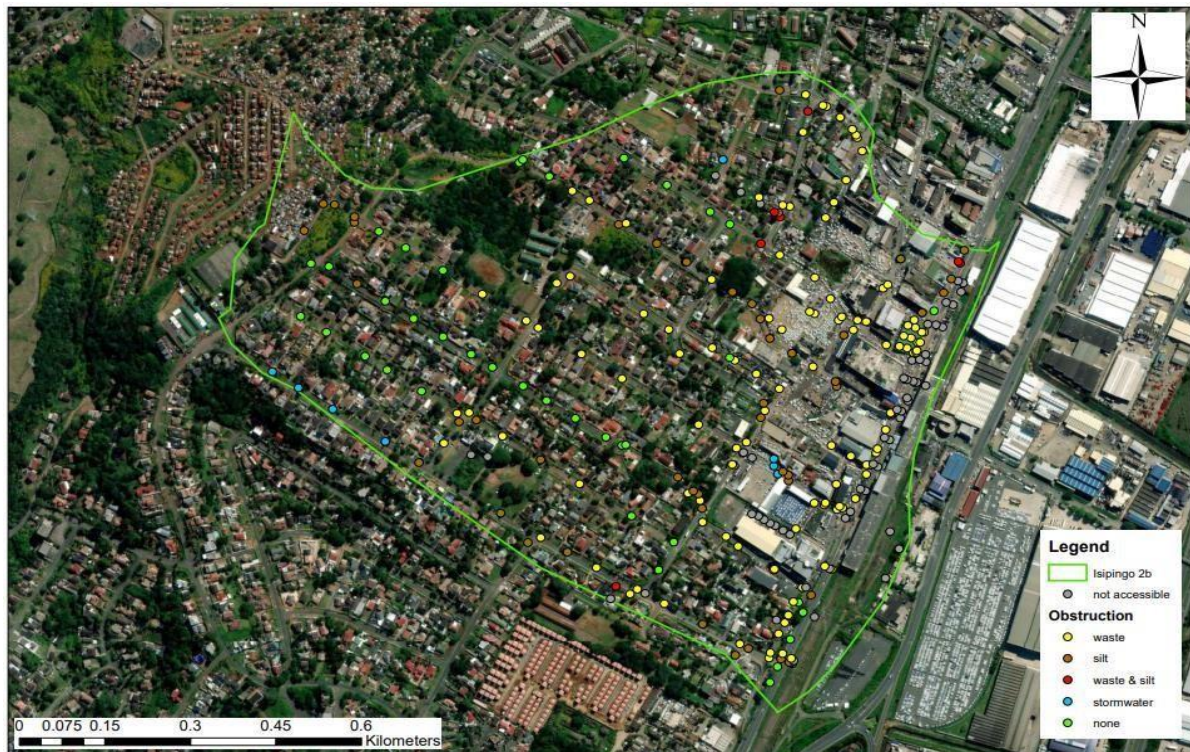
Figure 65: Isipingo 2b obstruction type.

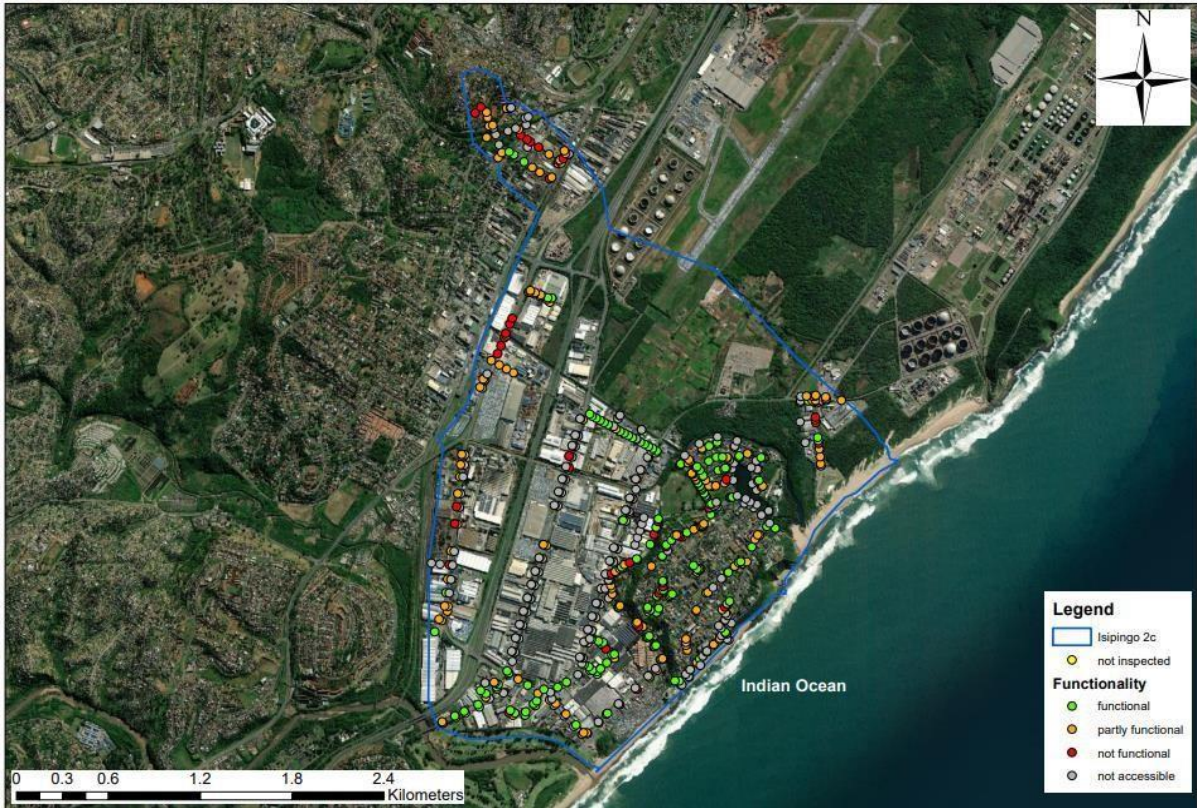
Figure 66: Isipingo 2c functional structures.

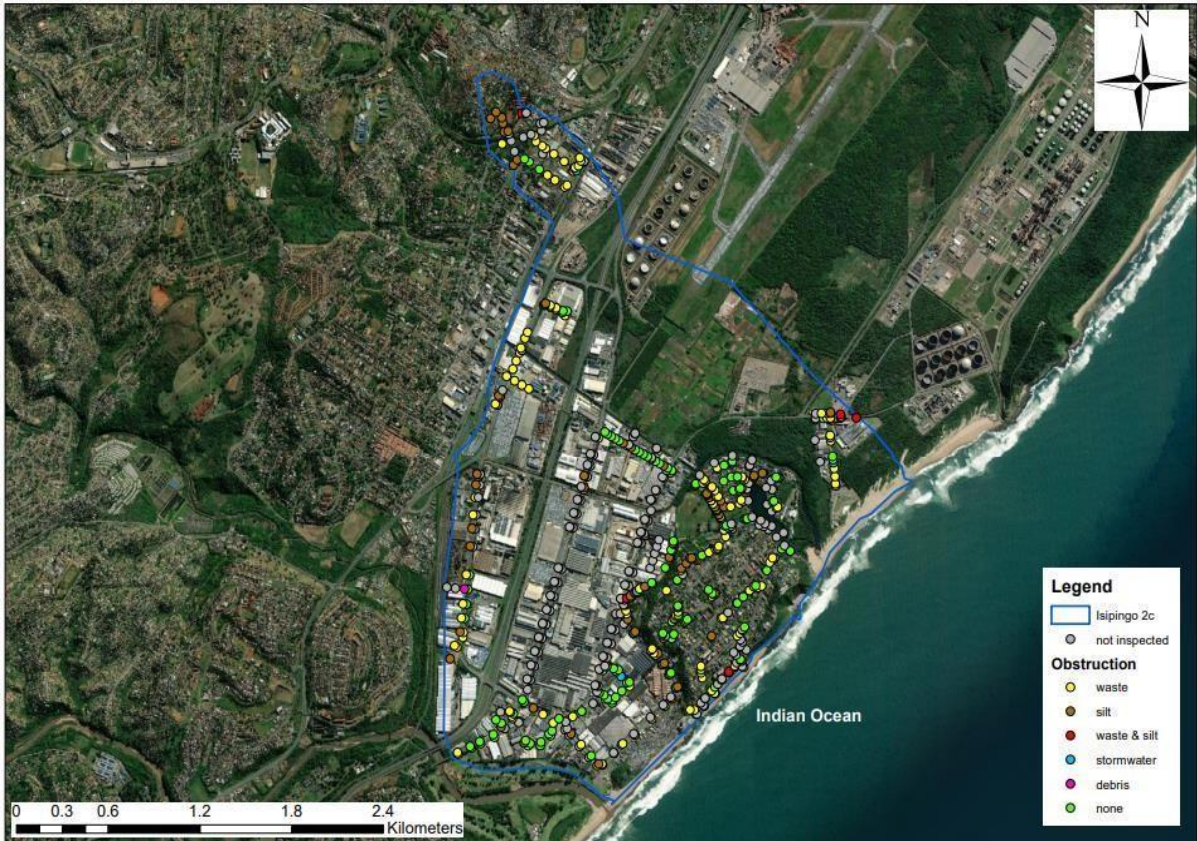
Figure 67: Isipingo 2c obstruction type.

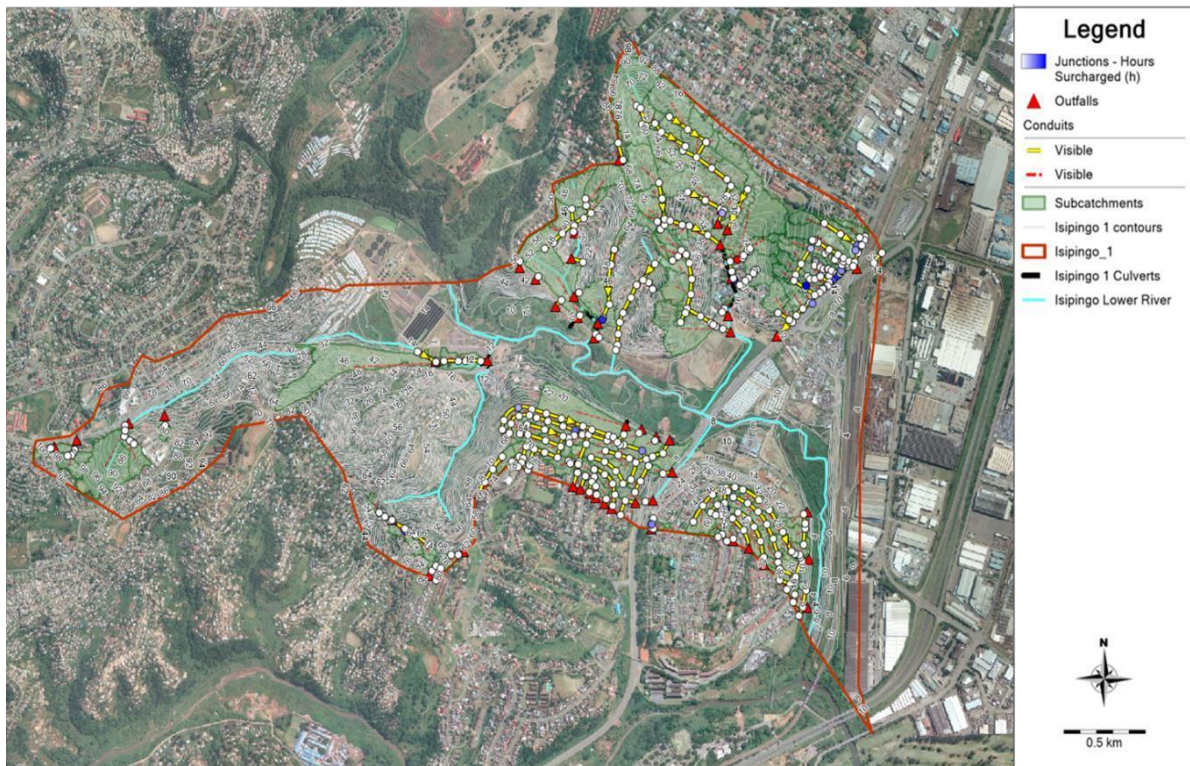
Figure 69 indicates the model results for Isipingo 1 with the 130 mm April 2019 flood rainfall. The model has sufficient capacity to mitigate stormwater runoff as the drainage infrastructure is functioning adequately with few isolated surcharging/flooding areas.

Figure 69: 130 mm rainfall April 2019 floods.

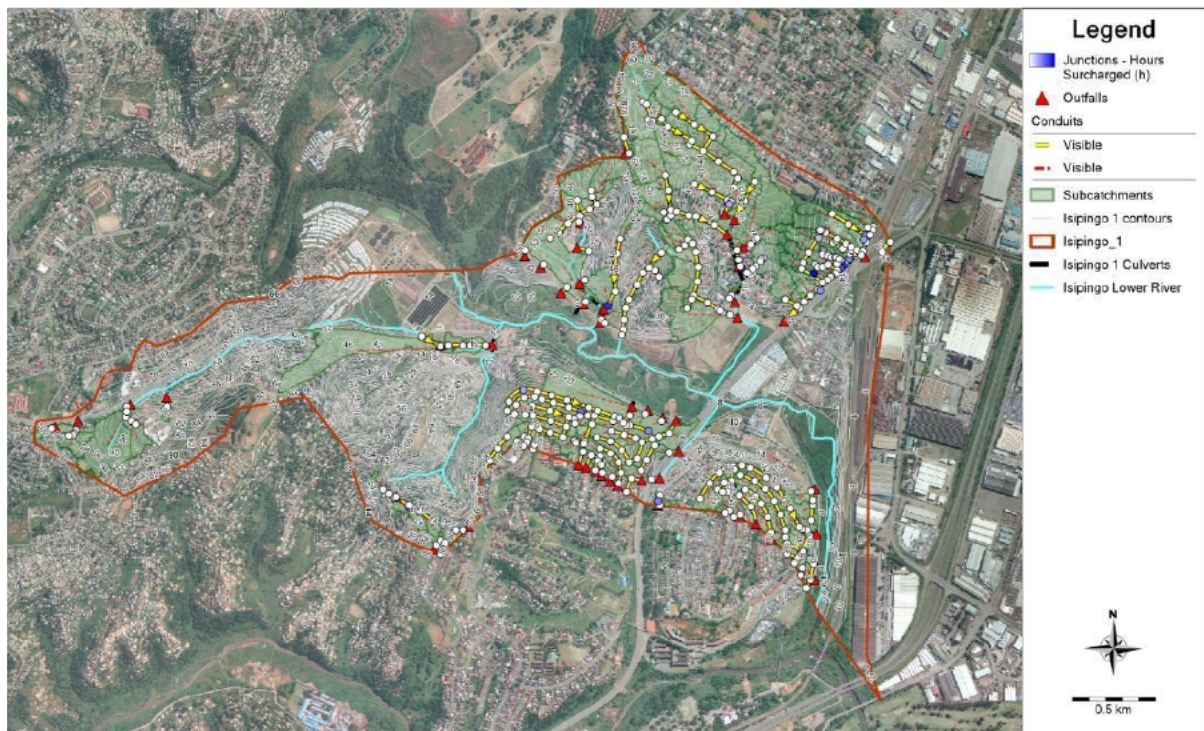
Figure 70: 158 mm rainfall April 2022 floods.

Figure 69, and Figure 70 are relatively similar regardless of the different rainfall gauges due to the same problematic areas caused by negative pipe slope, inaccurate cover, incorrect invert elevations and varying pipe sizes along the networks. This ultimately causes certain structures to surcharge or to flood along the network. The different rain gauges only change the shade of the blue along the network which is regarded as the degree of surcharging and subsequent flooding.

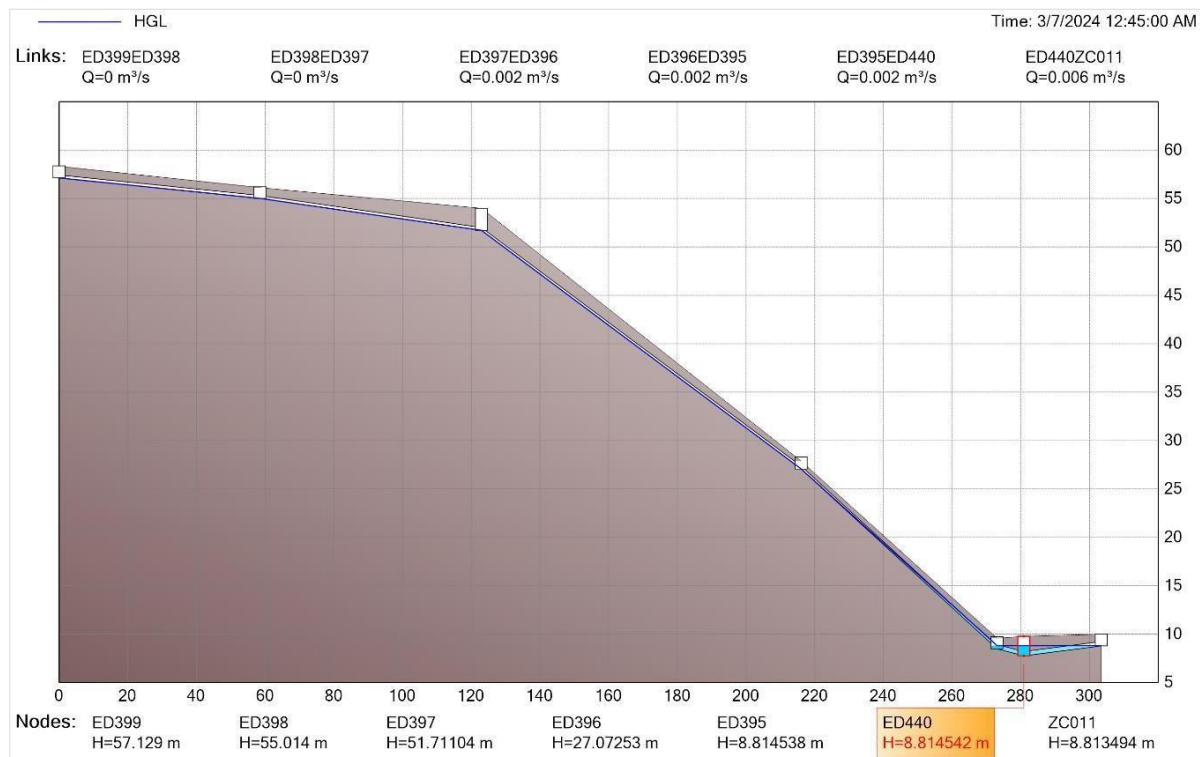
Figure 71: ED399ZC011 Longsection (Pepperberry Road)

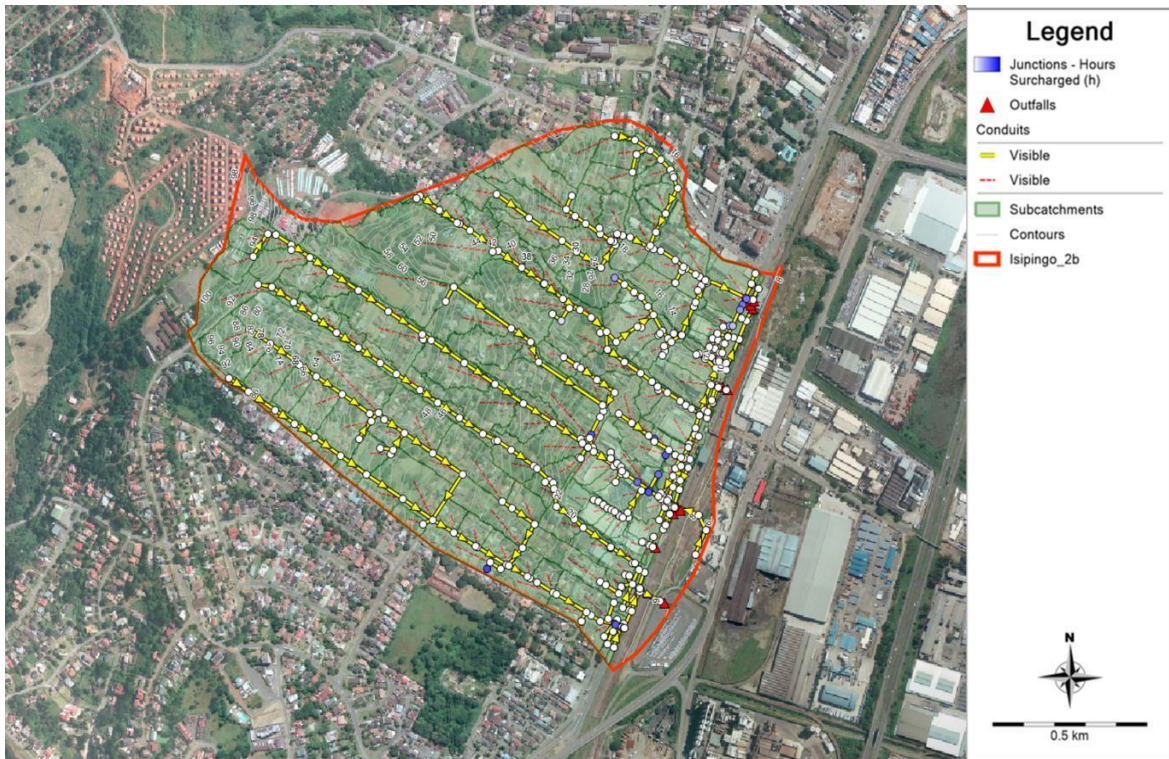
Figure 85: 149.3 mm 1 in 5-year design rainfall.

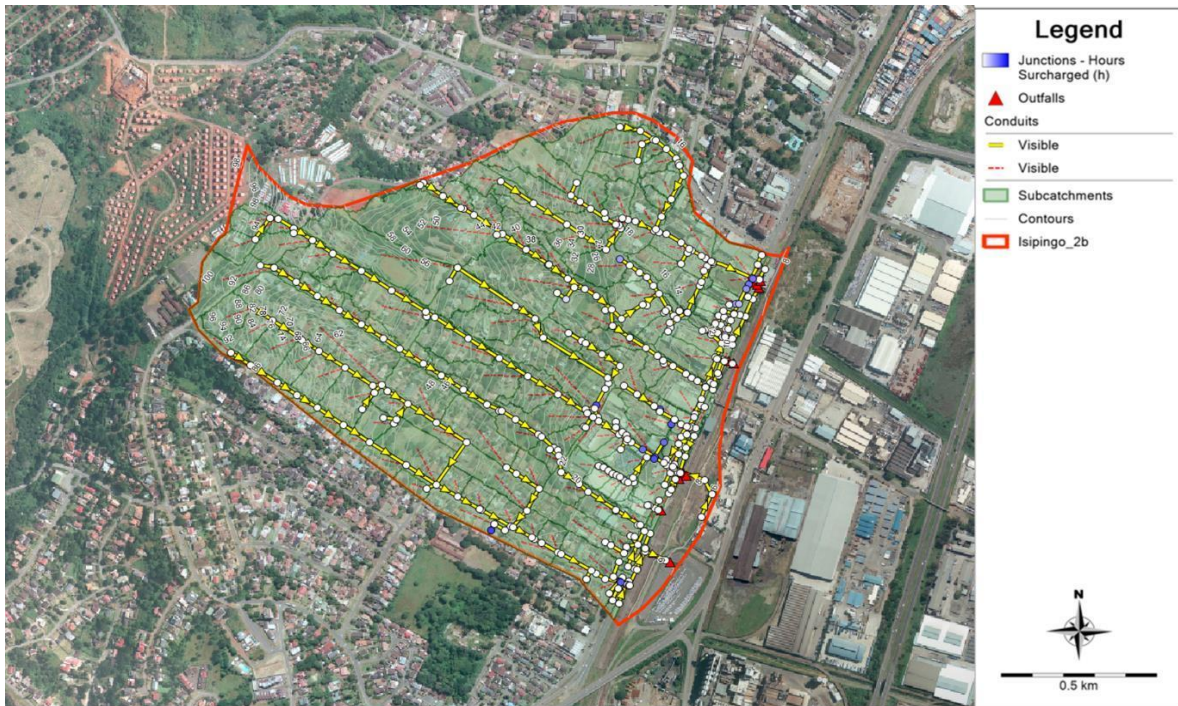
Figure 86: 130 mm rainfall April 2019 floods.

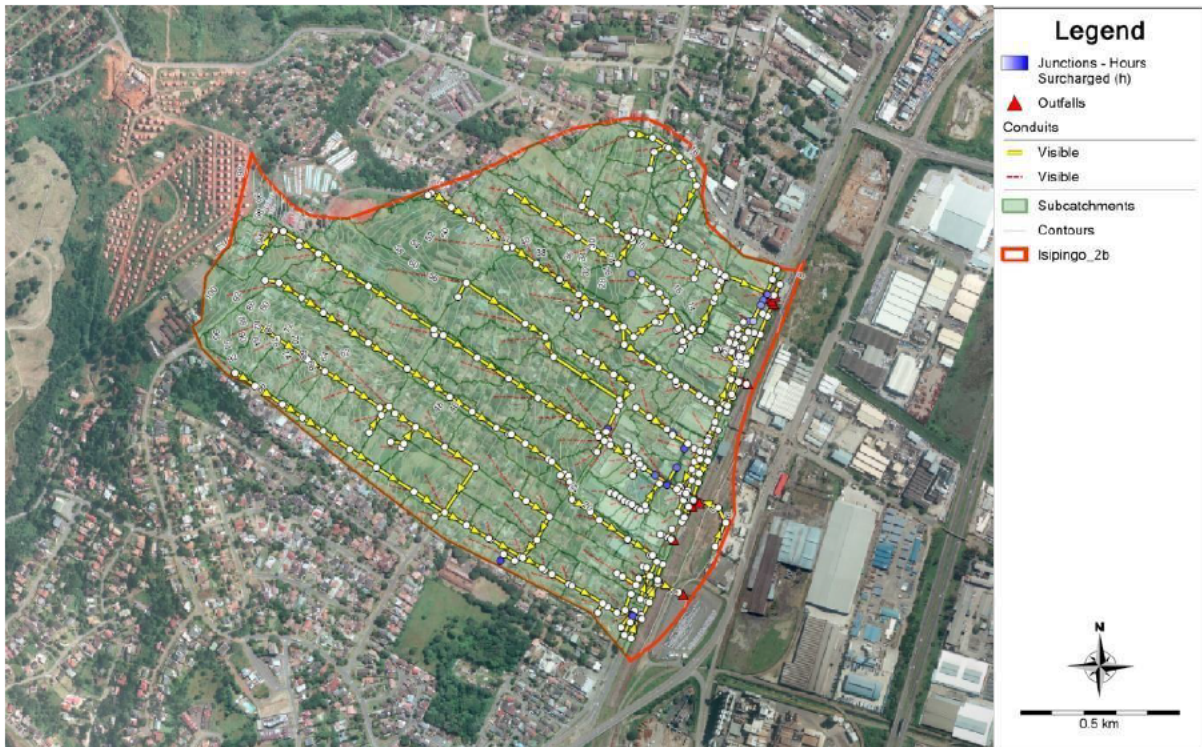
Figure 87: 158 mm rainfall April 2022 floods.

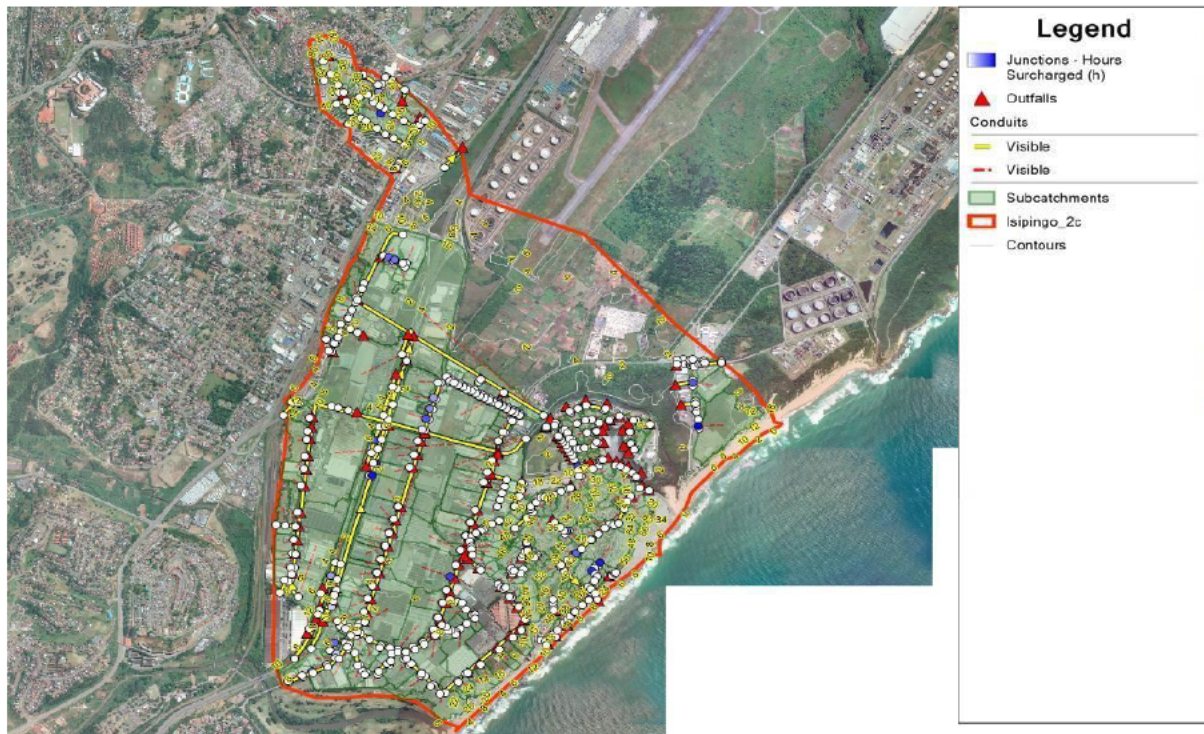
Figure 92: 151.6 mm 1 in 5-year design rainfall.

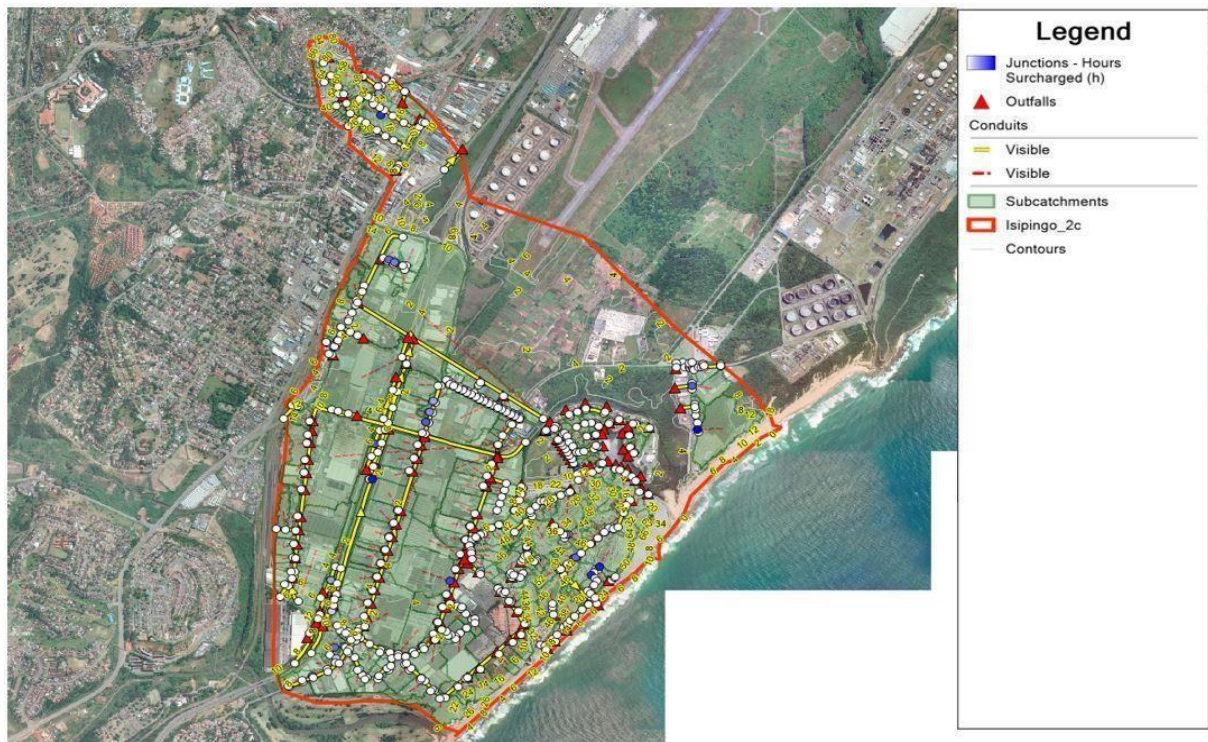
Figure 93: 130 mm April 2019 floods.

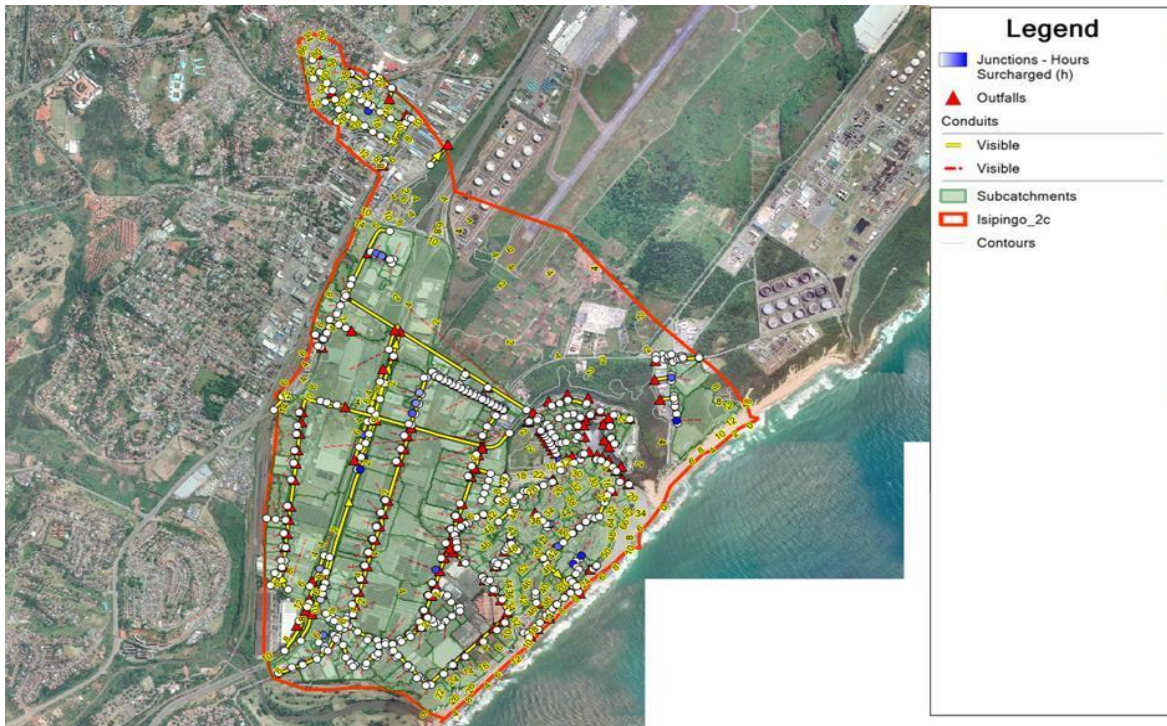
Figure 94: 158 mm rainfall April 2022 floods.

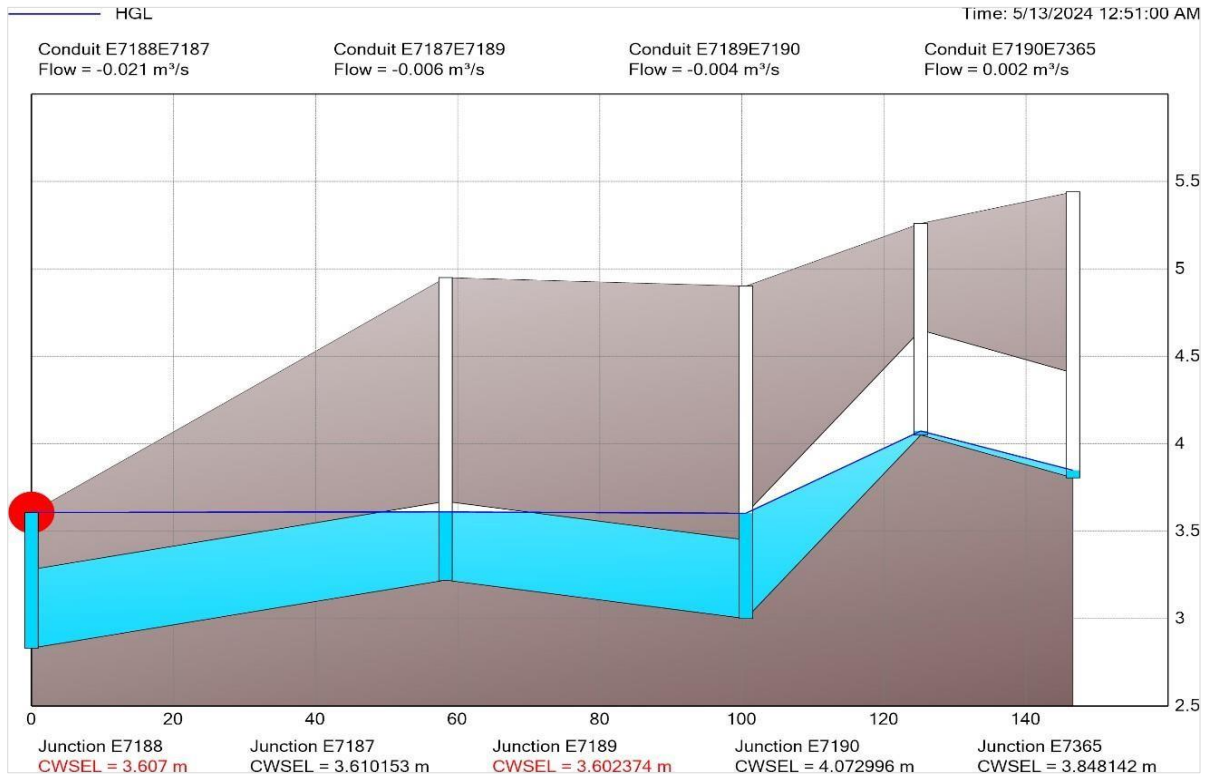
Figure 98: E7188E7365 Longsection (Prospecton Road)
