# **In-Service Condition Monitoring of Polymer Housed Surge Arrester within EThekweni Electricity**

A dissertation submitted in fulfillment of the requirements for the degree of Master in  
Technology

**Department of Electrical Power Engineering  
Faculty of Engineering and Built Environment**

February 2014

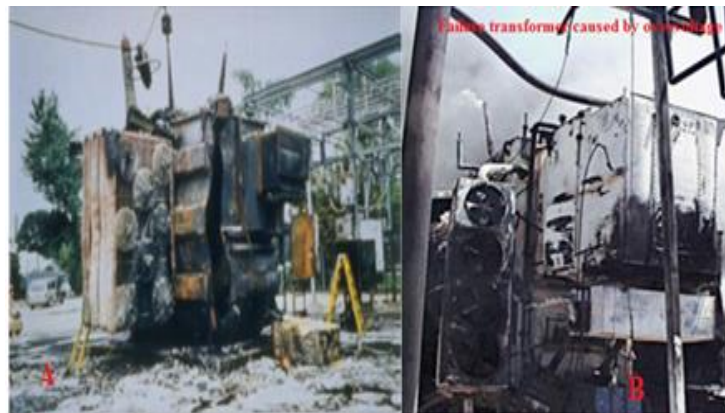
**Figure 2.10:** Failure power transformer due to overvoltage [8].

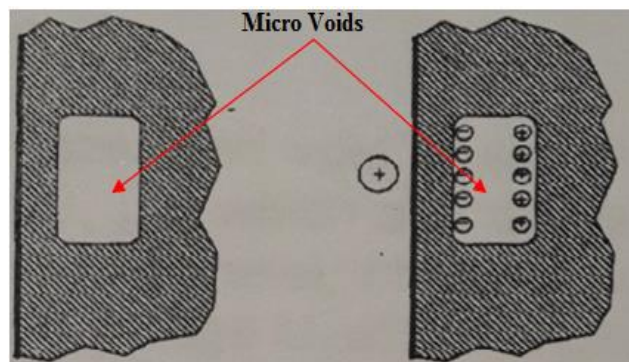
The pollution exhibited by moisture ingress could induce surface discharges which could damage the ZnO varistor of the arrester [38]. When the polymers are electrically stressed, partial discharge can form in regions of high electrical stress within the insulator as shown in Figure 2.13. [68].

**Figure 2.13:** Micro Voids on the insulator [11].

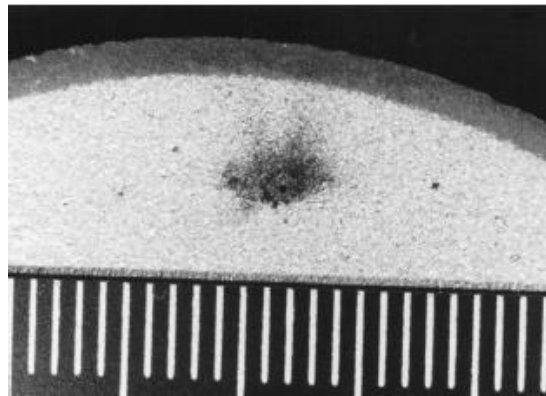
PD has been the most common cause of degradation [26], [68]. This can possibly cause the internal partial discharge on the surface area of ZnO varistor elements [26] as shown in Figure 2.14. Therefore, there is a need to monitor the condition of such insulators closely. Any damage needs early detection to avoid further degradation to complete breakdown.

**Figure 2.14:** Puncture on surface of zinc oxide varistor element [12].

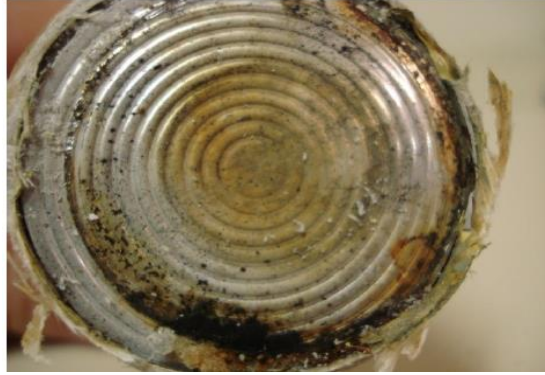
**Figure 2.14 (a):** Moisture ingress on the sealing interior [13].

A defective arrester may not be able to work satisfactorily when an electrical surge occurs. Hence, it could allow moisture to penetrate to surge arrester housing or sealing [62], (see Figures 2.14 (a) - (b)). A consequence of this effect is the reduction of the level of security in the performance of the apparatus [50], [70].

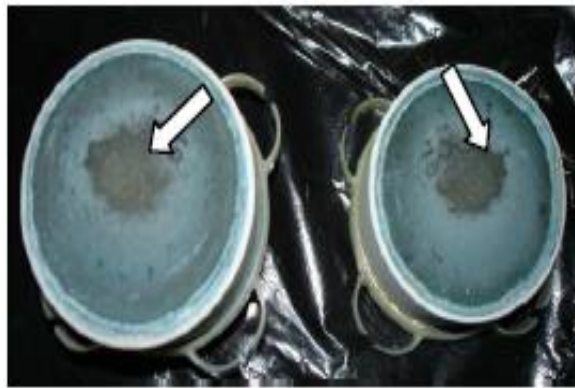
**Figure 2.14 (b):** Moisture ingress on the sealing interior [Ami & Salam].

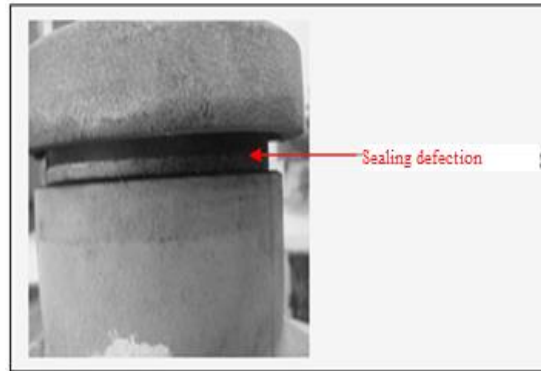
**Figure 2.15 (a):** Upper sealing defect [14].

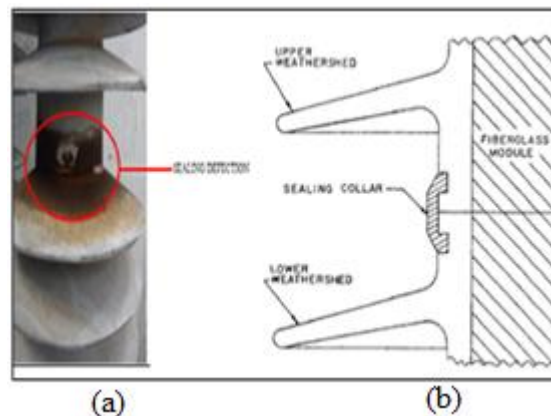
**Figure 2.15 (b):** Sealing collar defective [14], [15].

Besides adverse climatic conditions that accelerate the surge arrester aging, in normal operating conditions they are subjected to constant voltage, resulting in temperature rises, due to energy loss on a resistive current by a cyclic process [13], [94]. Furthermore, defective housing has been reported as a source of failure [20] (see Figure 2.15(b)).

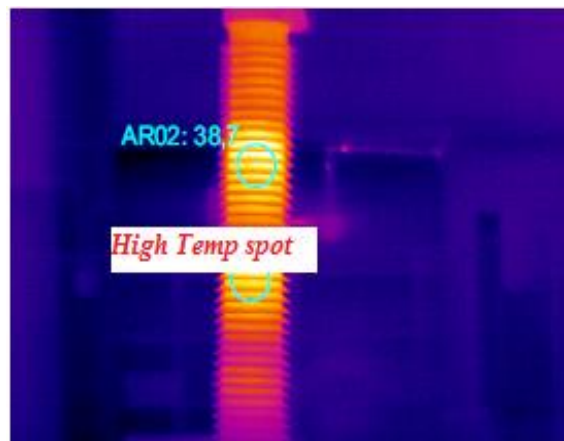
The formation of sparking discharge is closely related to the varying trends of the total leakage current and creates high temperature spots, leading to bond separation and other chemical changes on the surface insulation (see Figure 2.17).

**Figure 2.17:** High temperature [17].

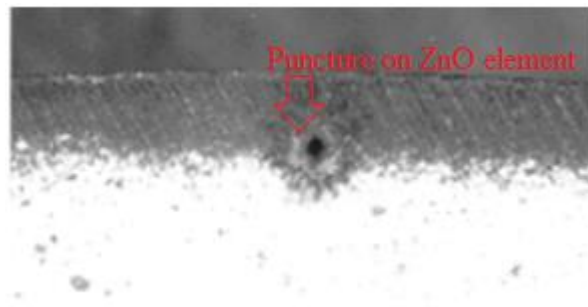
**Figure 2.20:** Damage to the disc created by lightning [47].

Significant ZnO varistor failure mechanisms include: electrical puncture as shown in Figure 2.20, thermal cracking, and thermal runaway (Figure 2.21), all resulting from excessive heating; in particular, from non-uniform heating.

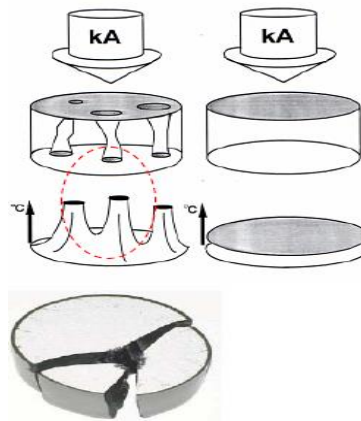
**Figure 2.21:** Thermal cracking on ZnO varistor [8].

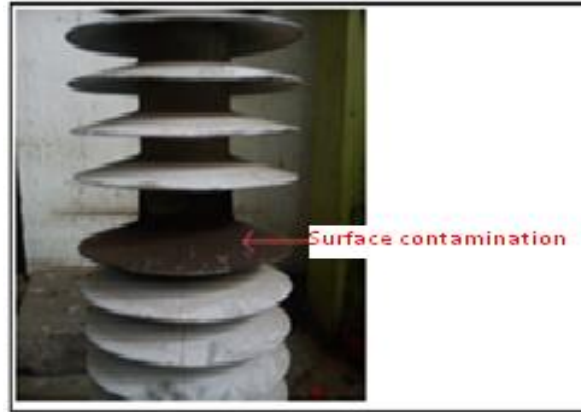
External pollution can cause serious problems for surge arresters in service. Pollution decreases the creepage distance for the current conduction, making possible the occurrence of discharges on the surface area of polymeric surge arresters [42], [48].

**Figure 2.24:** Surface contamination [19].

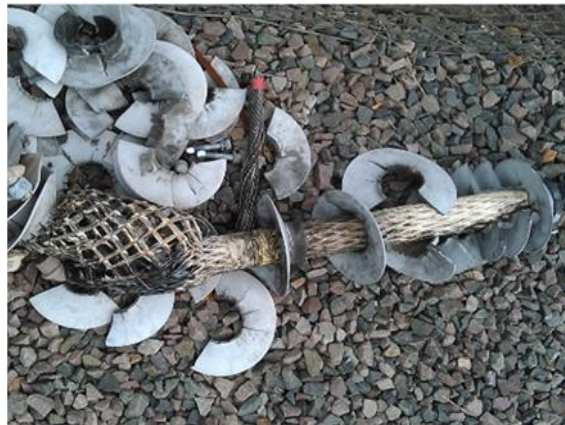
The arrester with polymer housing may burn open the external insulation; such failed arresters are shown in Figure 2.25.

**Figure 2.25:** Polymeric surge arrester that failed during in service condition [19].

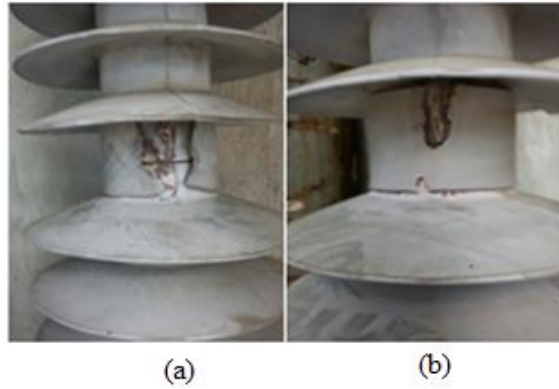
- Damage of sealing due to thermal heating produced inside varistor (see Figure 2.28).

**Figure 2.26:** Defective sealing increase high rate of moisture ingress [45].

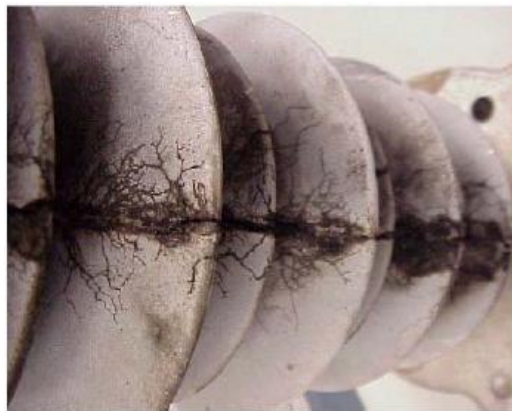
**Figure 2.27:** Deterioration on insulation housing [1].

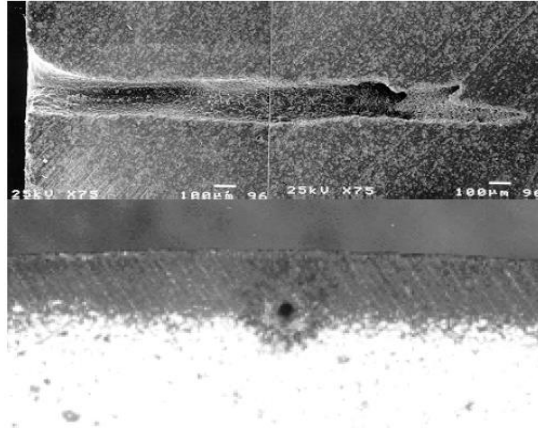
- Mechanical fractures in ZnO varistor due to thermal runaway after a high current surge (see Figure 2.28).

**Figure 2.28:** Mechanical cracks in varistor elements [20, 21].

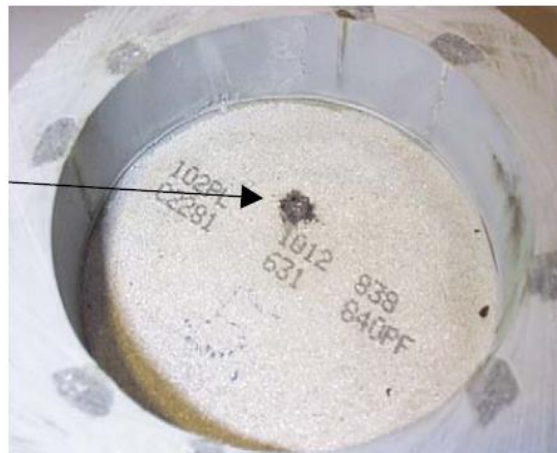
- Damage due to surge current concentration at the edge of the electrode resulting in failure (see Figure 2.29).

**Figure 2.29:** Damage to the ZnO disc created by lightning [22].

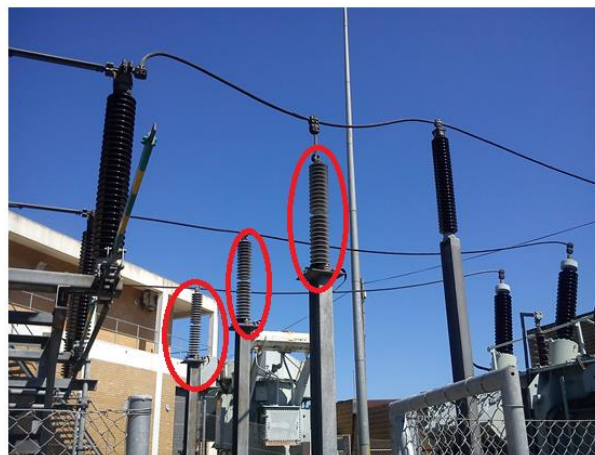
**Figure 4.3:** EThekweni Substation with polymer housed surge arresters.

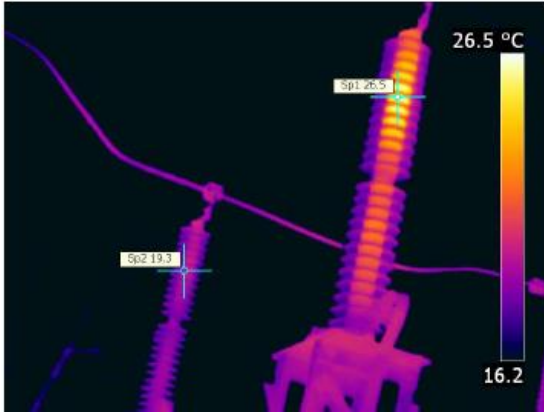
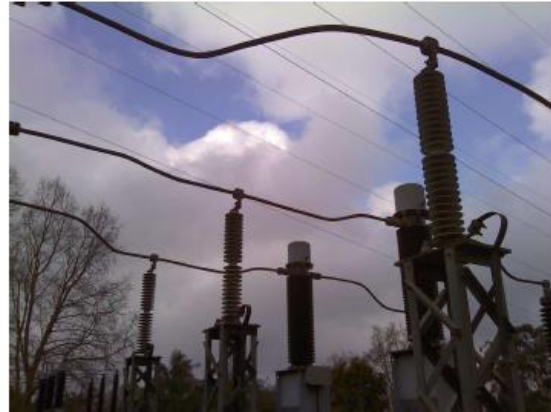
**Figure 6.3:** Thermo-grams for substation A indicated the amount of heat inside the arrester.

**Table: 6.1.**  $\Delta T$  ( $^{\circ}\text{C}$ ) for surge arrester at substations A, for phase R, W and B

$\Delta T(^{\circ}\text{C})$		
	Surge Arrester Phase (R,W,B)		
	R	W	B
<b>Sample 1</b>	48.5	35.8	44.2
<b>Sample 2</b>	45.5	43.6	52.2
<b>Sample 3</b>	30.3	41.2	40.7
<b>Sample 4</b>	29.9	22.1	27.1

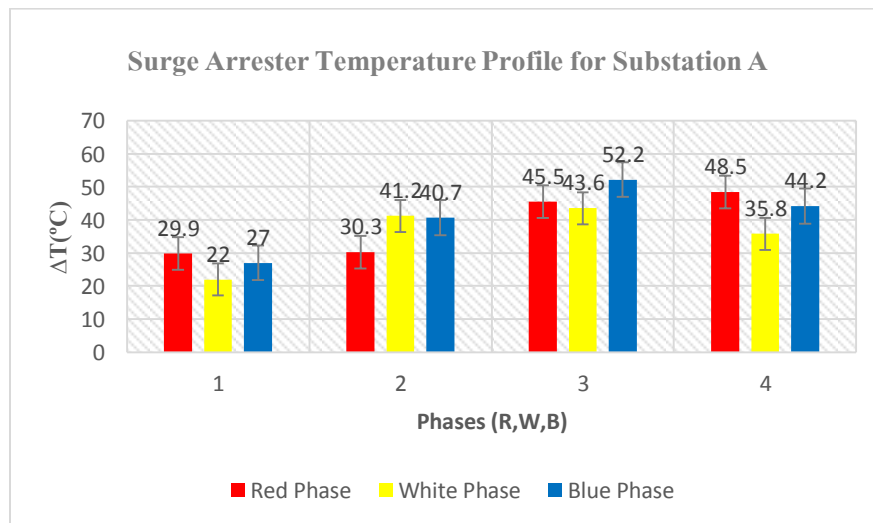
**Figure 6.4:** Temperature profile along the arrester of substation A.

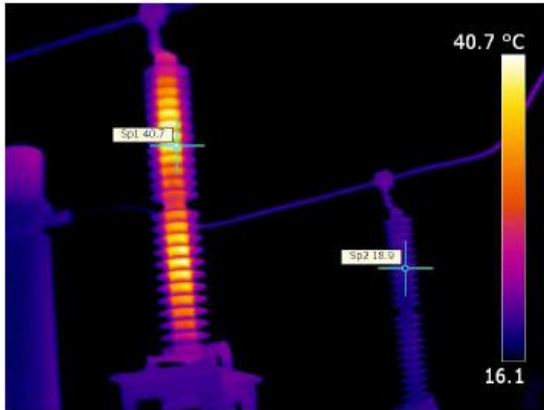
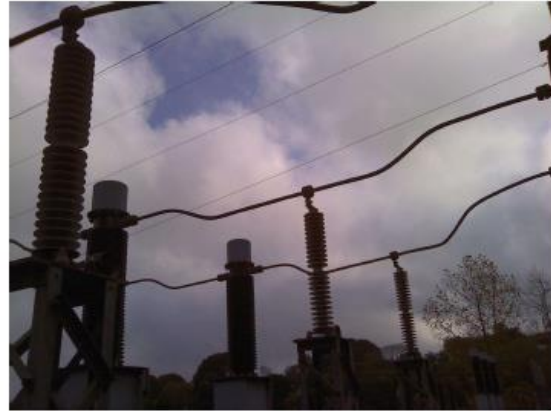
**Figure 4.5:** The thermal heating problem with these arresters could have affected the reliability of the substation B line 2.

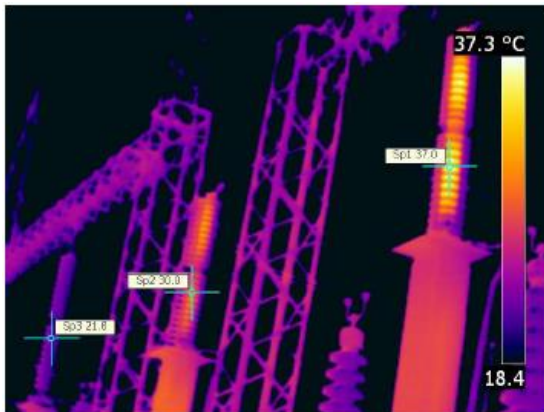
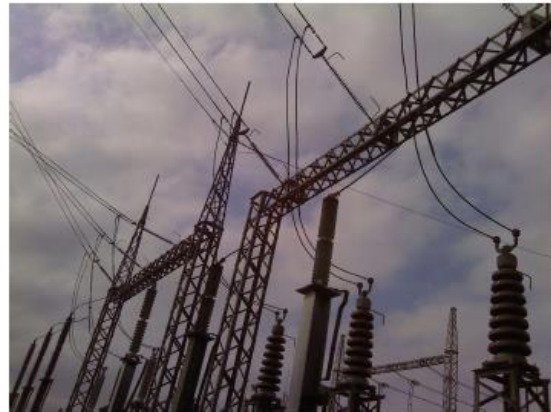
**Figure 6.6:** Thermo-grams for substation B showing the amount of heating inside arrester (132 kV surge arresters blue phase).

During infrared inspection six surge arresters of manufacturer A in substation B were hot. The conditions of these arresters were bad and replacement was recommended.

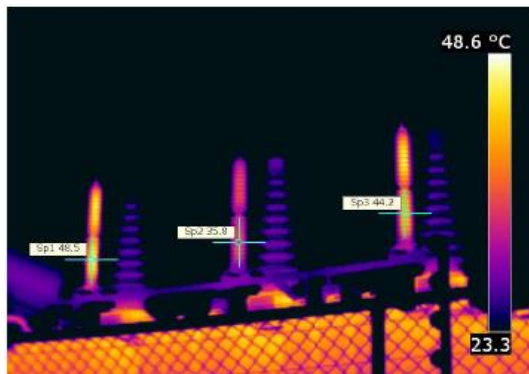
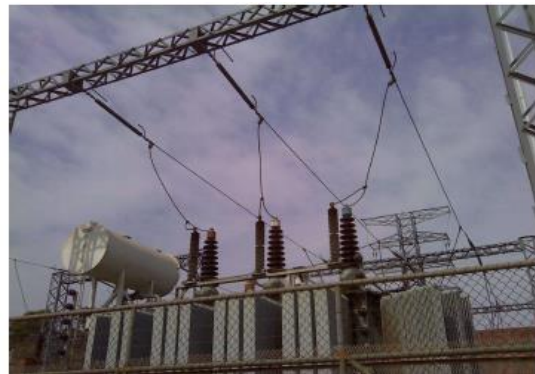
**Figure 6.11:** Thermo-grams for substation C showing the amount of heat inside arrester.

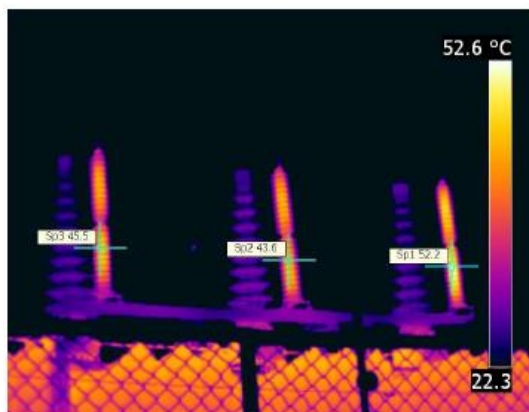
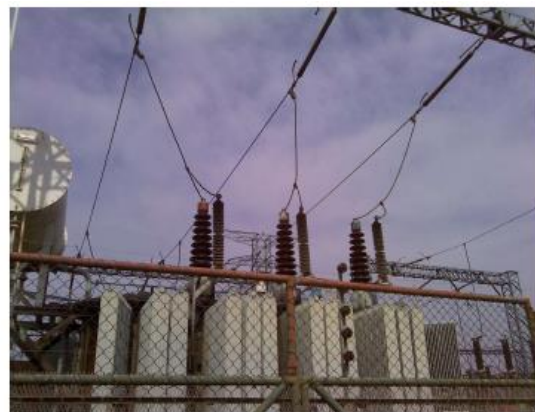
**Figure 6.12:** Thermo-grams for substation C showing the amount of heat inside arrester (transformer 1-132 kV Surge Arresters).

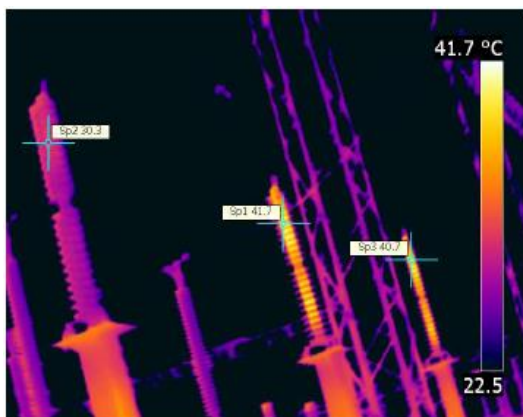
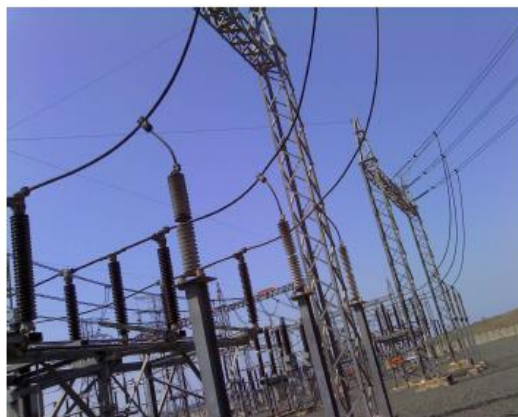
**Figure 6.13:** Thermo-grams for substation C showing the amount of heat inside arrester.

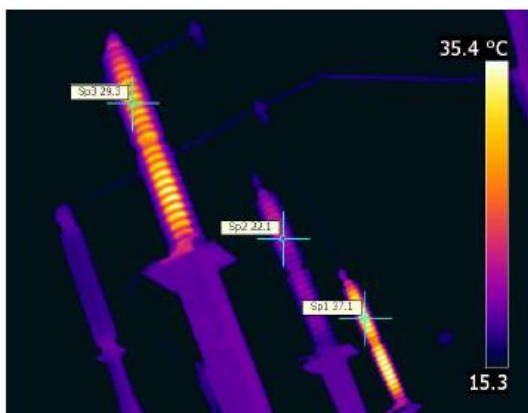
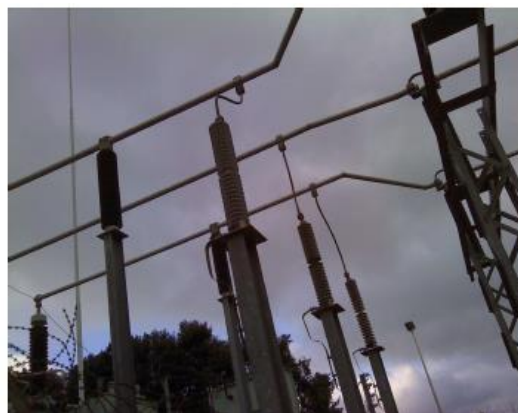
**Figure 6.14:** Thermo-grams for substation C showing the amount of heating inside arrester.

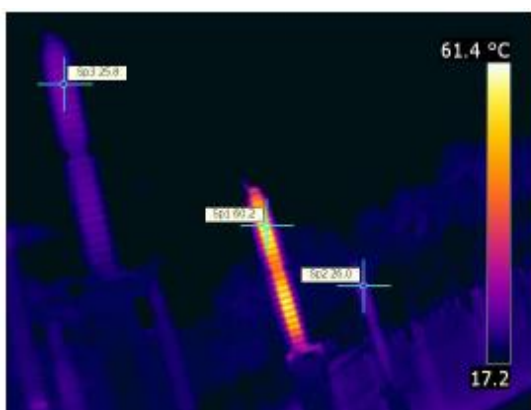
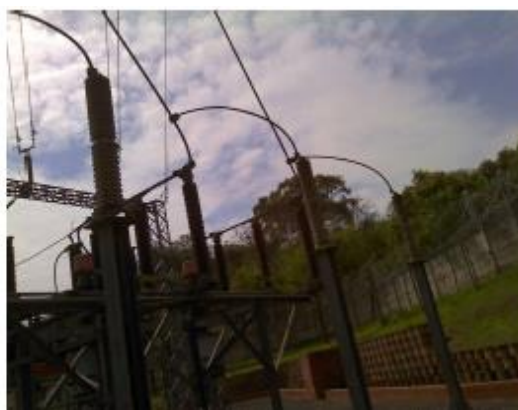
**Figure 6.15:** Thermo-grams for substation C showing the amount of heating inside arrester.

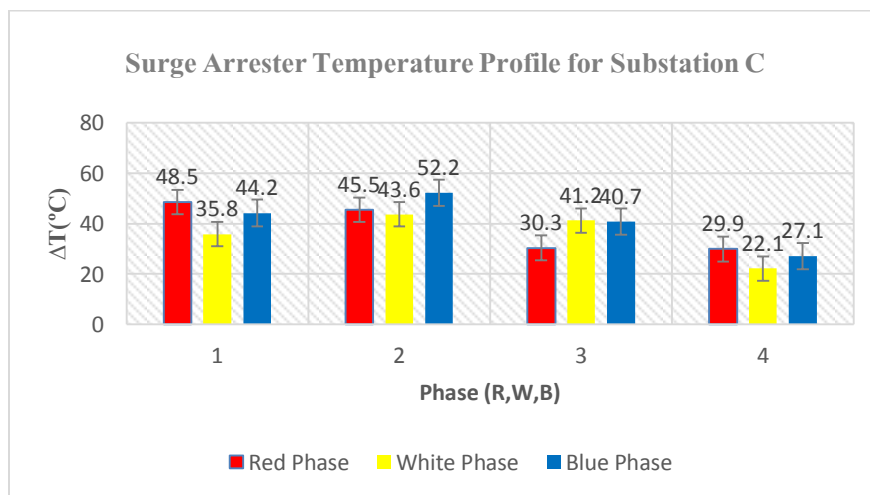
**Table: 6.3.**  $\Delta T$  ( $^{\circ}\text{C}$ ) for surge arrester at substations C, for phase (R, W and B).

$\Delta T(^{\circ}\text{C})$		
	Surge Arrester Phase (R,W,B)		
	R	W	B
Sample 1	23.8	29.6	28.0
Sample 2	30.7	51.8	46.4
Sample 3	19.3	26.5	
Sample 4	47.5	24.6	23.5

**Figure 6.17:** Temperature profile along the arrester of substation C.

On substation C, eight surge arresters showed high temperature inside the ZnO varistor blocks.

It is recommended that faulty surge arresters be replaced before catastrophic failure. Mostly, the measurable increase in the varistor temperature is caused by uneven surface distribution created by the wet pollution layer and moisture ingress. During site inspection evidence of dust pollution was noted on the surface of arresters. The increase in the varistor temperature causes the degradation or failure of the arrester.

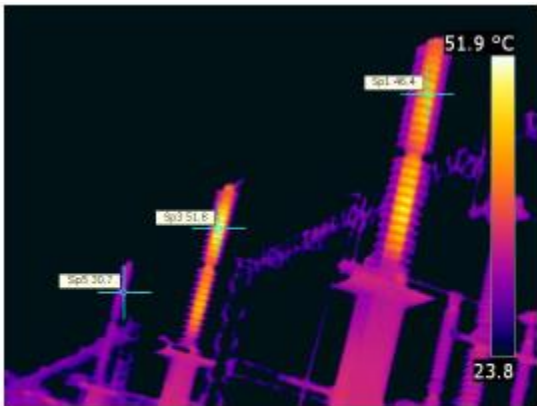
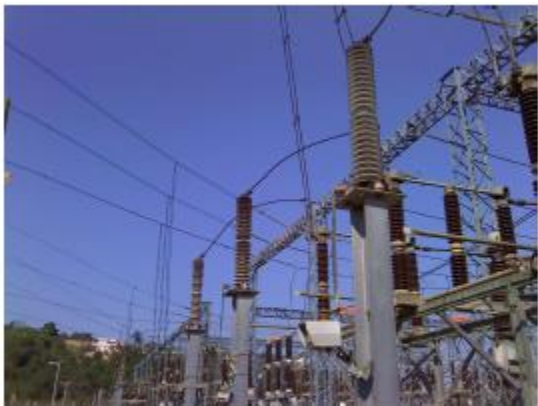
Priority 2: Replace all      Delta T = Sp3-Sp5 = 21.1  
3 within 7 Days      Degrees Celsius

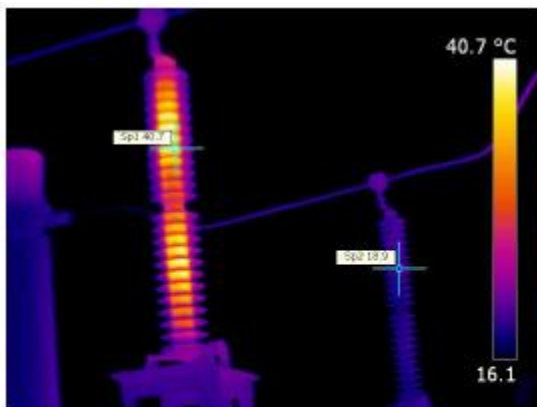
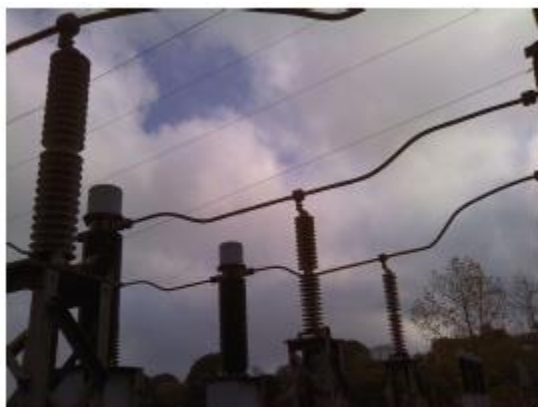
Priority 2: Replace      Delta T = Sp1-Sp2 = 21.8  
within 7 days      Degrees Celsius

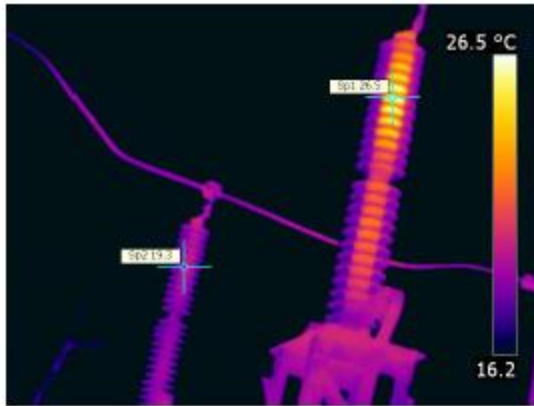
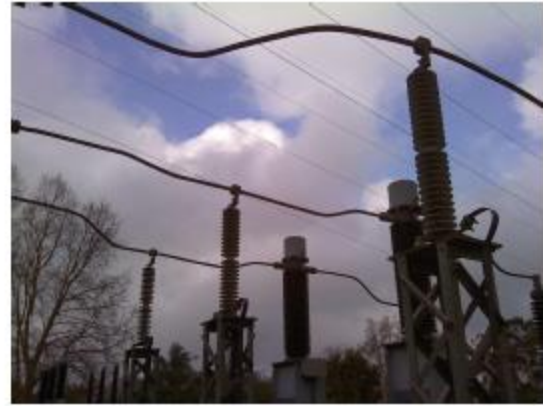
Priority 4: Further scan after 1 month  
Delta T = Sp1-Sp2 = 7.6 Degrees Celsius

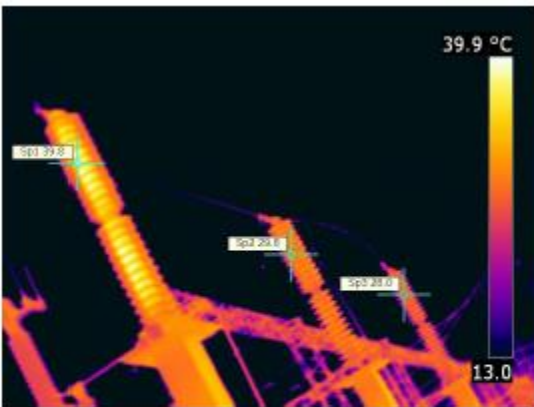
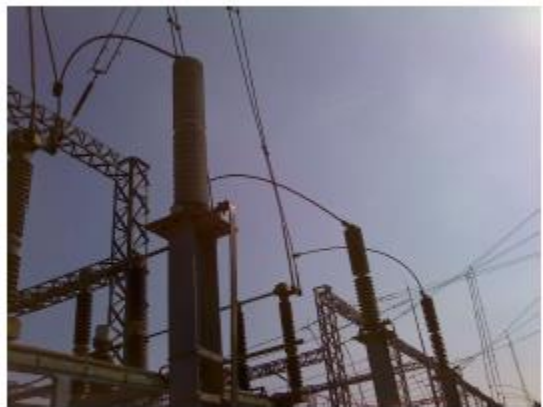
Priority 3: Replace all 3 within 30 days  
Delta T = Sp1-Sp3 = 11.8 Degrees Celsius

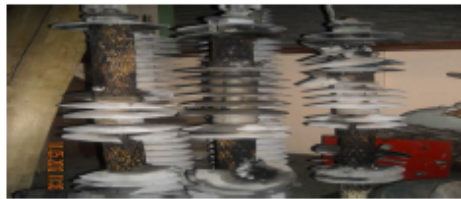
- The arrester with a polymer housing may burn open the external insulation; such failed arresters are shown in Figure 5.
- The aged or overloaded arresters may show reduced protection against overvoltages, e.g. during transient overvoltage's, for instance due to high energy temporary overvoltages, the arrester can fail before it actually has suppressed the overvoltages.
- An arrester can cause an earth fault due to internal flashover, partial discharge (which can be caused by external pollution or birds, monkeys etc.) and temporal overvoltage (TOV) which can occur in electrical networks etc.

Figure 5: Metal Oxide surge arresters with polymer housing that failed during normal service operation.

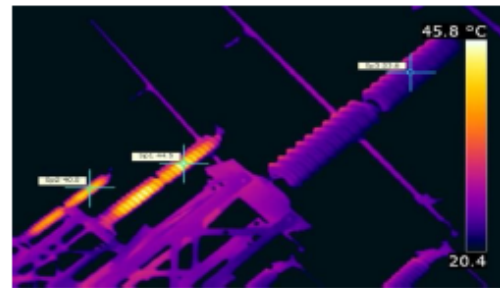
Figure 10: Thermo-grams for substation A, 2 arresters were showing high amount of heat

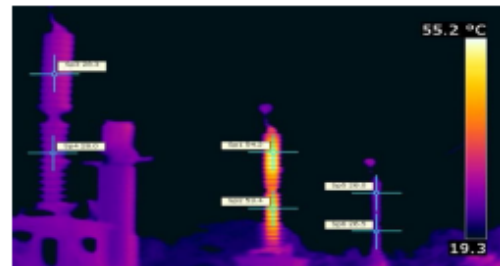
Figure 10: The thermal heating problem with these arresters could have affected the reliability of the substation B line 2

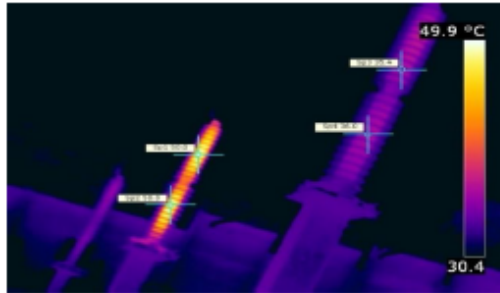
Figure 11: Thermo-grams for substation C was showing the high amount of heating inside arrester

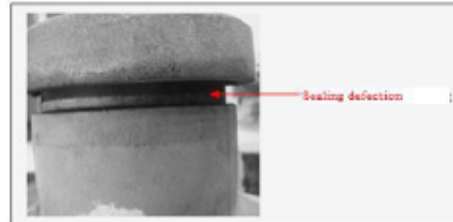
A defective arrester may not be able to work in a satisfactory way when an electrical surge occurs [9]. Hence, it could allow moisture to penetrate to a surge arrester housing or sealing (see Fig. 4 and Fig. 5). A consequence of this effect is the reduction of the level of security in the performance of the apparatus. As it has a continuous leakage of gases, the system of protection against explosion becomes inefficient, being no longer capable of performing on extreme heating [5].

Figure 4. Upper sealing deflection.

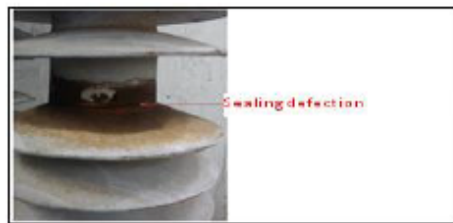
Figure 5. Sealing collar defective [14].

As a consequence of the result statements above, recommendations for the eThekwini electricity are that they should change their supplier and tender specifications should be upgraded, surge arresters to be used on the network must not have a sealing collar; but must be continuously insulated from top to bottom.

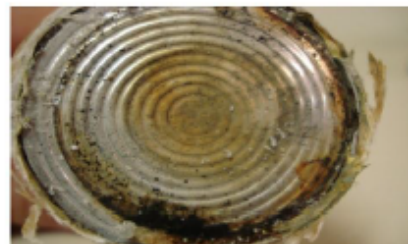
Figure 6. Moisture ingress on the sealing interior [16].

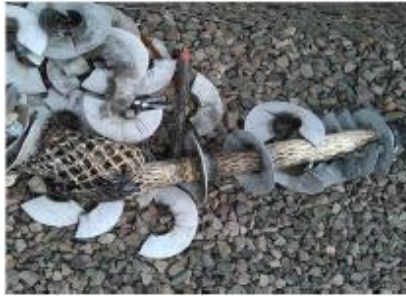
The arrester with polymer housing may burn open the external insulation; such failed arresters are shown in Fig. 7.

Figure 7. Metal oxide surge arresters with polymer housing that failed during in service condition.

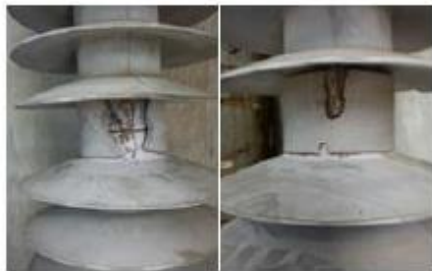
- Damage of sealing due to thermal heating produced inside varistor (see Fig. 8)

Figure 8. Defective sealing increase high rate of moisture ingress.

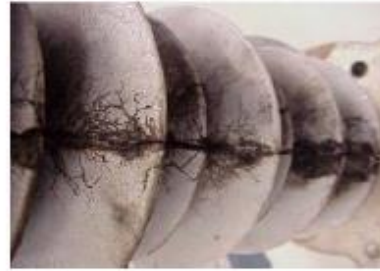
- Localized losses and discharges caused by poor inter-disc contact
- Housing deterioration or pollution changing the voltage distribution along the stack (see Fig. 9)

Figure 9. Deterioration on insulation housing [17].

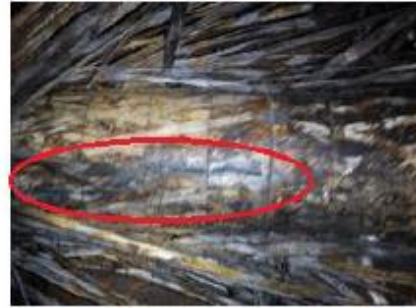
- Mechanical fractures in ZnO varistor due to thermal runaway after a high current surge (see Fig. 10)

Figure 10. Mechanical cracks in varistor elements.

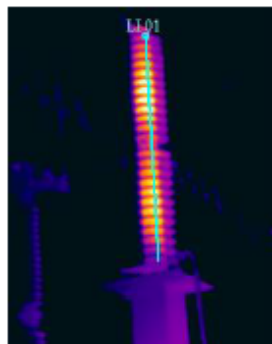
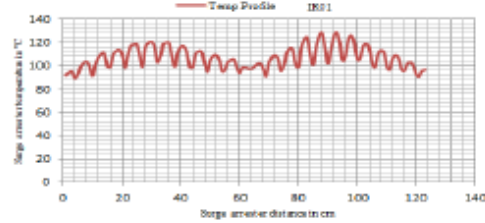
During the field trail analysis the results of failing arresters were obtained. Images of surge arresters showed the high rate of thermal heat. Results showed the thermal image and temperature profile of surge arresters tested, (see Fig. 12-Fig. 14). Note that the yellow in center of the image is a hot spot. This designates that instant de-energization and replacement must be undertaken before they failure.

Figure 12. Thermal image of arrester and temperature profile along the arrester.

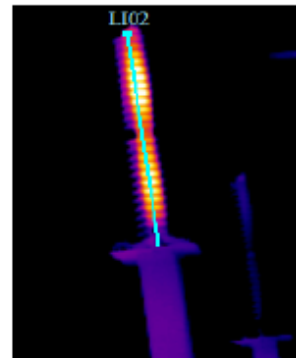
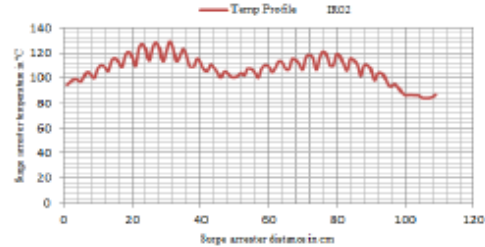
Figure 13. Thermal image of arrester and temperature profile along the arrester.

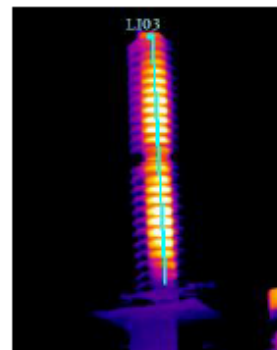
Figure 14. Thermal image of arrester and temperature profile along the arrester.

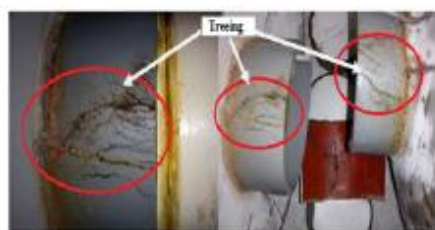
The results obtained during the visual inspection of the surge arresters of manufacturer A, (see Fig. 15-Fig. 18). The moisture ingress through the sealing collar causes serious problems such as surface discharges. These factors can eventually end with a full breakdown over the insulation system. Water treeing inside the sealing collar was noted as were cracks on the zinc oxide blocks closest to the sealing, this indicates that that the failing started here.

Figure 16. Water treeing on the sealing collar.

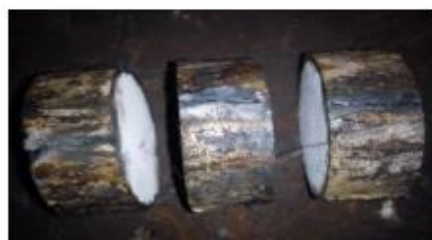
Figure 17. Cracks and damp on zinc oxide blocks.

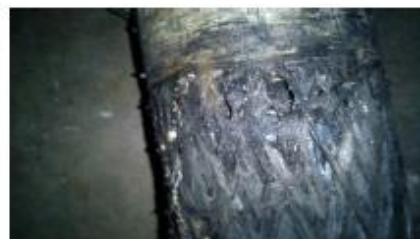
Figure 18. Damp on zinc oxide varistors.
