**“ AN INVESTIGATION INTO CONCRETE POLE
DAMAGE TO THE INWABI PLATEAU
DISTRIBUTION LINE “**

**Submitted as the dissertation component in partial fulfillment of the
requirements for the Masters Diploma in Technology (Electrical Engineering –
Heavy Current) in the Department of Electrical Engineering, ML Sultan
Technikon on the 16th of September 1998.**

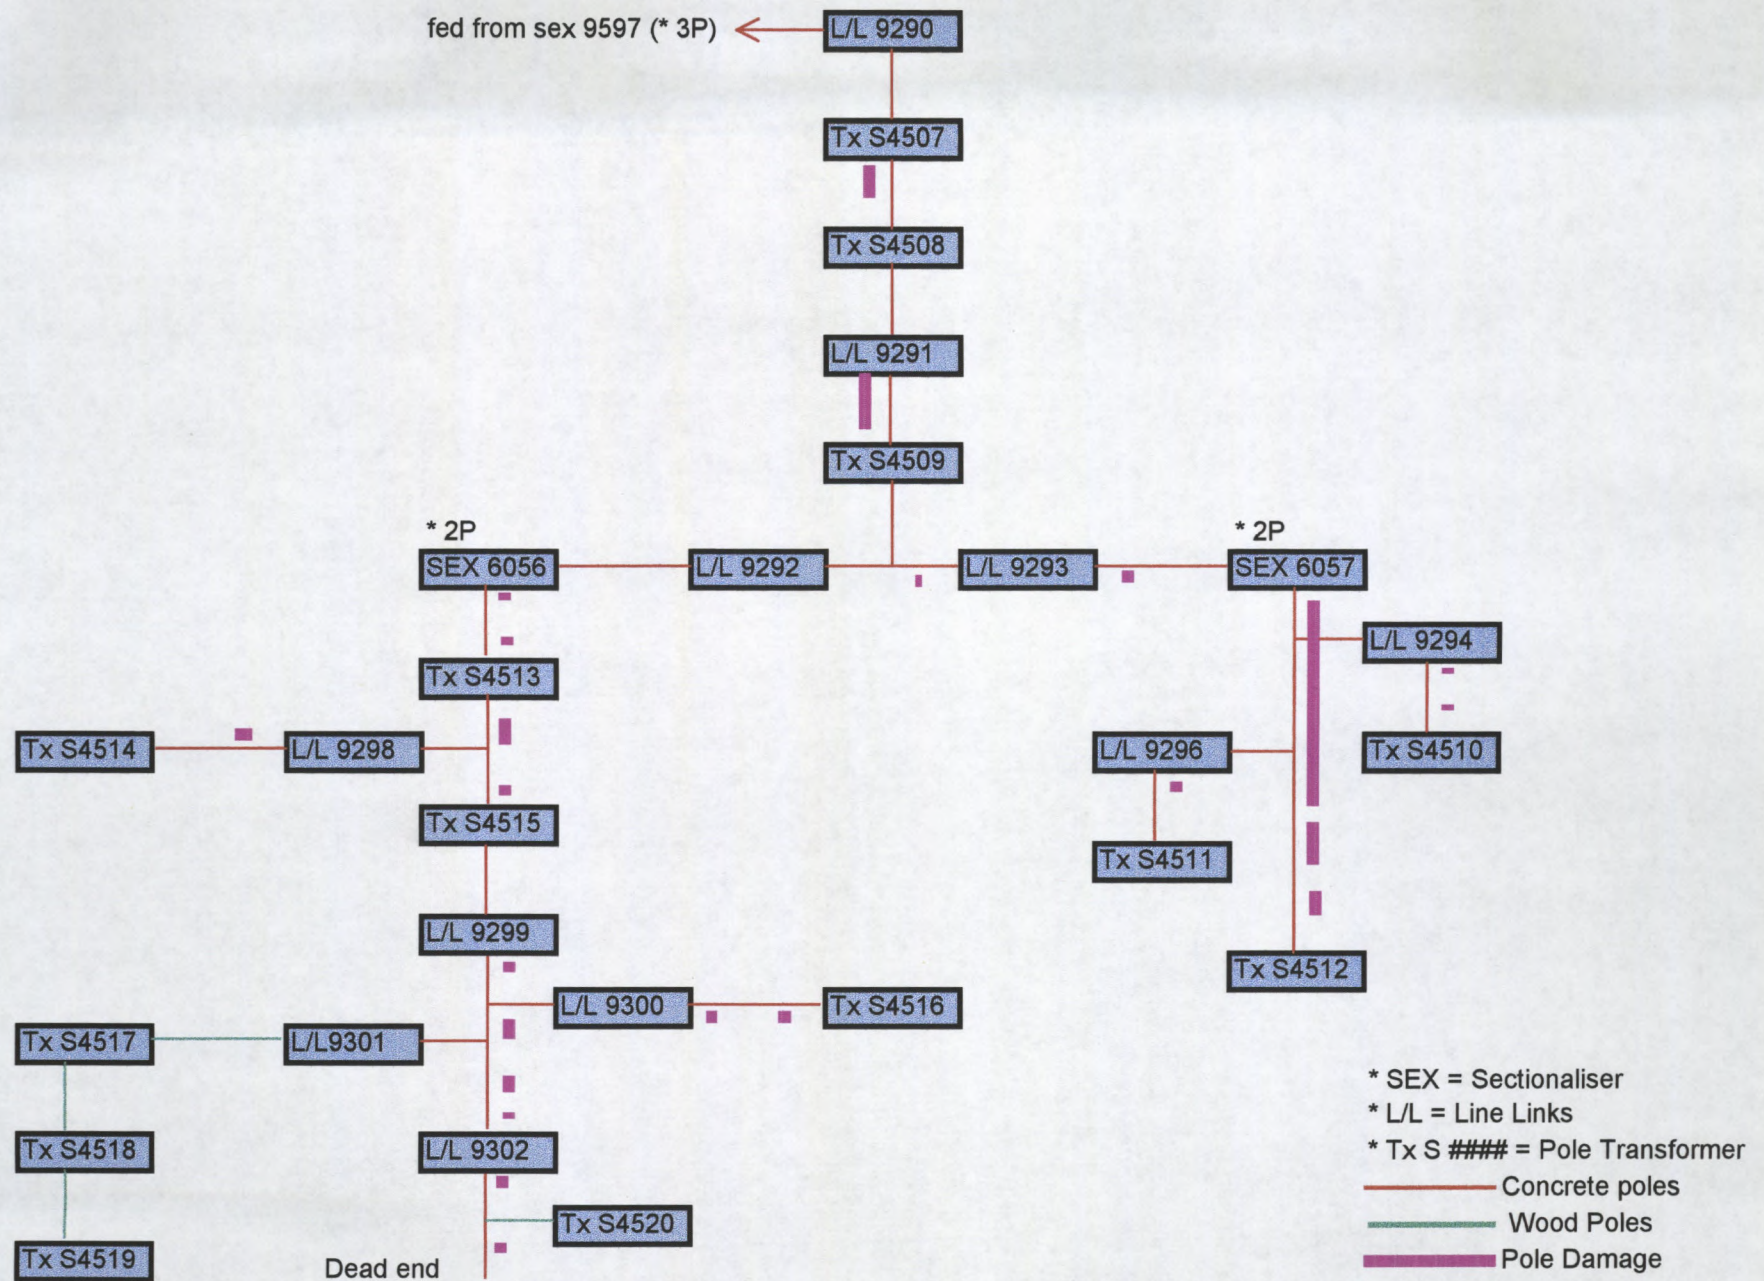
Fig 3.4 - Pole damage distribution

Table 3.1 provides a summary of what was discovered during the initial inspection and provides an overall indication as to the extent of the damage. Figs 3.2 and 3.3 on page 48 give a graphical representation of table 3.1. Fig. 3.4 on page 49 shows the distribution of damage throughout the line.

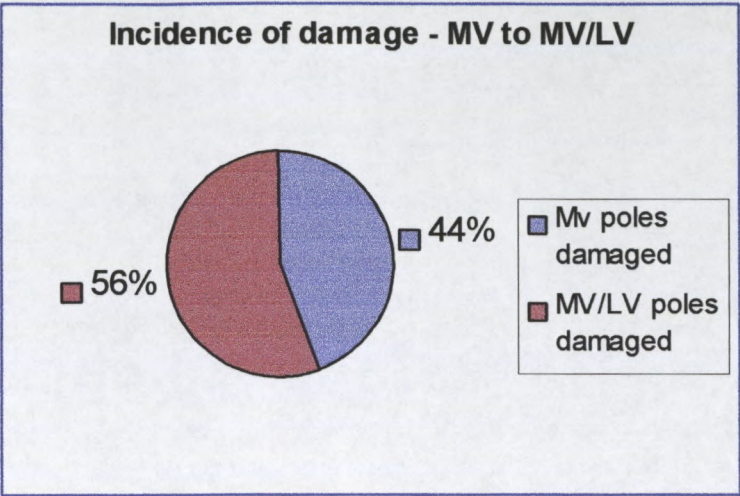
Fig. 3.7 – Incidence of damage - MV to combined MV/LV

After compensating for the differences in the number of poles inspected between the MV poles and the combined MV/LV poles, overall there is a higher incidence of damage on the combined poles. However, in the case of bad damage, the incidence of to the MV poles is statistically slightly higher after compensation (31%) as compared to combined MV & LV poles (26%). This is contrary to expectation as it is assumed that due to the lower impulse level of the LV system that these poles would sustain more damage. The incidence of moderate damage & slight damage is statistically higher on the combined MV & LV poles. This is as expected although the margins are small.

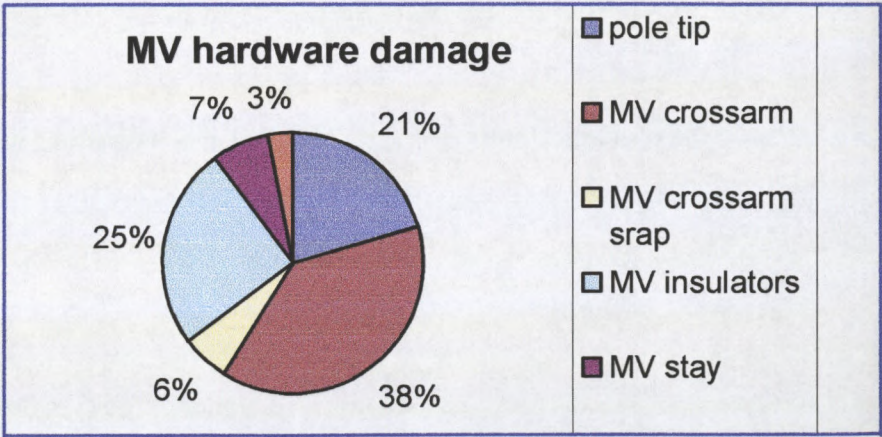
Fig. 3.8 – Damage in the vicinity of MV hardware

Referring to table 3.4 and fig. 3.8, it can be seen that most of the damage at the various hardware positions occurs in the vicinity of the

MV crossarm. By comparison the highest point on the pole (pole tip) accounts for 21 %. This is significant, as the crossarm is located about 800mm below the pole tip. Referring to the classification “MV insulators”, this is at pole positions where the strain insulators are attached directly to the pole without a crossarm and the conductors are configured in a vertical formation (see plate 18 on page 58).

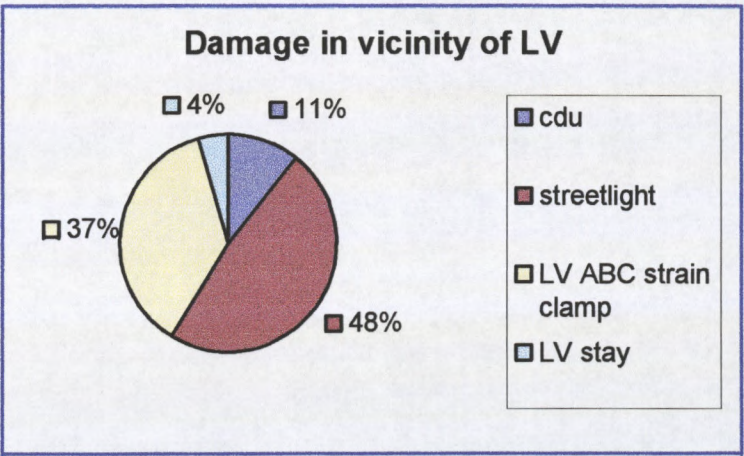
Fig. 3.9 – Damage in the vicinity of LV hardware

Referring to table 3.5 and fig. 3.9, the majority of damage is concentrated around the streetlight and LV ABC strain clamp. In the case of the streetlight this is significant as the streetlight hardware is earthed via the LV ABC combined neutral earth conductor. Damage in this area is consistent in terms of a low impulse dissipation path for lightning.

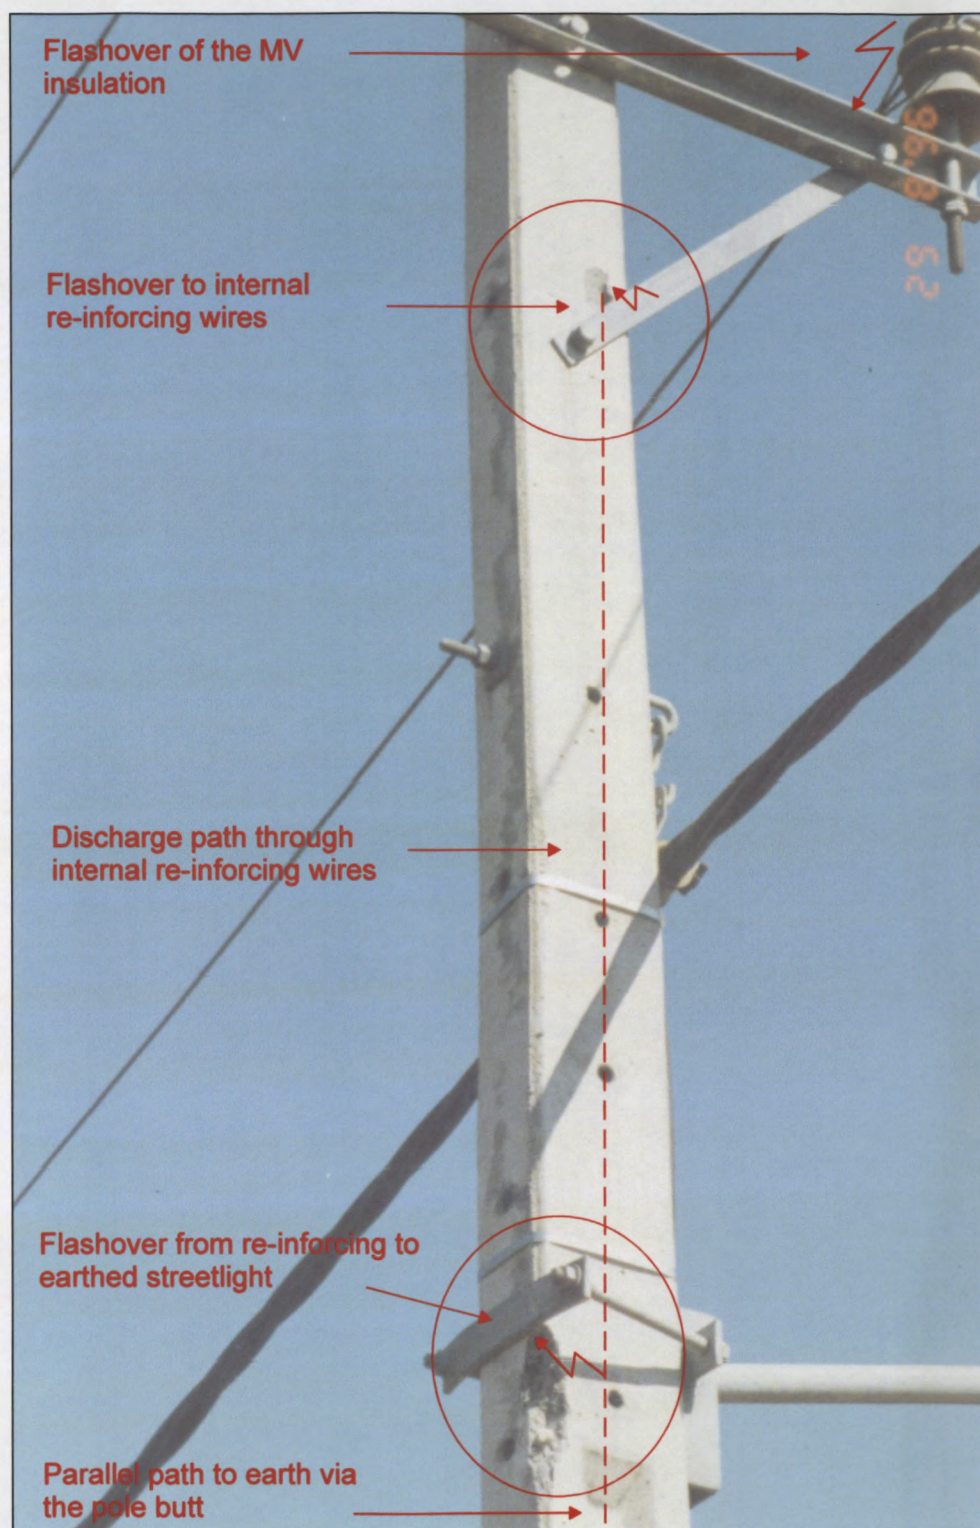
Plate 23 - Possible breakdown paths to earth

The probable path for a lightning discharge therefore, appears to be a flashover or puncture of the MV insulators, together with breakdown or puncture of the concrete to the re-inforcing and finally, exiting the pole re-inforcing in the vicinity of the earthed LV system. This would represent a relatively low impulse path for lightning discharge currents. Typically, the exit points of the discharge current are at the streetlight fittings & the LV ABC. Plate 23 on page 65 shows the discharge path as described above. There is damage at the concrete bracing strap where the discharge current may have entered the pole reinforcing after breakdown of the MV insulation. The exit from the pole re-inforcing appears lower down at the earthed streetlight fitting. Another path exists in parallel with the one just described. As before, there is a breakdown of the MV insulation and flashover to the pole re-inforcing, the re-inforcing then conducts the discharge current down the pole and then into the surrounding earth. In a lot of cases there was visible damage in the vicinity of the earthed LV hardware but with no apparent damage in the vicinity of the MV hardware. The reason for this may be that the puncture or breakdown of the concrete has taken place within the pre cast hole through which the crossarm mounting bolt is fitted. Practically this was not possible to verify. On Poles that support MV conductors only, the

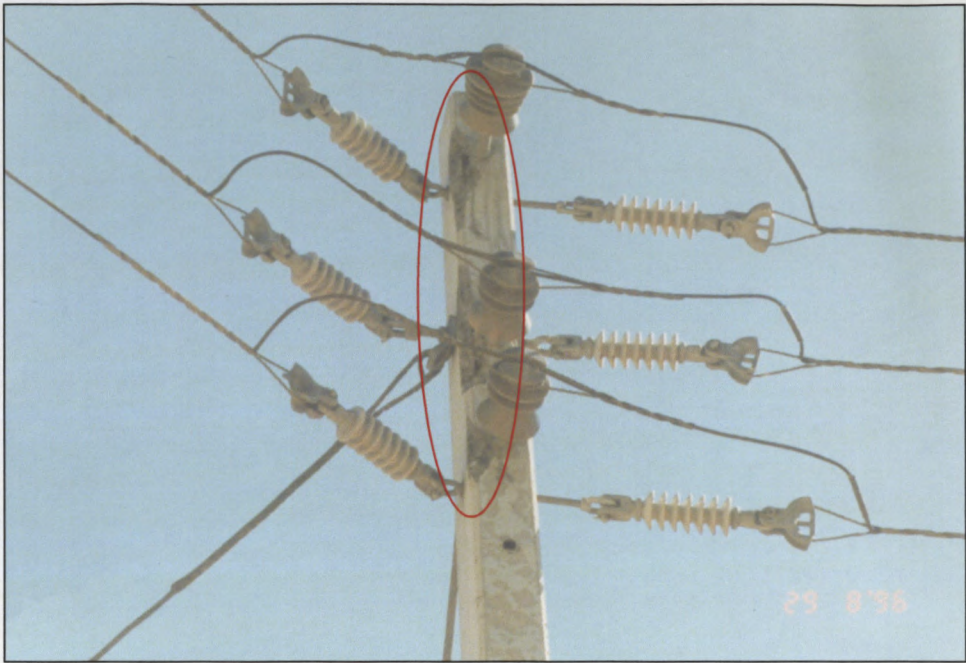
Plate 24 - 3-phase flashover (MV conductors only)

only possible dissipation path for lightning current is a flashover or puncture of the MV insulation, together with a flashover to the re-inforcing wires and then flowing into the surrounding earth below ground level. The excavation shown in plates 24 and 25 on page 66 verified this. Plate 24 shows what appears to be a classical 3-phase flashover to the pole due to an equally induced overvoltage on all 3 phases. The pole is seriously damaged and re-inforcing wire is visible. The stay wires shown are insulated to earth using 350kV continental guy insulators, these are not visible in the plate. There was no damage detected on the stay insulators. The only other low impulse path for the discharge is down the pole re-inforcing wires and into the earth. Plate 25 shows the pole butt after excavation where damage and carbonising is visible. It must also be noted that the extent of the damage to the pole may not be entirely due to lightning current alone, but may be due to power follow through current immediately following insulation failure as a result of the lightning overvoltage.

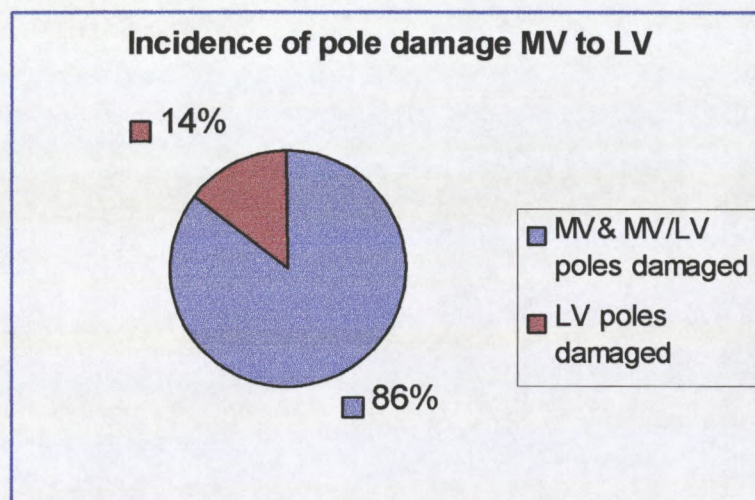
Fig. 3.10 – Comparison of damage between MV & LV poles

recorded on MV and MV/LV poles (any pole carrying MV conductors) to the incidence of damage recorded on LV poles (poles carrying LV only). The difference is significant given the fact that these poles are all located in the same area. The lack of damage on the LV poles can possibly be

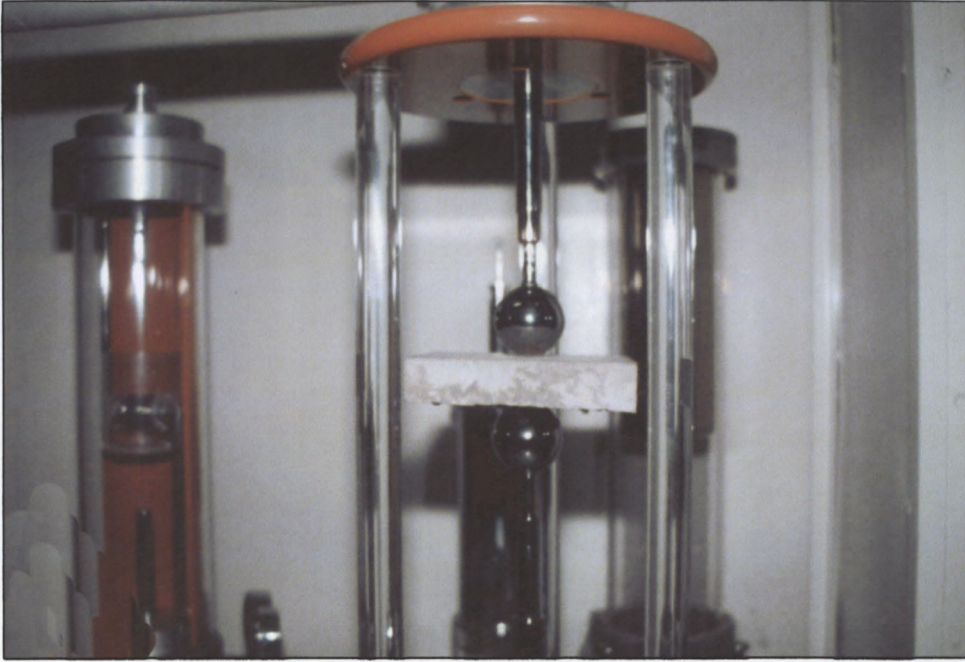
Plate 30 - Concrete sample between test electrodes

Additional impulse tests were then conducted with the sample set up between 2 sphere electrodes as shown in plate 30 overleaf. The simulated lightning impulse was applied to the upper electrode with the lower electrode being at earth potential. These tests also included wet samples, which were left immersed in a bucket of water for 24 hrs prior to testing.

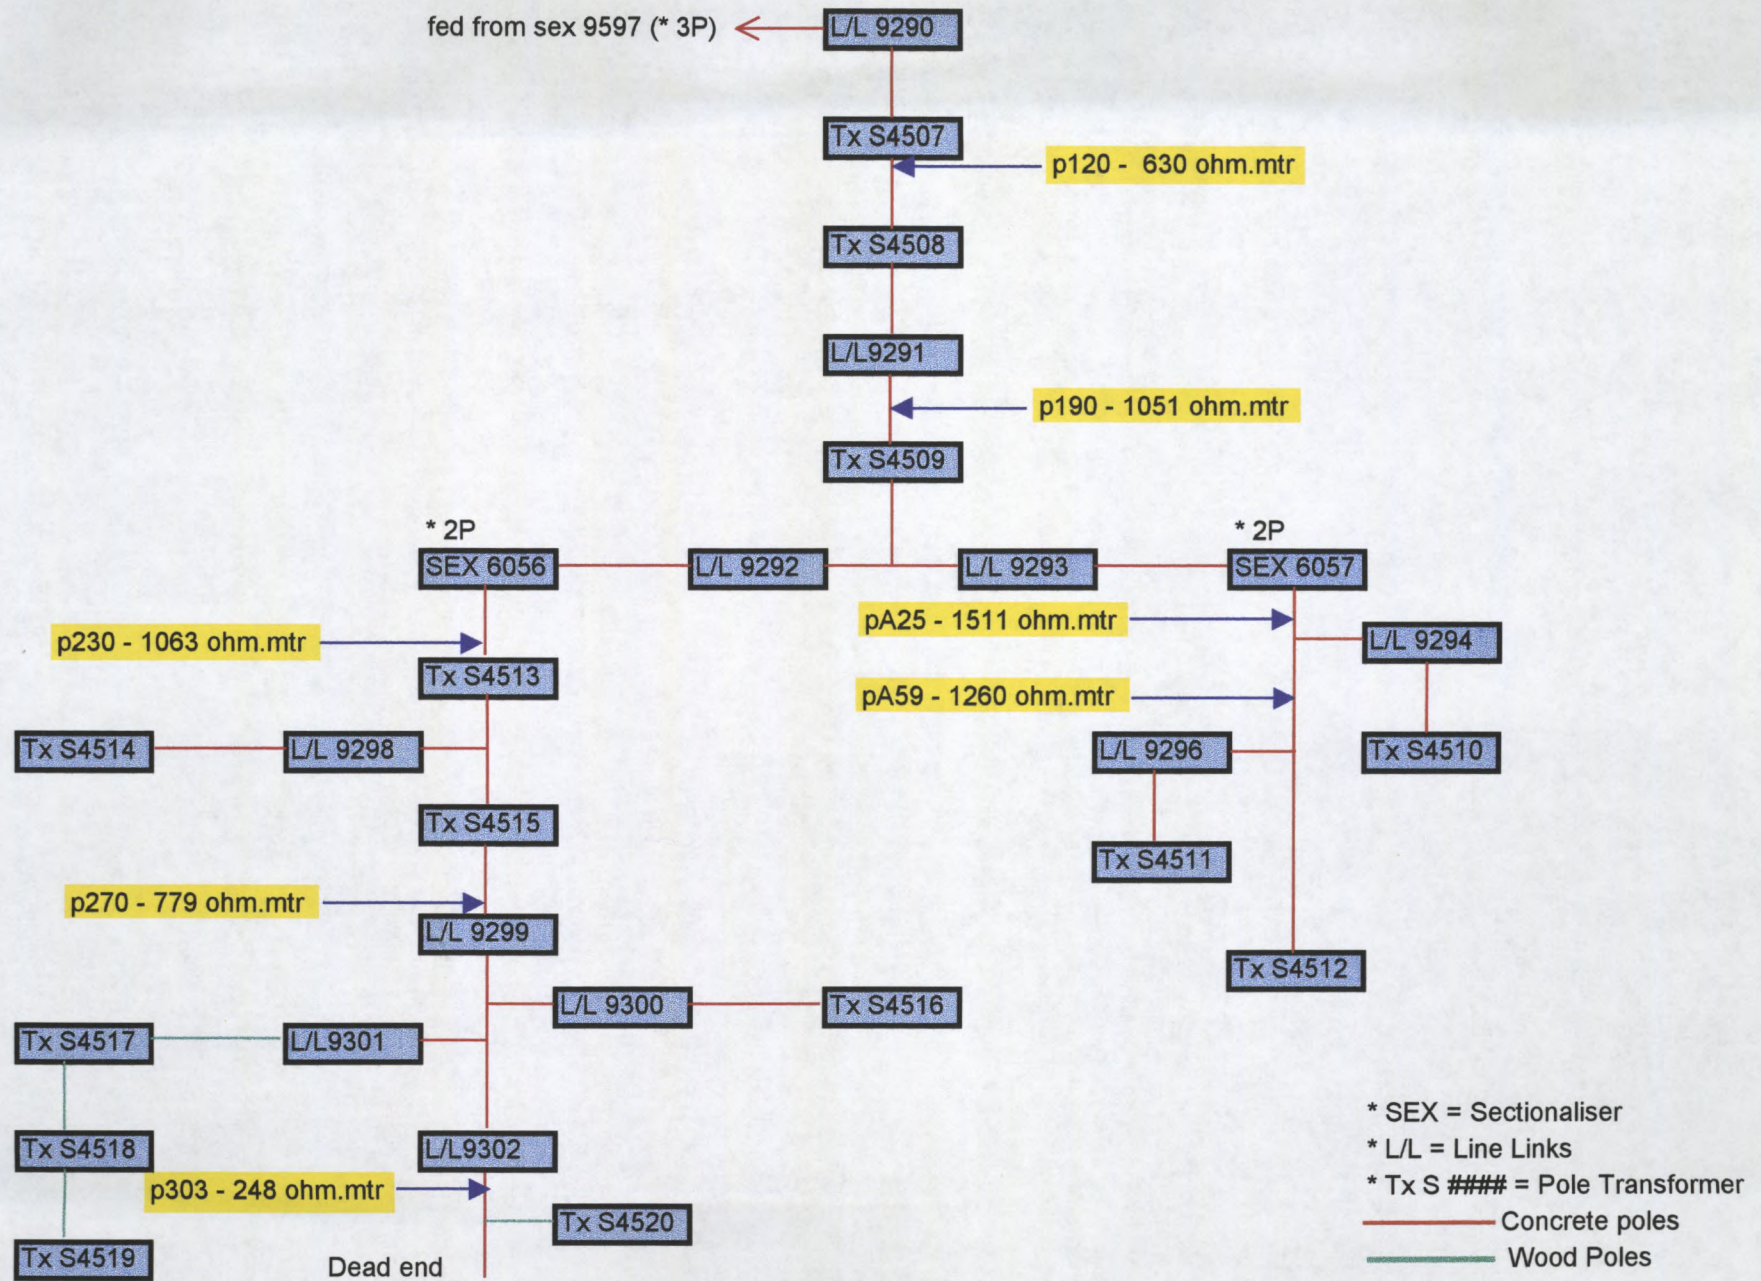
Fig. 4.6 - Earth resistivity measurements

Figure 4.5 shows the standard 4-probe method known as the Schlumberger array. The distance “a” between the probes gives the apparent resistivity of the soil at a depth equivalent to “a” from the surface. Soil soundings using a TERR243E earth meggar were done at 1 metre and 2 metre depths, as these are practically the ranges within which a standard 1.5metre earth electrode would be installed. The concrete pole planting depth is 1,8 metre, which is also within the 1 to 2-metre depth range. Seven different locations were chosen as shown in fig. 4.6. overleaf. The resistivity varied between 169 $\Omega\cdot\text{m}$ and 2090 $\Omega\cdot\text{m}$. Readings were repeated at monthly intervals at the same locations in order to check for seasonal variations – refer to appendix C. The overall average soil resistivity for the area was found to be 935 $\Omega\cdot\text{m}$ and this figure was used for calculation purposes.

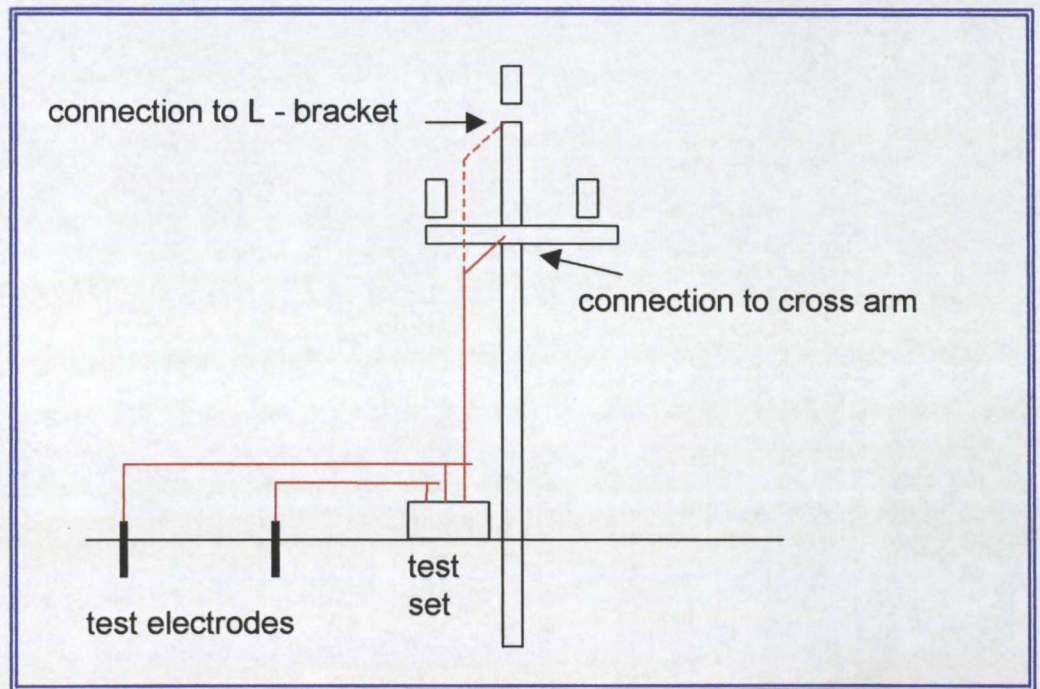
Fig. 4.7 – Earth resistance of a concrete pole

The test set was first connected to the pole via the steel crossarm, which is bolted to the pole and testing was carried out. A second test was done by connecting to the L-bracket, which is also bolted to the pole. At all three poles there was no measurable result as the reading was greater than 999 ohms, which is beyond the range of the test set. The soil resistivities at each site were recorded and were found to be 182, 532 and 530 Ω . meters respectively. The difference between the calculated

and the test measurement is that, in the case of the test, it was not possible to connect the test set directly to the internal re-inforcing wires. As the connection of the test set was made externally to the crossarm and the L-bracket, this effectively introduces another resistance component into the measurement. This additional resistive component is the resistance represented by the cross-section of concrete between the crossarm/L-bracket and the internal re-inforcing wires. A representation of this is shown in fig 4.8 overleaf, this is for a pole without LV ABC or other earthed hardware. Referring to fig 4.8, it is effectively $Z_2 + Z_3$ which are under test. The results of this test ($> 999 \Omega$) suggests that an external down wire of suitable buried depth and relatively lower resistance to earth could be used to short-circuit the concrete pole to ground. This may prevent the lightning from discharging through the pole to ground.

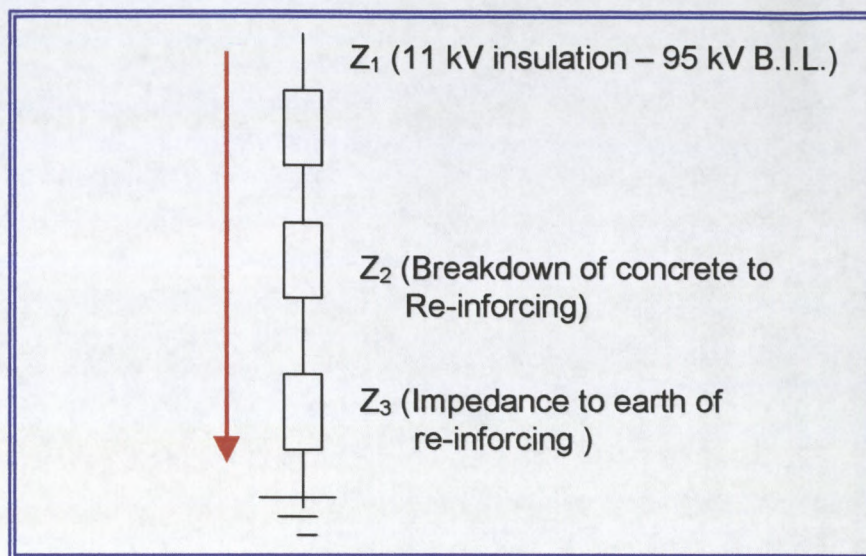
Fig. 4.8 – Representation of the line B.I.L. for a medium voltage pole without downwires

Fig. 4.8 shows the individual elements that influence the line B.I.L. for a pole supporting only medium voltage conductors with no down wires to earth or any other earthed hardware components

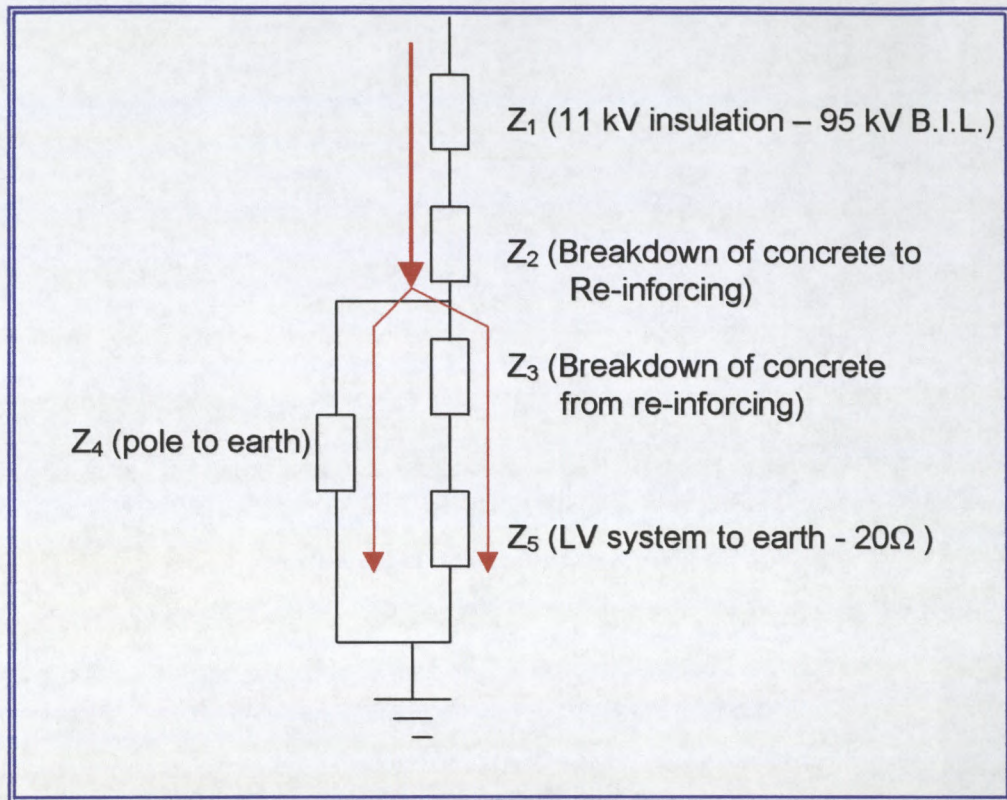
Fig. 4.9 – Representation of the line B.I.L. for a combined MV/LV pole

and other earthed hardware components, such as streetlight fittings etc. The branch Z_3 and Z_5 represents the impedance to earth through the LV system. In parallel with this branch is Z_4 , which is the impedance to earth of the pole itself (as calculated in eq. 4.3).

The impedances in fig. 4.9 represent transient values of breakdown between the concrete and re-inforcing wires. Based on the impulse testing done on the concrete samples and the results in table 4.3, the impulse impedances Z_2 and Z_3 may be considered to be around 63kV

each. This is based on the test values obtained for 15mm concrete. The 15mm concrete is in line with the concrete coverage on the poles (10 to 25mm). It is probable that once breakdown has occurred through a pole that sufficient carbonisation will have taken place due to the high concentrated current, thereby effectively reducing the impulse withstand of the pole. The breakdown damage on the test samples was very slight in comparison to the damage found on the poles due to the limited energy available from the impulse generator. The impedance Z_4 may behave differently to the impedances Z_2 and Z_3 in fig. 4.9 as the concrete is completely surrounded by soil over its entire surface area. The specific soil resistivity being as high as it is may result in a high transient impedance in comparison with the series impedance $Z_3 + Z_5$. This may account for the concentration of damage around the low voltage system, which is earthed through the LV ABC neutral conductor. As stated previously, the impedances Z_4 and Z_5 are steady state or D.C. measurements and that the transient impedance due to lightning frequency current could be significantly higher.

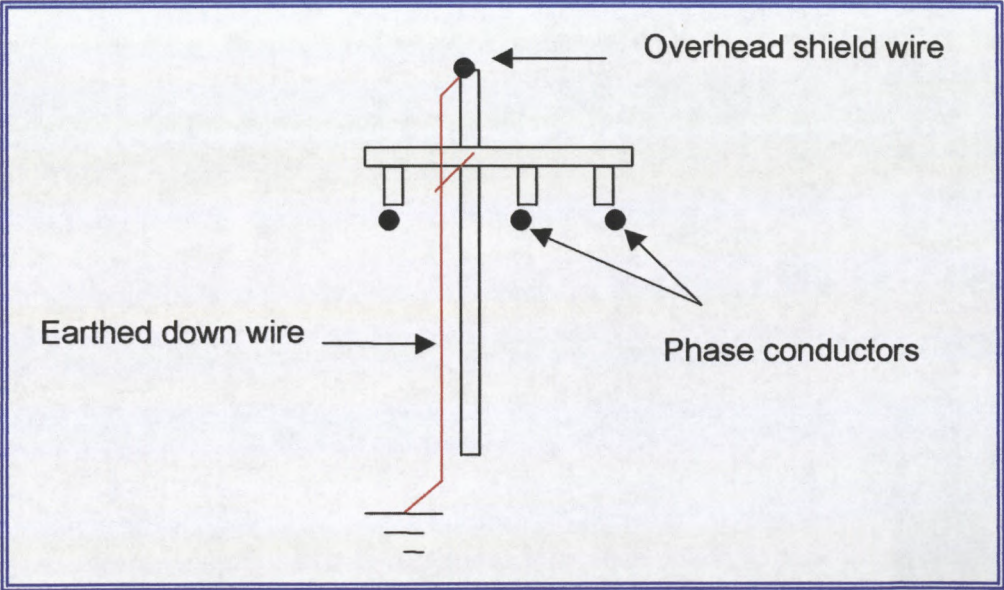
Fig 5.1 – Line configuration with an overhead shield wire

with the MV hardware occurred at the pole tip. The majority of damage occurred below on the lower crossarm (38%) and this casts doubt on the effectiveness of having an overhead shield wire in the same position as the white phase conductor. As discussed in chapter 3, there is also doubt as to whether the pole damage can be attributed to direct strikes.

A shield wire provides protection from both direct and induced overvoltages. The installation of a shield wire would require a reconfiguration of the line. Normal practice is to position the shield wire above the phase conductors at the pole tip. In order to accommodate this, the line would have to be re-configured. A practical configuration would be a horizontal formation as shown below. The shield wire is earthed at certain intervals by running a conductor from the shield wire down to an earth electrode installed at the base of the pole. In areas of poor soil resistivity more frequent earthing of the shield wire will be

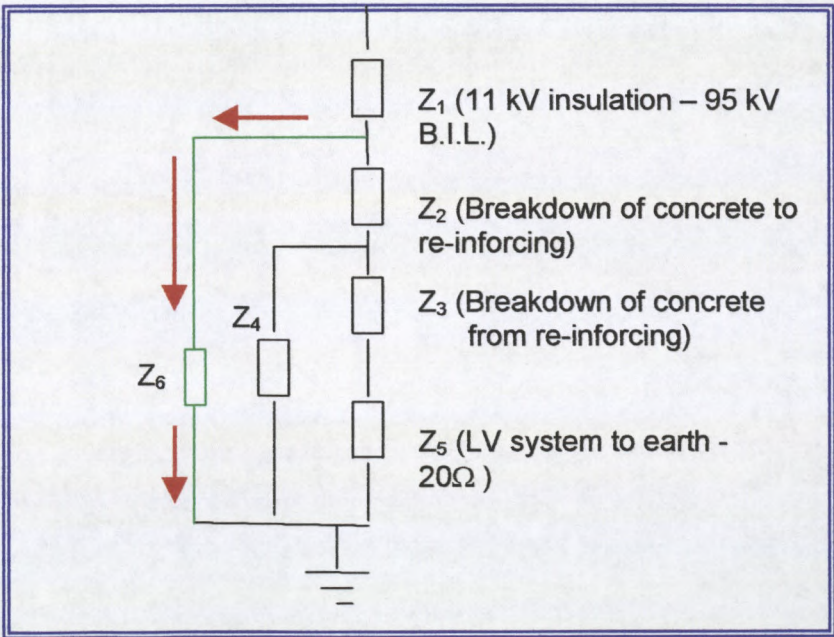
Fig. 5.2 – Representation of an earthed downwire (MV/LV pole)

Fig. 5.2 shows a representation of the earthed downwire for a pole supporting both MV and LV conductors. The downwire is in parallel with the pole discharge path, Z_2 and Z_4 and the LV system discharge path, Z_2 , Z_3 and Z_5 . Based on the test impulse values for concrete in the lab tests (63kV) and the field measurements of the pole's resistance to earth ($>999 \Omega$), the impedance of the downwire, Z_6 may effectively short-circuit the other discharge paths. This may prevent current entering and damaging the pole. For a pole supporting only MV conductors, the LV system discharge path, Z_3 and Z_5 is not applicable.

This modification can be done relatively inexpensively, but the compromise would be at the expense of line performance as tripouts could be expected for every induced surge in excess of 95kV. If however proper auto reclosing is used with sufficient dead time to allow for arc quenching, this option could be feasible. This is also providing that the flashovers are transient, and that insulators are not permanently damaged or punctured during flashover. With the existing insulators, the insulation level would be limited to 95kV. Considering the worst case, that each lightning related event on the line resulted in a flashover with subsequent power follow through current, then the theoretical number of trip outs expected would be the total direct strikes plus the total induced strikes per year, 18. With properly coordinated auto reclosing the number of permanent lockouts may be minimal.

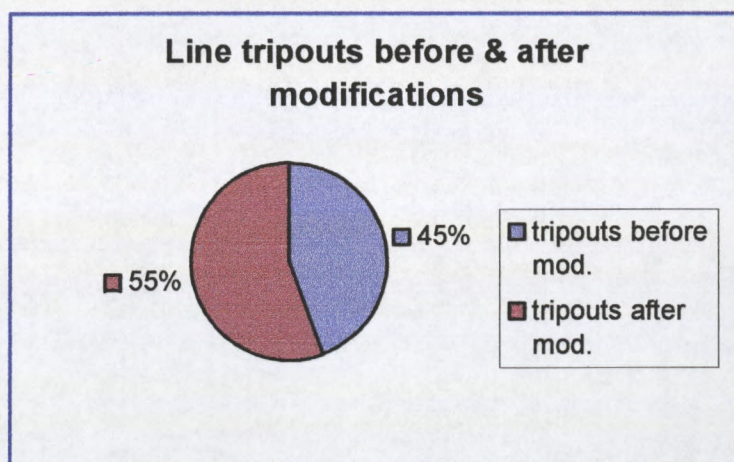
The line tripout statistics in appendix F were analysed for the periods before and after line modifications. Fig. 6.1 shows the comparison before and after modifications. There has been an increase of 10% in the number of tripouts after modification.

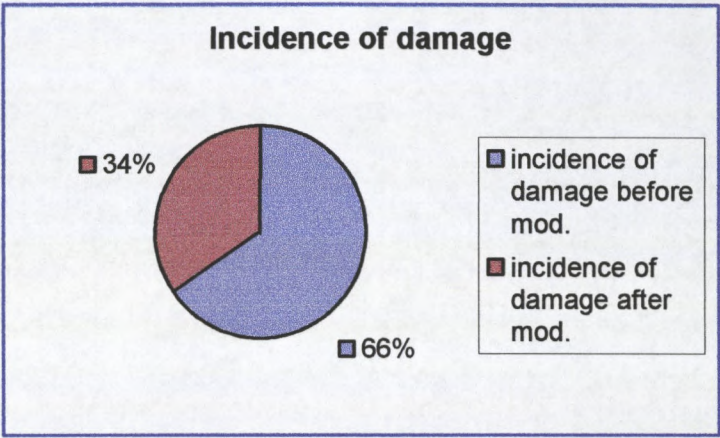
The cumulative damage recorded on inspections 1 and 2 was therefore used to establish the damage prior to modifications and the cumulative damage recorded on inspections 3 through 6 was used to establish the damage after modifications. Fig. 6.2 shows the incidence of damage before and after modification. A total of 95 new incidences of damage were recorded on inspections 3 through 6, compared 175 recorded in inspections 1 and 2. It should be pointed out that the cumulative damage recorded prior to modifications, was accumulated over the period 30/09/94 until 20/11/96, whereas the cumulative damage after modifications only covers the period 20/11/96 until 22/02/98. This may

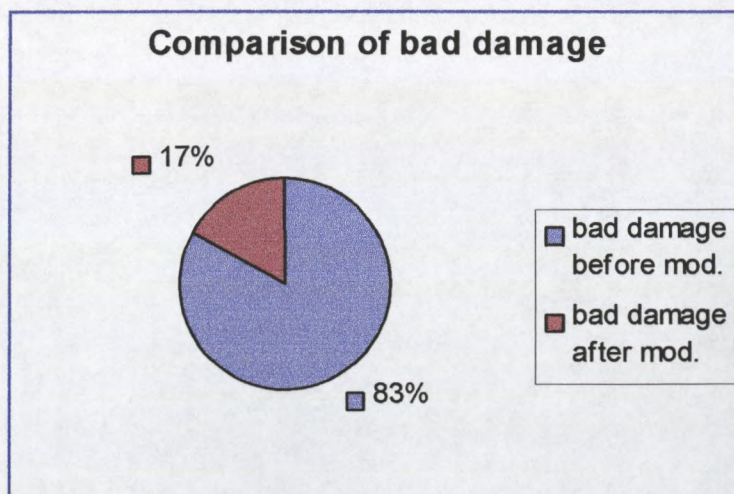
Fig. 6.3

There were 10 new incidences of bad damage recorded on inspections 3 through 6, compared with 49 recorded on inspections 1 and 2. This is shown in fig. 6.3 below. Despite the difference in the time periods over which the damage was recorded, there is still a marked decrease in the incidence of bad damage.

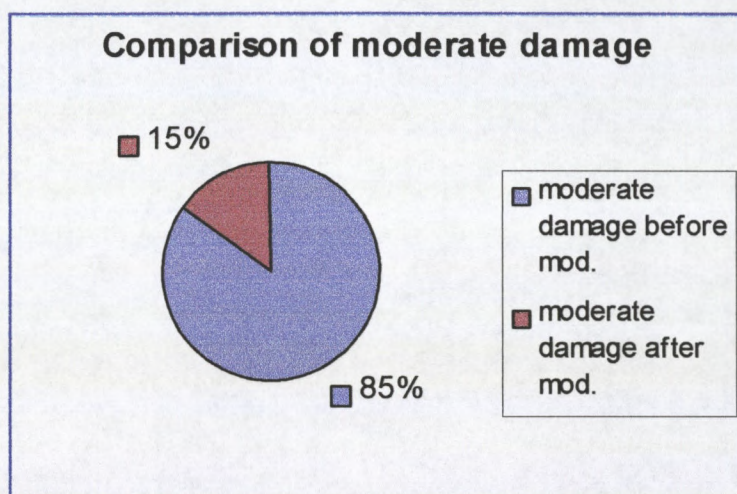
Fig. 6.4

The comparison of moderate damage is shown in fig. 6.4 below. Similarly, in the moderate damage category, there were 60 recorded incidences of moderate damage prior to modification and 12 new incidences of moderate damage recorded on inspections 3 through 6. Once again, the improvement is significant, despite the time periods involved.

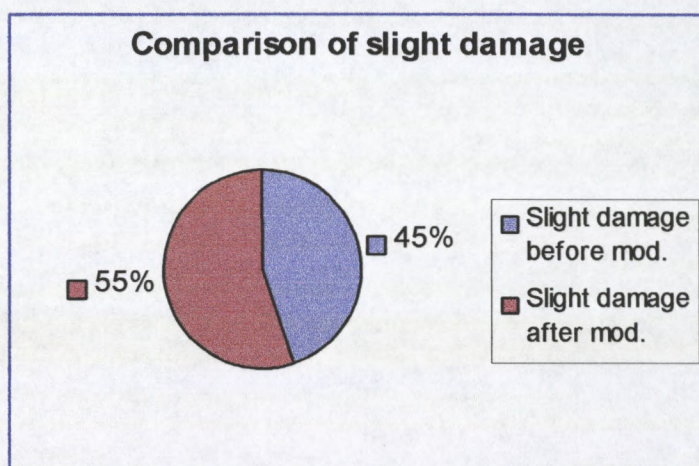
Fig. 6.5

In the slight damage category, shown in fig. 6.5 below, there were 59 incidences of slight damage recorded on prior to the modifications. There were 73 new incidences of slight damage recorded after the modifications. This represents an increase of 10%. It appears that the improvements gained in the bad and moderate categories come at the expense of an increase in slight damage.

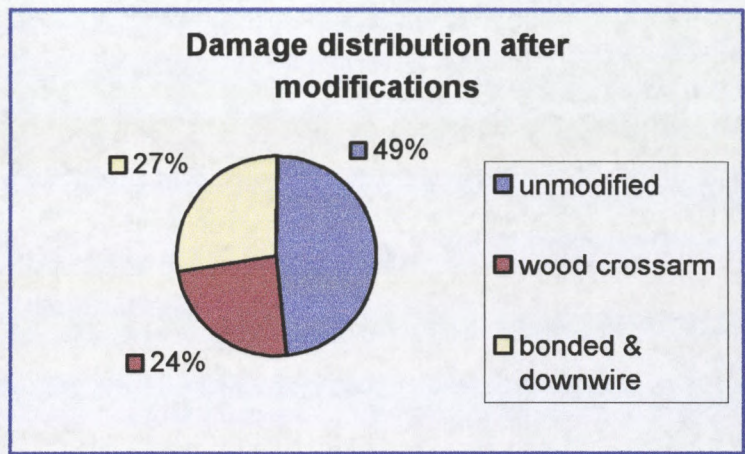
Fig. 6.6

The amount of damage that has occurred on the unmodified poles is significantly higher than for both types of modified poles.

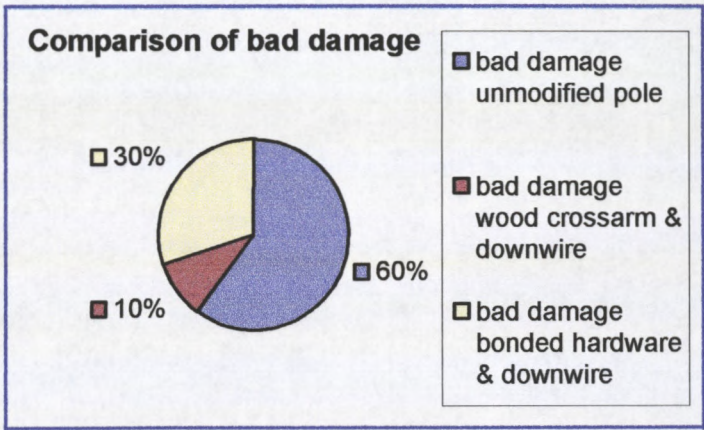
Fig. 6.7 below shows the bad damage distribution between each modification and the unmodified poles (reference). There were 6 new incidences of bad damage recorded on the unmodified poles on inspections 3 through 6. There was 1 new incidence of bad damage recorded on the wood crossarm with downwire poles and 3 new incidences on the bonded hardware with downwire poles. Most of the damage has occurred on the unmodified poles. Both types of modifications show a significant reduction, especially the wood crossarm with downwire poles.

- Both types of modified poles have shown a significant reduction in the incidence of bad damage when compared with the unmodified poles. (fig.6.7). Reductions of 27% and 23% for the wood crossarm with downwire and bonded hardware with downwire poles respectively,

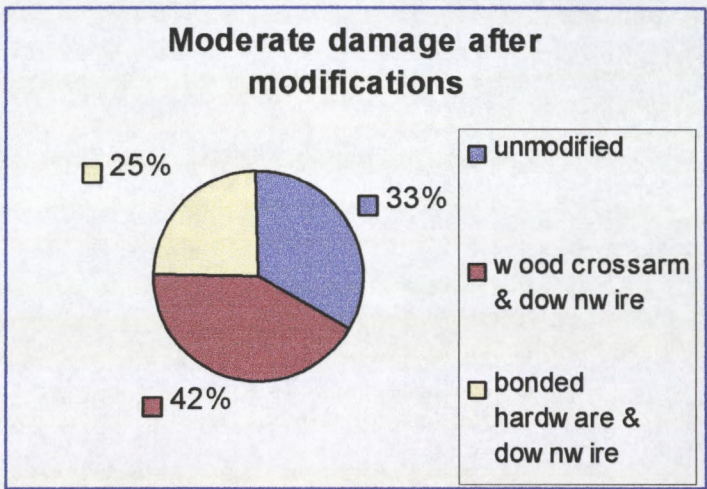
Fig. 6.8 shows the moderate damage distribution between each modification and the control reference (unmodified pole). There were 4 new incidences of moderate damage recorded on the unmodified poles, 5 on the wood crossarm poles and 3 on the bonded hardware poles. There is a higher relative incidence of moderate damage to the wood crossarm with downwire poles, which is difficult to explain.

- Contrary to the above, there has been a slight increase in moderate damage recorded on the wood crossarm with downwire poles over the other modification and control (fig. 6.8). This is contrary to expectation as flashover on these poles should only occur for direct strikes to the line. If there were direct strikes to the line, then the incidence of moderate damage on the bonded hardware with downwire poles should be similar to the wood crossarm with downwire poles. There is therefore uncertainty as to the reliability of this statistic.
- The slight damage after modifications has also shown a reasonable improvement on the modified poles over the unmodified poles (fig. 6.9).
- During inspections 3 through 6, two separate incidences of damage were discovered, which are interesting and involve each type of modified pole:

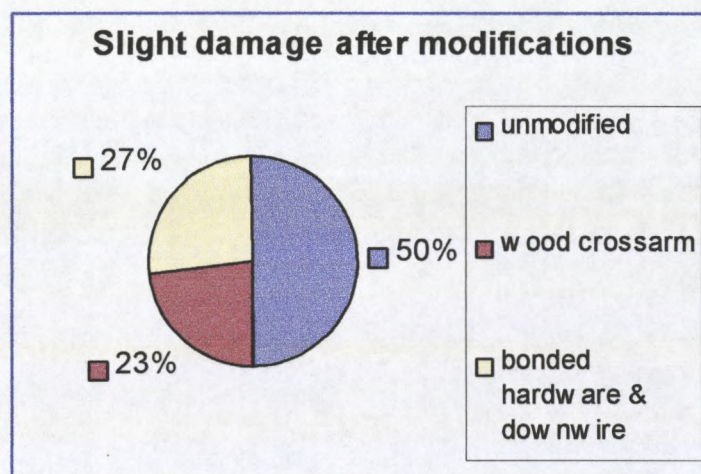
Fig. 6.9 below, shows the slight damage distribution between each modification and the control reference (unmodified pole). There were 36 new incidences of slight damage recorded on the unmodified poles. There were 17 and 20 new incidences of slight damage recorded on the wood crossarm with downwire poles and the bonded hardware with downwire poles, respectively. Similar to the bad damage category, there has been a significant reduction in damage occurring to both types of modified poles over the reference.
