### VISUAL ASSESSMENTS OF CURRENT PAVEMENT CONDITIONS IN THE STACK AREAS OF BERTH 203-205 AT THE DURBAN CONTAINER TERMINAL – PIER 2

**Rowen Naicker and Dhiren Allopi**

Department of Civil Engineering and Surveying, Durban University of Technology, P O Box 1334,  
Durban, 4000, South Africa

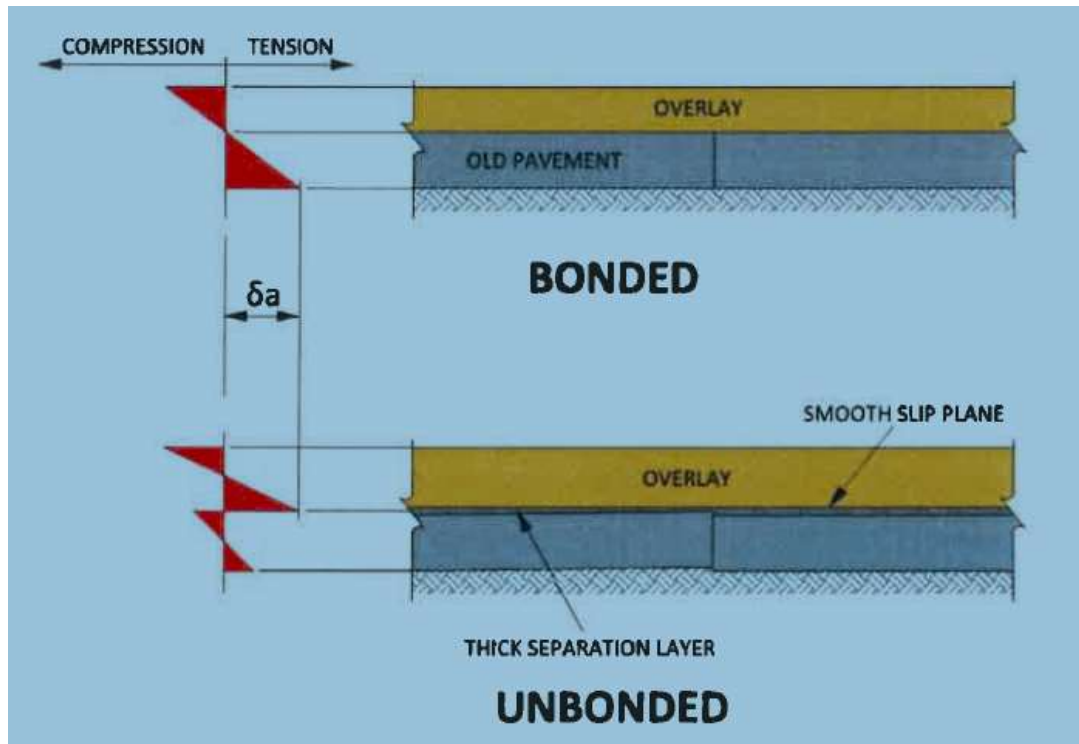
After site observations, it has been concluded that much of the terminal is in a good condition therefore construction overlay is an option. Concrete overlays may either be bonded or un-bonded. In the case of bonded overlays the existing slab has to be free of defects whereas in the case of un-bonded overlays it is more tolerant of defects in the existing slab. It has been concluded that in the case of structural overlays the un-bonded option will be more suitable.

The advantages of structural overlay include the following:

- Construction time is minimized and will reduce terminal disruption
- The construction cost is lower than the alternative of reconstruction
- The remaining capacity of the existing pavement is utilized
- This option is more environmentally friendly as demolition and disposing large volumes of rubble is avoided

As this option has the benefit of utilizing the remaining pavement capacity, increasing the load capacity, causing the least operational disruption and having a modest construction cost, this option is the recommended alternative in preference to reconstruction.
