Agnes Mokhosi (South Africa), Bloodless Dzwairo (South Africa)

## Microbiological water quality along Vaal Gamagara's potable water distribution system

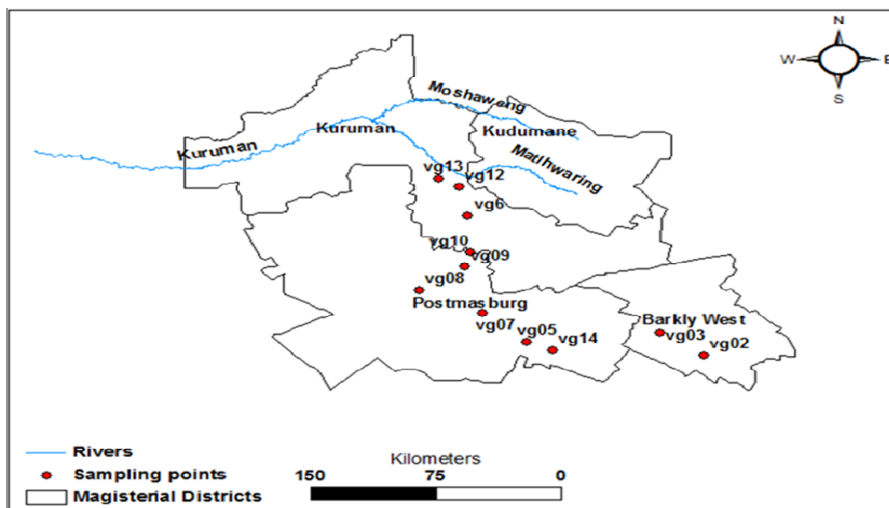
Fig. 2. Vaal Gamagara Sedibeng Water Board sampling points

The study area covers Delpportshoop near Barkly West (VG02 in Fig. 2) to Black Rock, with a total pipeline length of approximately 370 km. The furthest point in the distribution system is at Blackrock (VG13) (Fig. 2).

Disinfection occurs at the treatment works (VG02) and at Beeshoek (VG05) near Postmansburg that is located 150 km away from the water treatment works.

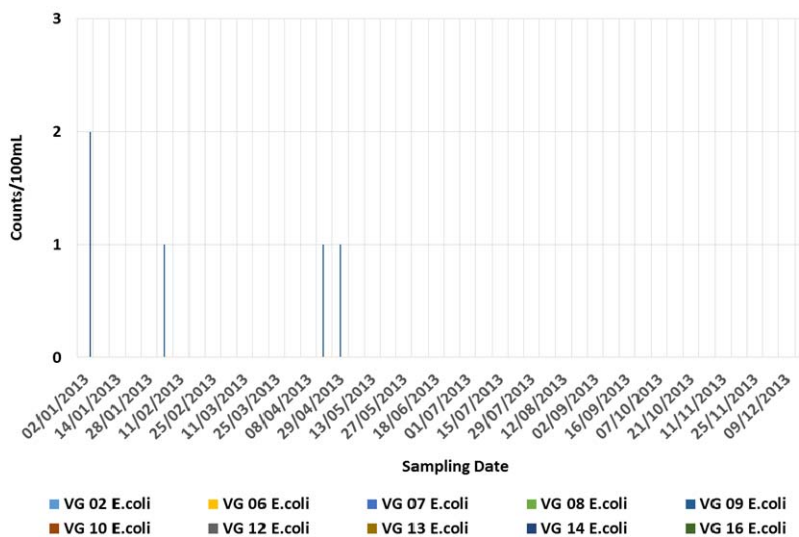
Fig. 3. *E. coli* results for January to December 2013

Fig. 3 shows the results of *E. coli* over a period of 12 months. The results indicate that only 0.1% of samples analyzed were positive for *E. coli*.

The *E. coli* and TC results showed very low percentages, which means that there was no fecal contamination from the samples that were collected from Vaal Gamagara distribution system.

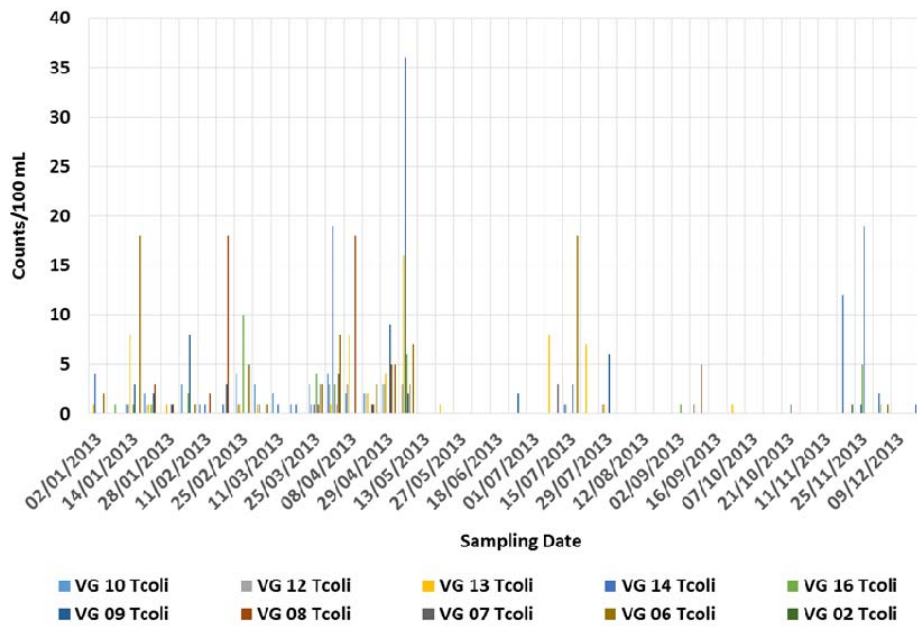
Fig. 4. Total coliform results for January to December 2013

Figure 4 illustrates the results of TC along a period of 12 months. The results showed that the TC above

recommended standard limit were detected in only 0.4% of samples analyzed.

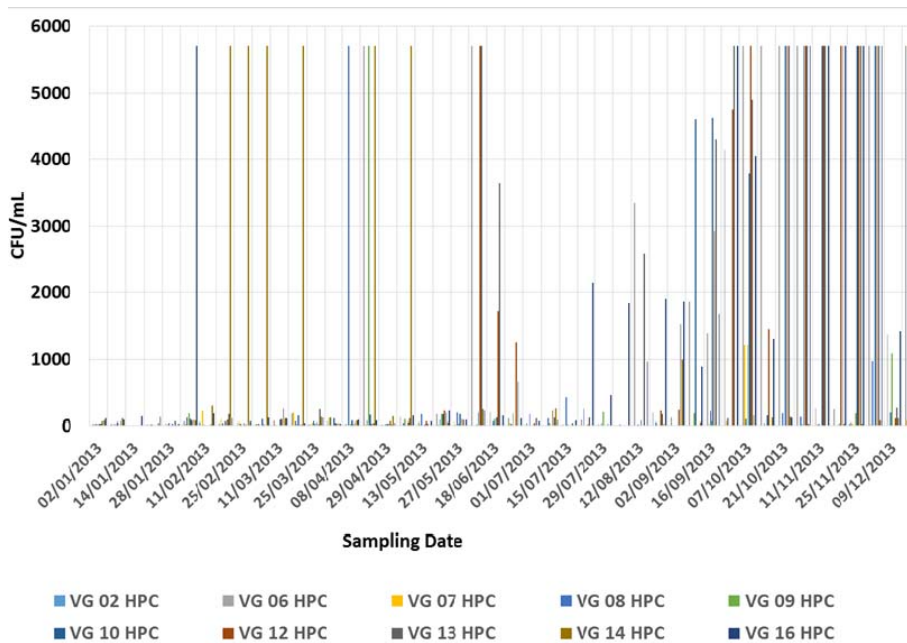
Fig. 5. Heterotrophic plate count results for January to December 2013

Figure 5 shows the results of HPC for a period of 12 months. The results show that from January to May 2013, there were occasional HPC failures in the distribution. However, between June and December 2013, HPC failures (not complying with

the standard limits as prescribed in SANS 241, 2011), became regular. From June to December 2013, the concentration of HPC was above 1000 CFU/mL in 40% of the samples analyzed.

The HPC results showed a trend of failures (Figure 5, 7) starting June 2013 to December 2013 as a result of the residual chlorine which fluctuated during that period. Further investigation is in progress in order to:

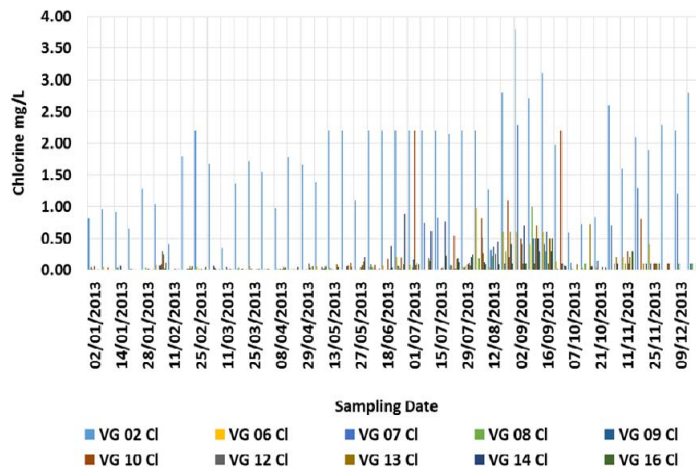
Fig. 6. Residual chlorine results for January to December 2013

Figure 6 shows the results of residual chlorine for a period of 12 months. The results show that from January to May 2013, the chlorine residual was < 0.1 mg/L for most of the sampling points except for the initial treated water at VG02. From June to De-

cember 2013, the chlorine residuals increased but the HPC still failed. The results indicate that inefficient disinfection is one of the factors that contribute to high HPC in the distribution system, but in this case other factors would require further investigation.

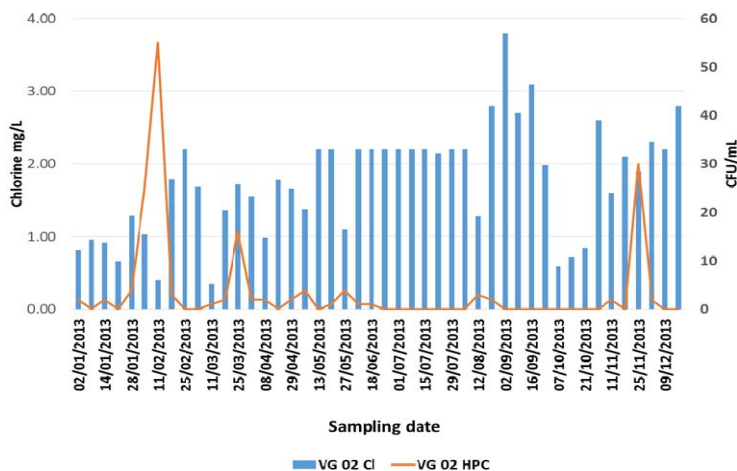
Fig. 7. Graph of chlorine and HPC for VG02

Figure 7 shows the results of HPC versus chlorine for VG02 (which is the initial sampling point at the plant, for final treated water). The results show good residual

chlorine throughout the year and HPC was not detected in most cases. The highest HPC result detected was 50 CFU/mL with chlorine residual of <1.0 mg/L.

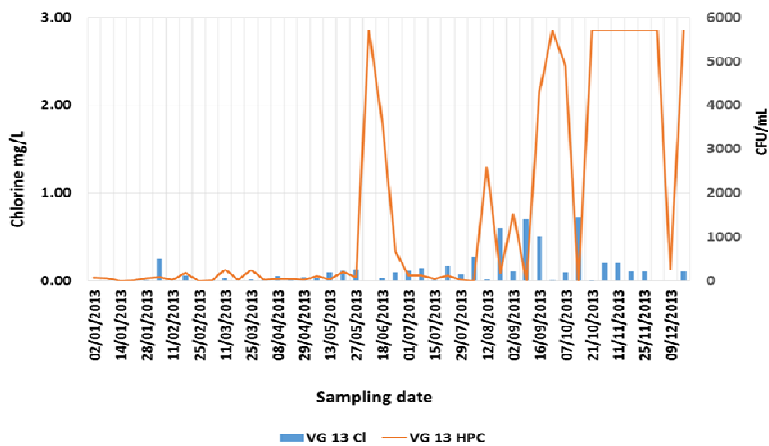
Fig. 8. Graph of chlorine and HPC for VG13

Figure 8 shows the results of residual chlorine versus HPC for VG13, which is the furthest point from the treatment plant, in the distribution system. The results show that residual chlorine from January to May 2013 was as low as 0.01 mg/L while the HPC were always below 1000 CFU/mL,

which is the standard limit. Starting June 2013 to December 2013, the residual chlorine improved, but HPC was >5700 CFU/mL in most cases. The value >5700 CFU/mL was statically changed to 5701 for analysis purposes, as described in Dzwairo et al. (2011).
